National Dam Inspection Program. Eberle
Dam (NDI PA 036, PA-456), Susquehanna
River Basin, Closes Creek, Tioga County,
Pennsylvania. Phase I Inspection Report.

PHASE I REPORT
National Dam Inspection Program

PA-456 Dam (Eberle Dam): NDS I.D. No. PA-00036

Owner: Tioga County Commissioners
State Located: Pennsylvania (PennDER I.D. No. 59-63)
County Located: Tioga County
Stream: Closes Creek
Inspection Date(s): 6 November 1978
Inspection Team: GAI Consultants, Inc.
570 Beatty Road
Monroeville, Pennsylvania 15146

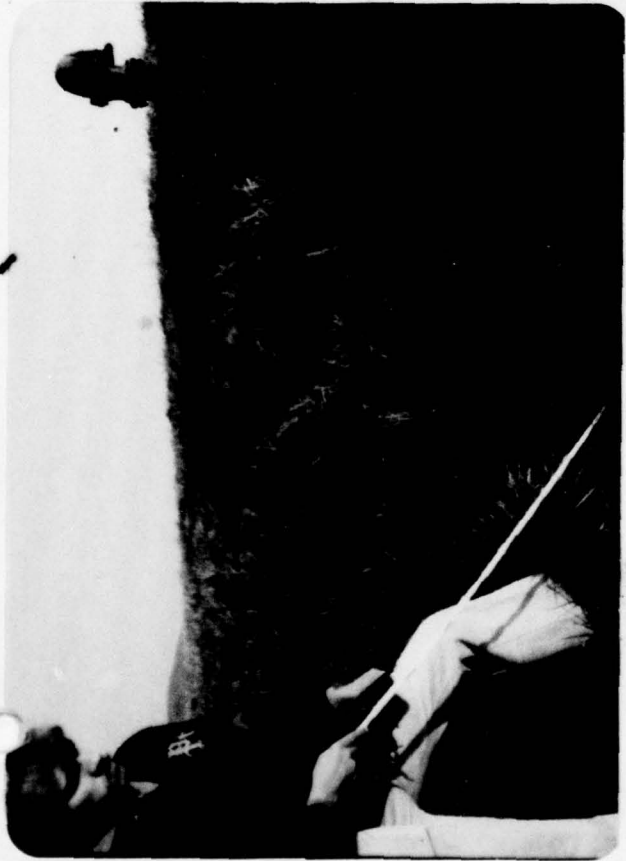
5

a) Service Spillway. The service spillway is a drop inlet type structure consisting of a reinforced concrete riser and a 30-inch diameter, reinforced concrete, discharge conduit. The riser is a 23-foot high structure and is located along the upstream toe between Stations 6+00 and 7+00. The intake orifice is two feet wide by one foot high and is set at elevation 1518.7 (see Figures 6 and 7 and Photograph 4). The riser unit is provided with an 8-inch diameter vent pipe which extends along the upstream slope of the embankment and rises to an elevation just above the crest of the dam (see Figure 6 and Photographs 2 and 5).
