**GRAVEL LICK DAM
NDI No. Pa - 807**

**PHASE I INSPECTION REPORT
NATIONAL DAM INSPECTION PROGRAM**

27 June 1978 (visual inspection)

Inspection Team - GAI Consultants, Inc.
570 Beatty Road
Monroeville, Pennsylvania 15146

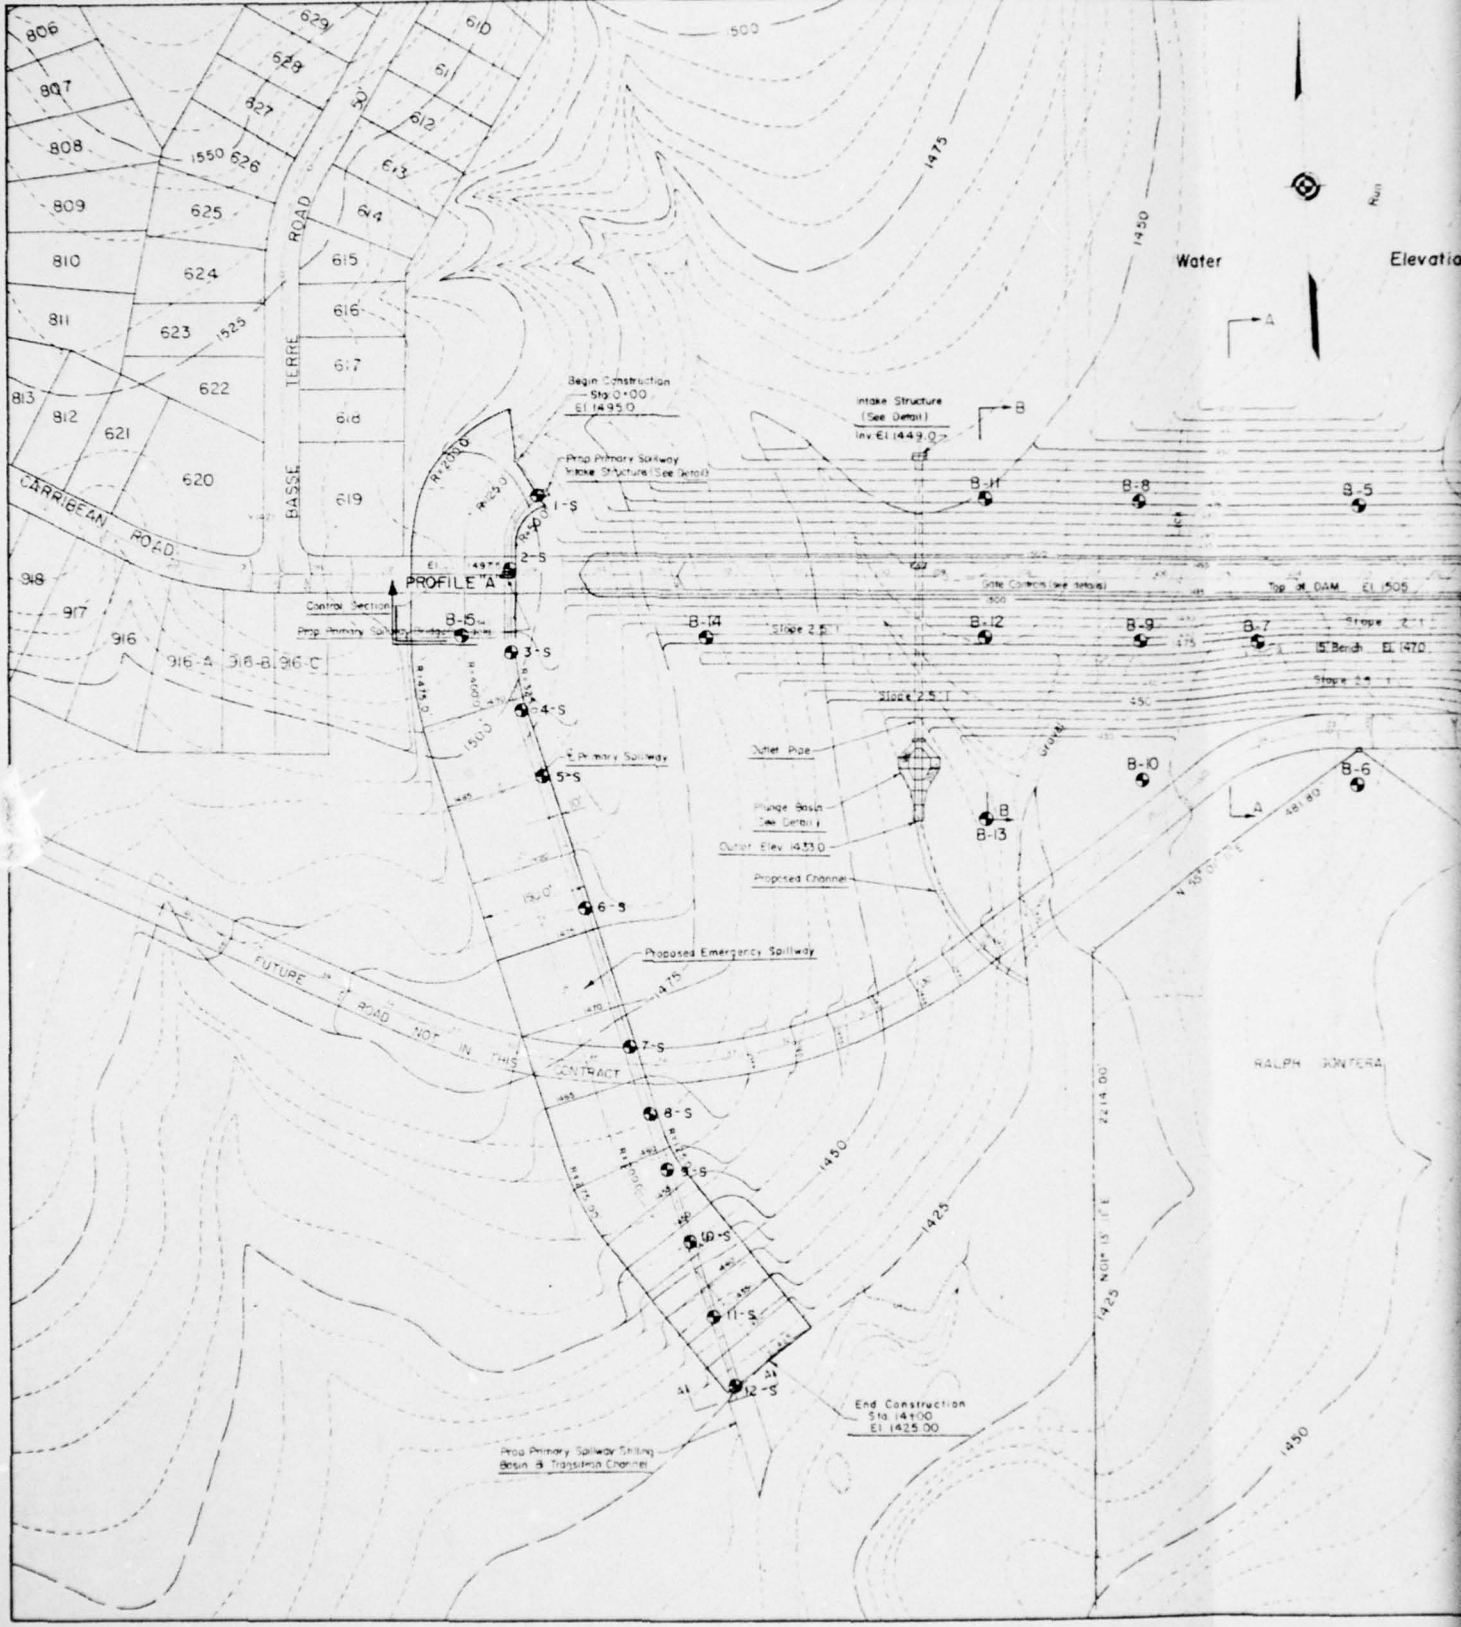
FIGURE 2

1. Embankment. The contract drawings indicate the dam embankment is a zoned earthfill structure. An impervious core and cutoff trench to rock are provided along the embankment centerline. Ten-foot wide filters are provided on each side of the impervious core material (see Figure 2).

The outer zones are comprised of semi-pervious material. The embankment is provided with side slopes of 3H:1V upstream and 2-1/2H:1V downstream above elevation 1470. There is a 15-foot wide berm at elevation 1470 on the downstream face. The slope below this elevation is 3H:1V. The dam crest was measured to be 40 feet wide and contains an asphalt roadway surface. A 2-foot thick zone of riprap covers an 8-inch filter blanket on the upstream face between elevation 1485 and the top of the dam. A 30-foot wide drain is located at the downstream toe to control the phreatic surface within the embankment (see Figure 2).

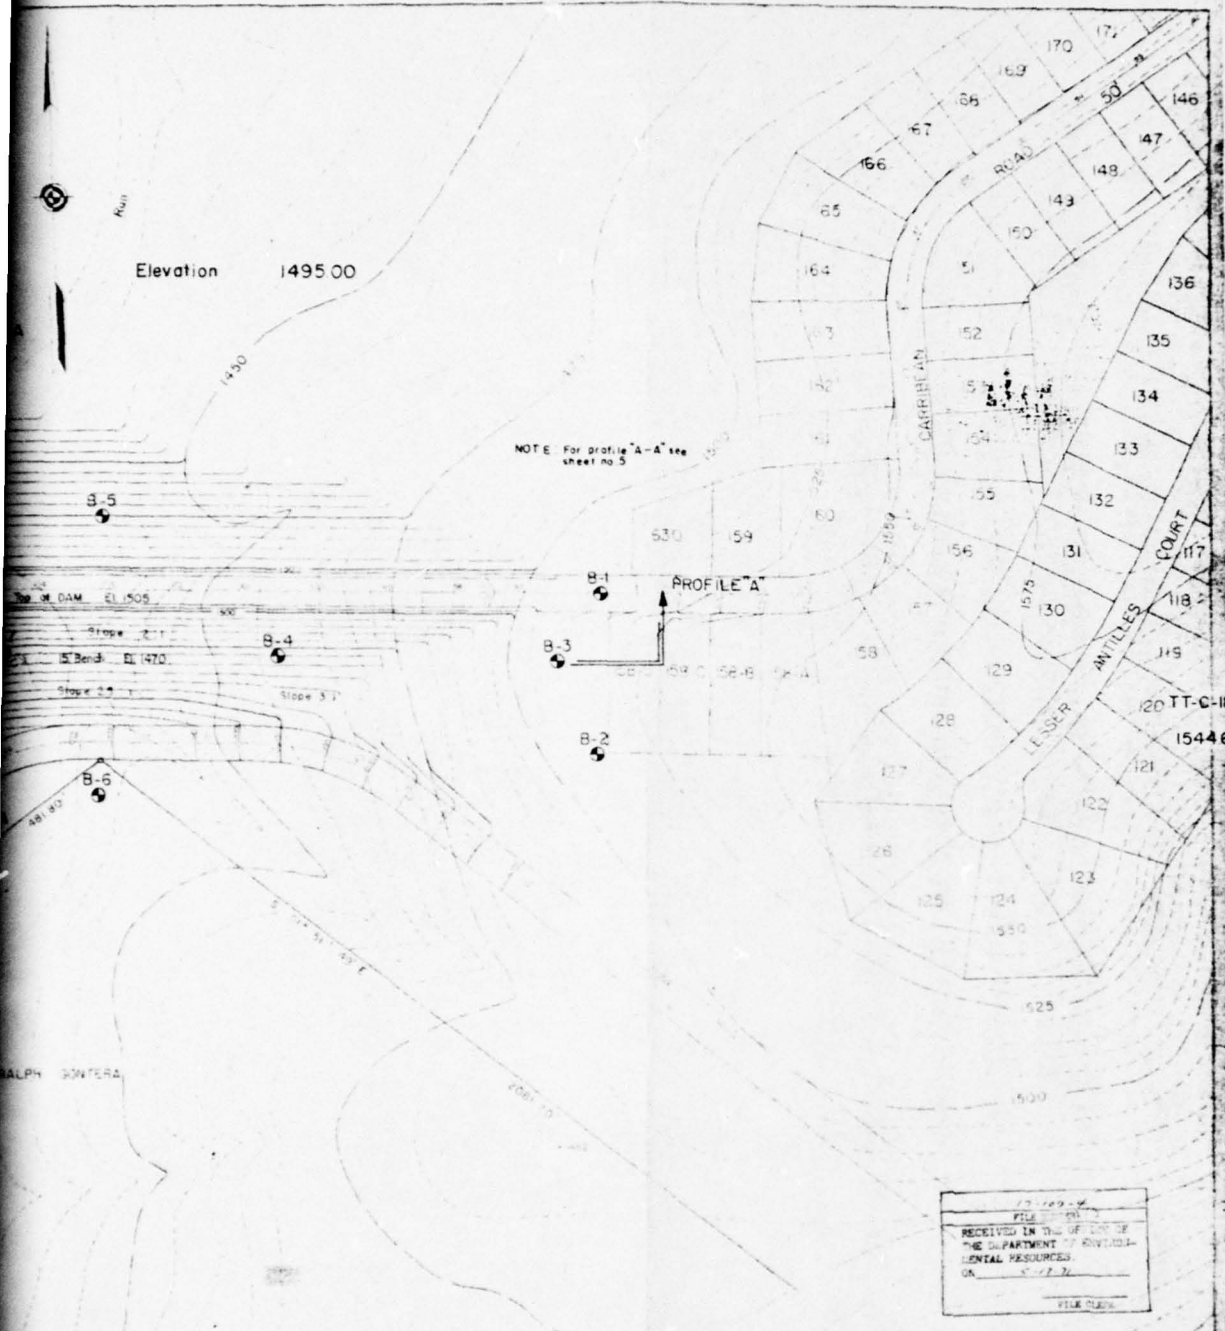
FIGURE 3

The outlet works consists of a 24-inch diameter concrete pipe. This line is valved at the intake and is located to the right of the dam center. The pipe carries flow approximately 360 feet before it is discharged into a riprap-lined channel at the toe of the dam (see Figure 3).

a) Service Spillway. The service spillway is a rectangular, 8-foot wide reinforced concrete channel located within the emergency spillway at the right abutment (see Figure 3 and Photograph 6). A "drop inlet" type concrete weir controls flow at the entrance. An 8-inch thick by 2-foot deep reinforced concrete key is constructed at the entrance just downstream of the weir. The wingwalls are backfilled with 1.5 feet of gravel to facilitate proper drainage.

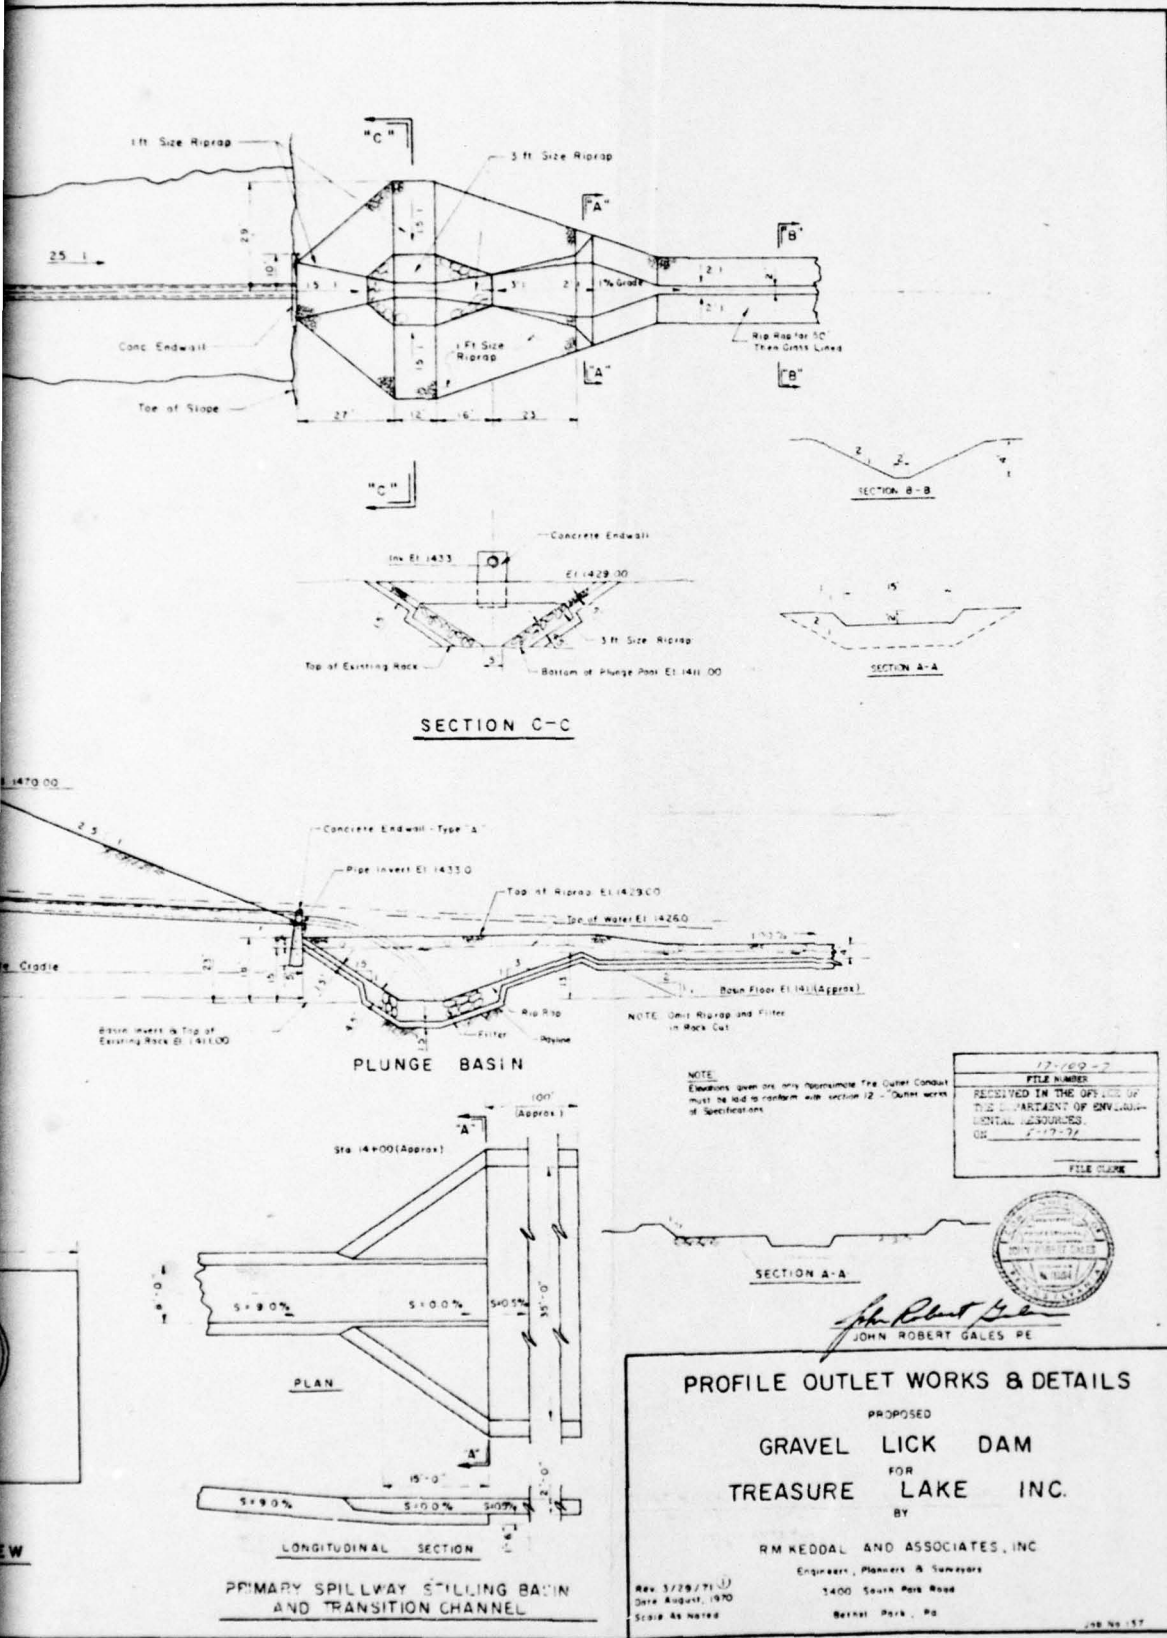
FIGURE 4

c) Outlet Works. The outlet works serving Gravel Lick Dam are located to the right of the dam center. The system includes a submerged intake structure, a sliding trash screen and sluice gate, a 24-inch pipe passing through the dam, and a riprap-lined plunge pool (see Figures 3, 4, 5, and 6).

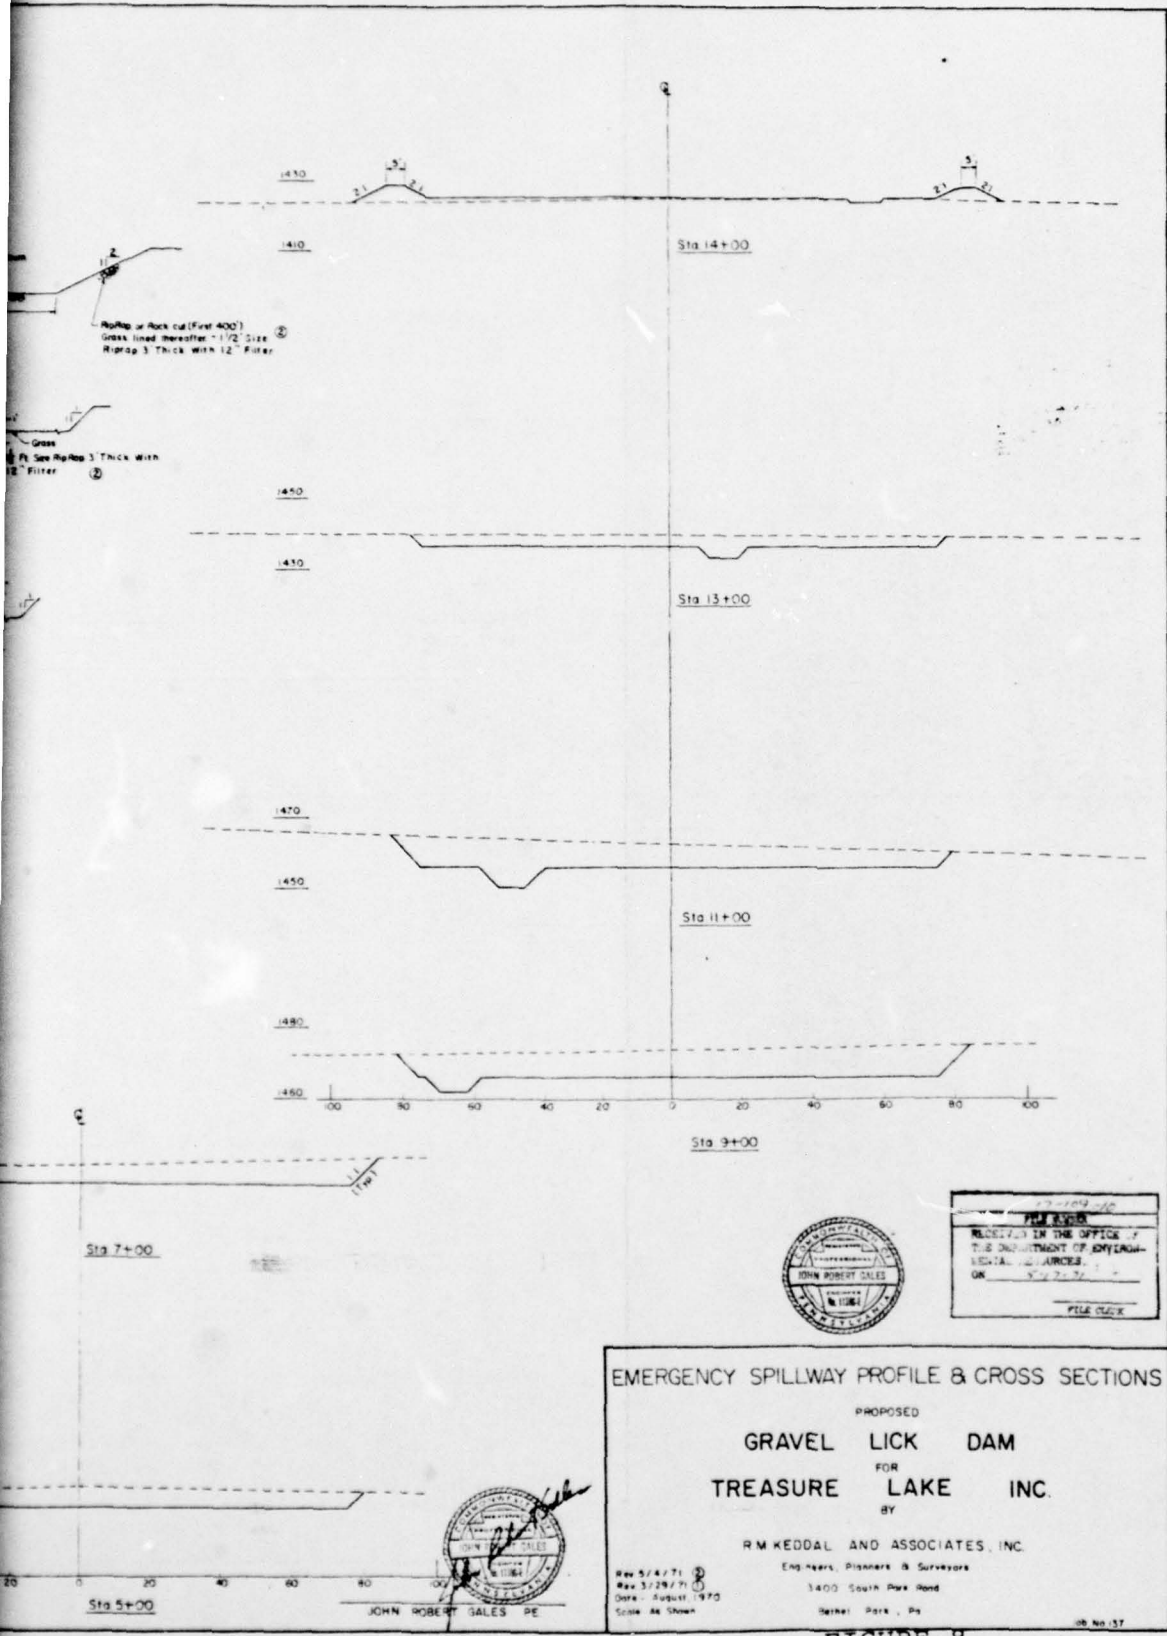
FIGURE 8

b) Emergency Spillway. The emergency spillway is a trapezoidal channel, 150 feet wide at the base, cut into rock at the right abutment. The side slopes are 2H :1V. The depth of the spillway at the control section is 7.5 feet below the crest of the dam (see Figures 3 and 8).
