RARITAN RIVER BASIN  
AMBROSE BROOK, MIDDLESEX COUNTY  
NEW JERSEY

**LAKE NELSON DAM**

**NJ 00376**

**PHASE 1 INSPECTION REPORT  
NATIONAL DAM SAFETY PROGRAM.**

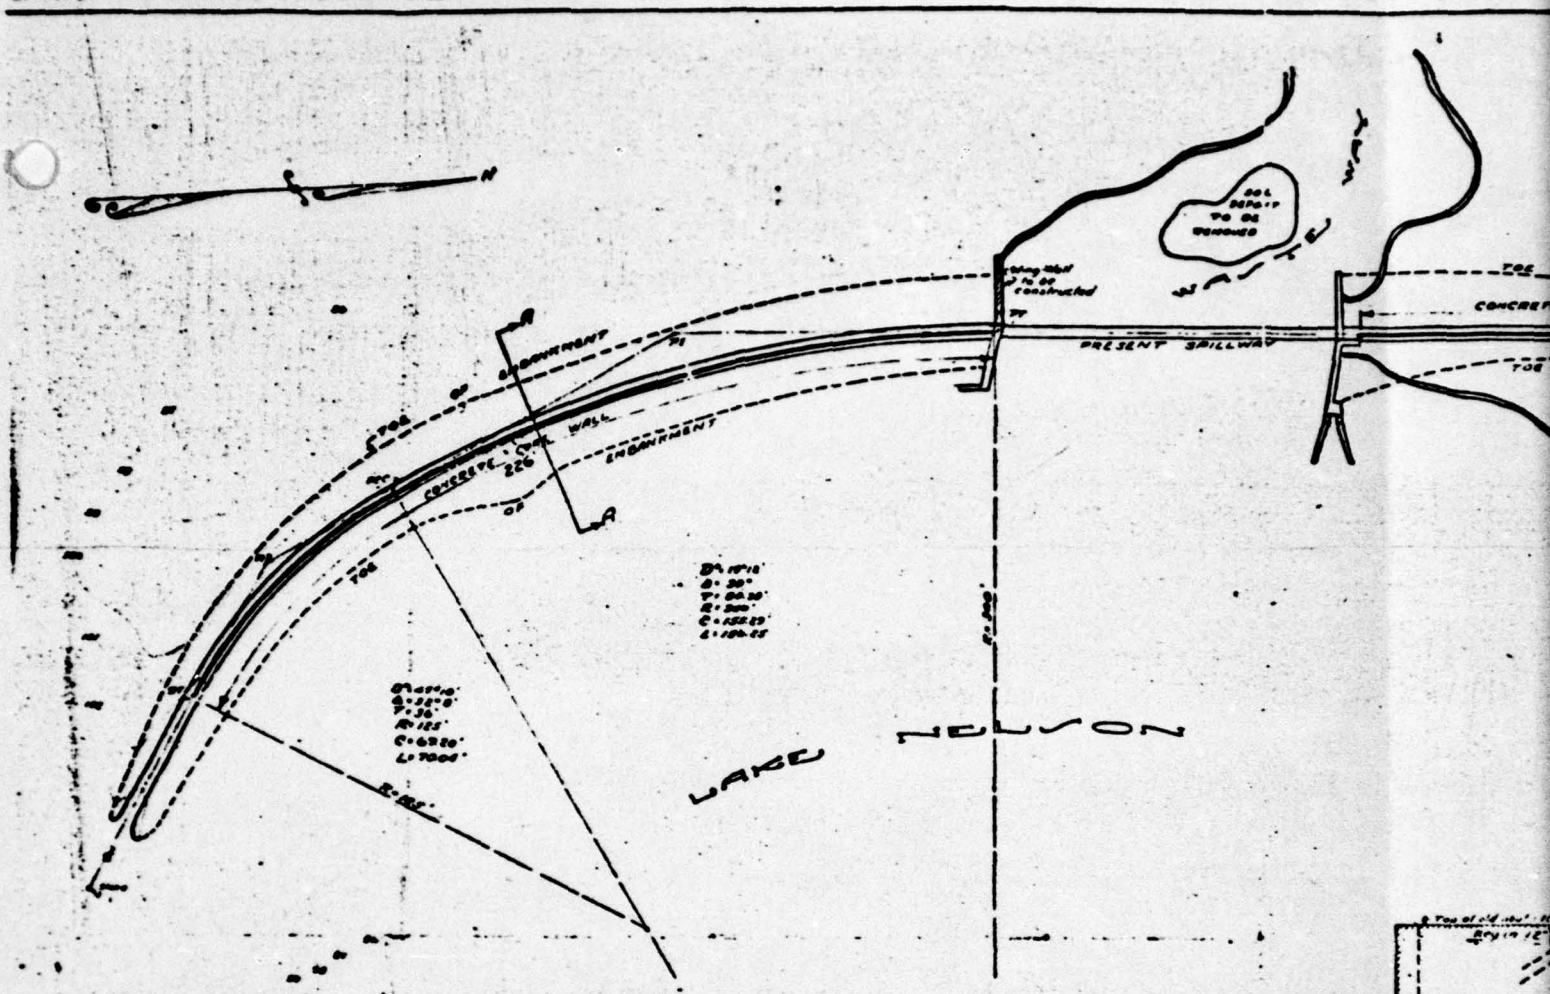
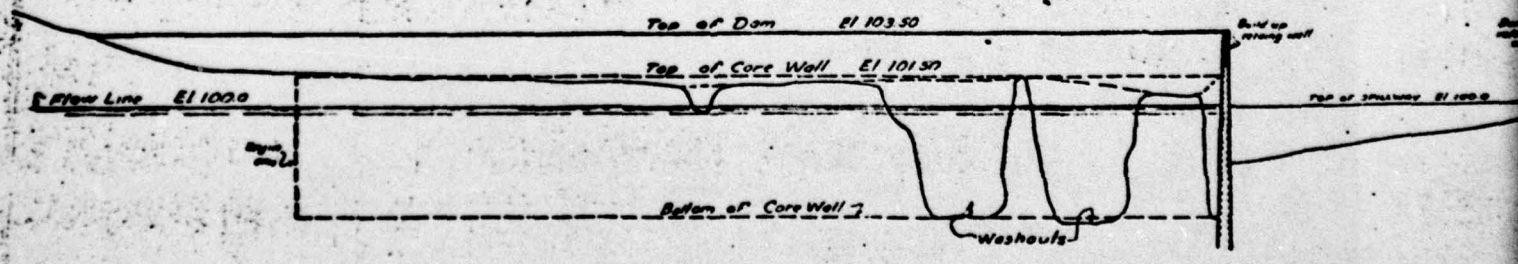
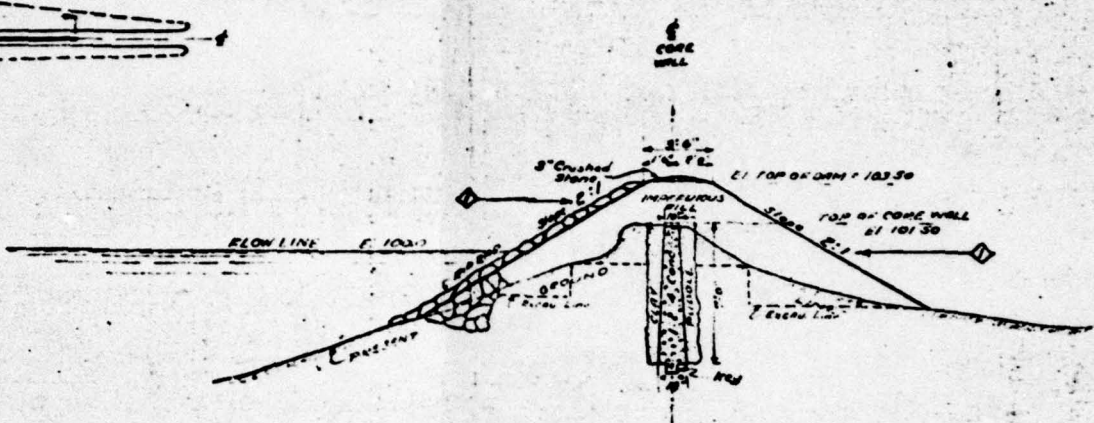
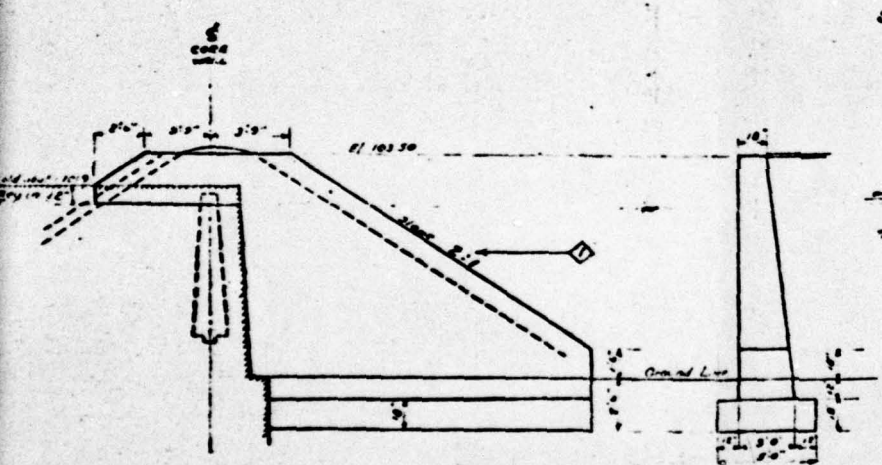
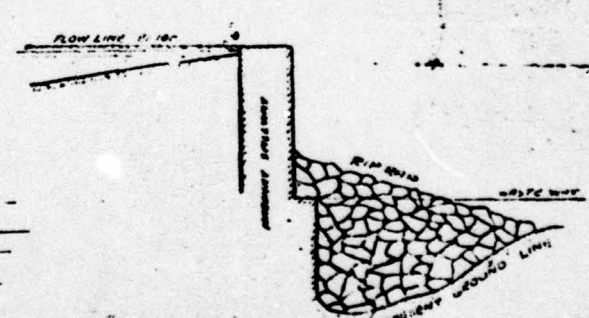
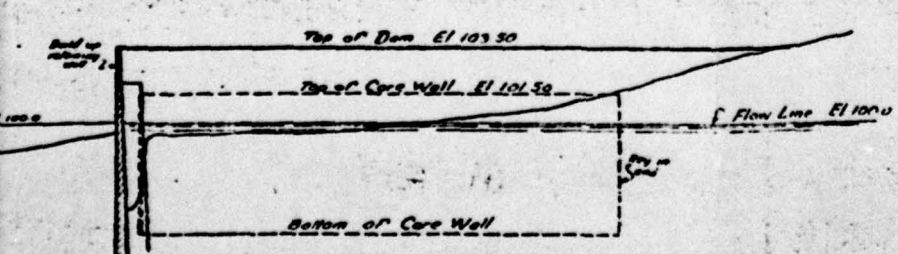
PROPOSED RECONSTRUCTION  
OF  
**LAKE NELSON DAM**  
AT  
NEW MARKET, N.J.  
OCT 1, 1956 SCALE 1/4" = 1'-0"

Visual inspection indicates that the existing dam differs somewhat from that shown in Plate 2. This drawing indicates that the top of the embankment was to be raised to the top of the spillway wing walls; however, the top of the dam is presently approximately 1.5 feet below the top of the wing walls, possibly due to subsequent erosion. The present configuration of the spillway discharge channel is not as shown on Plate 2, and a concrete wall has been added at the upstream side of the north embankment. In addition, the spillway buttresses and apron and the emergency spillway are not shown on Plate 2. A sketch of the present configuration of the general spillway area based on visual inspection is shown on Plate 3.
