**ATSION LAKE DAM**

**NJ 00041**

**PHASE 1 INSPECTION REPORT  
NATIONAL DAM SAFETY PROGRAM**

**DEPARTMENT OF THE ARMY**

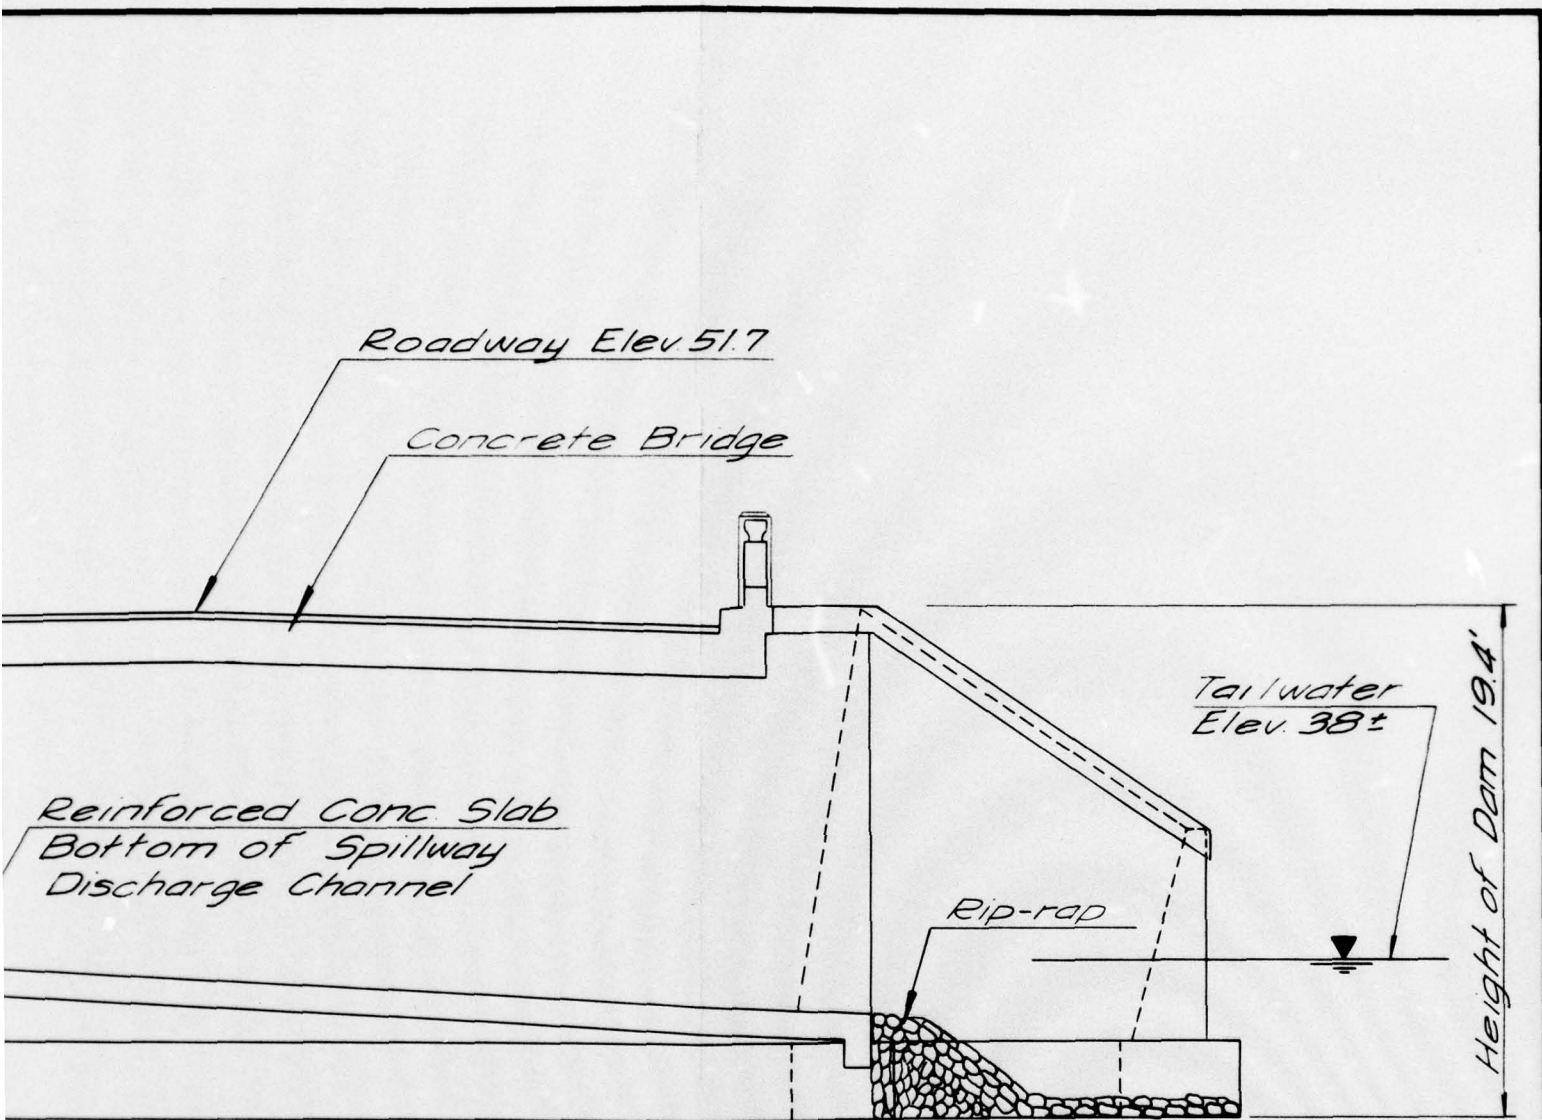
PLATE 6

Lake Water Level at  
time of inspection  
Elev. 46.0

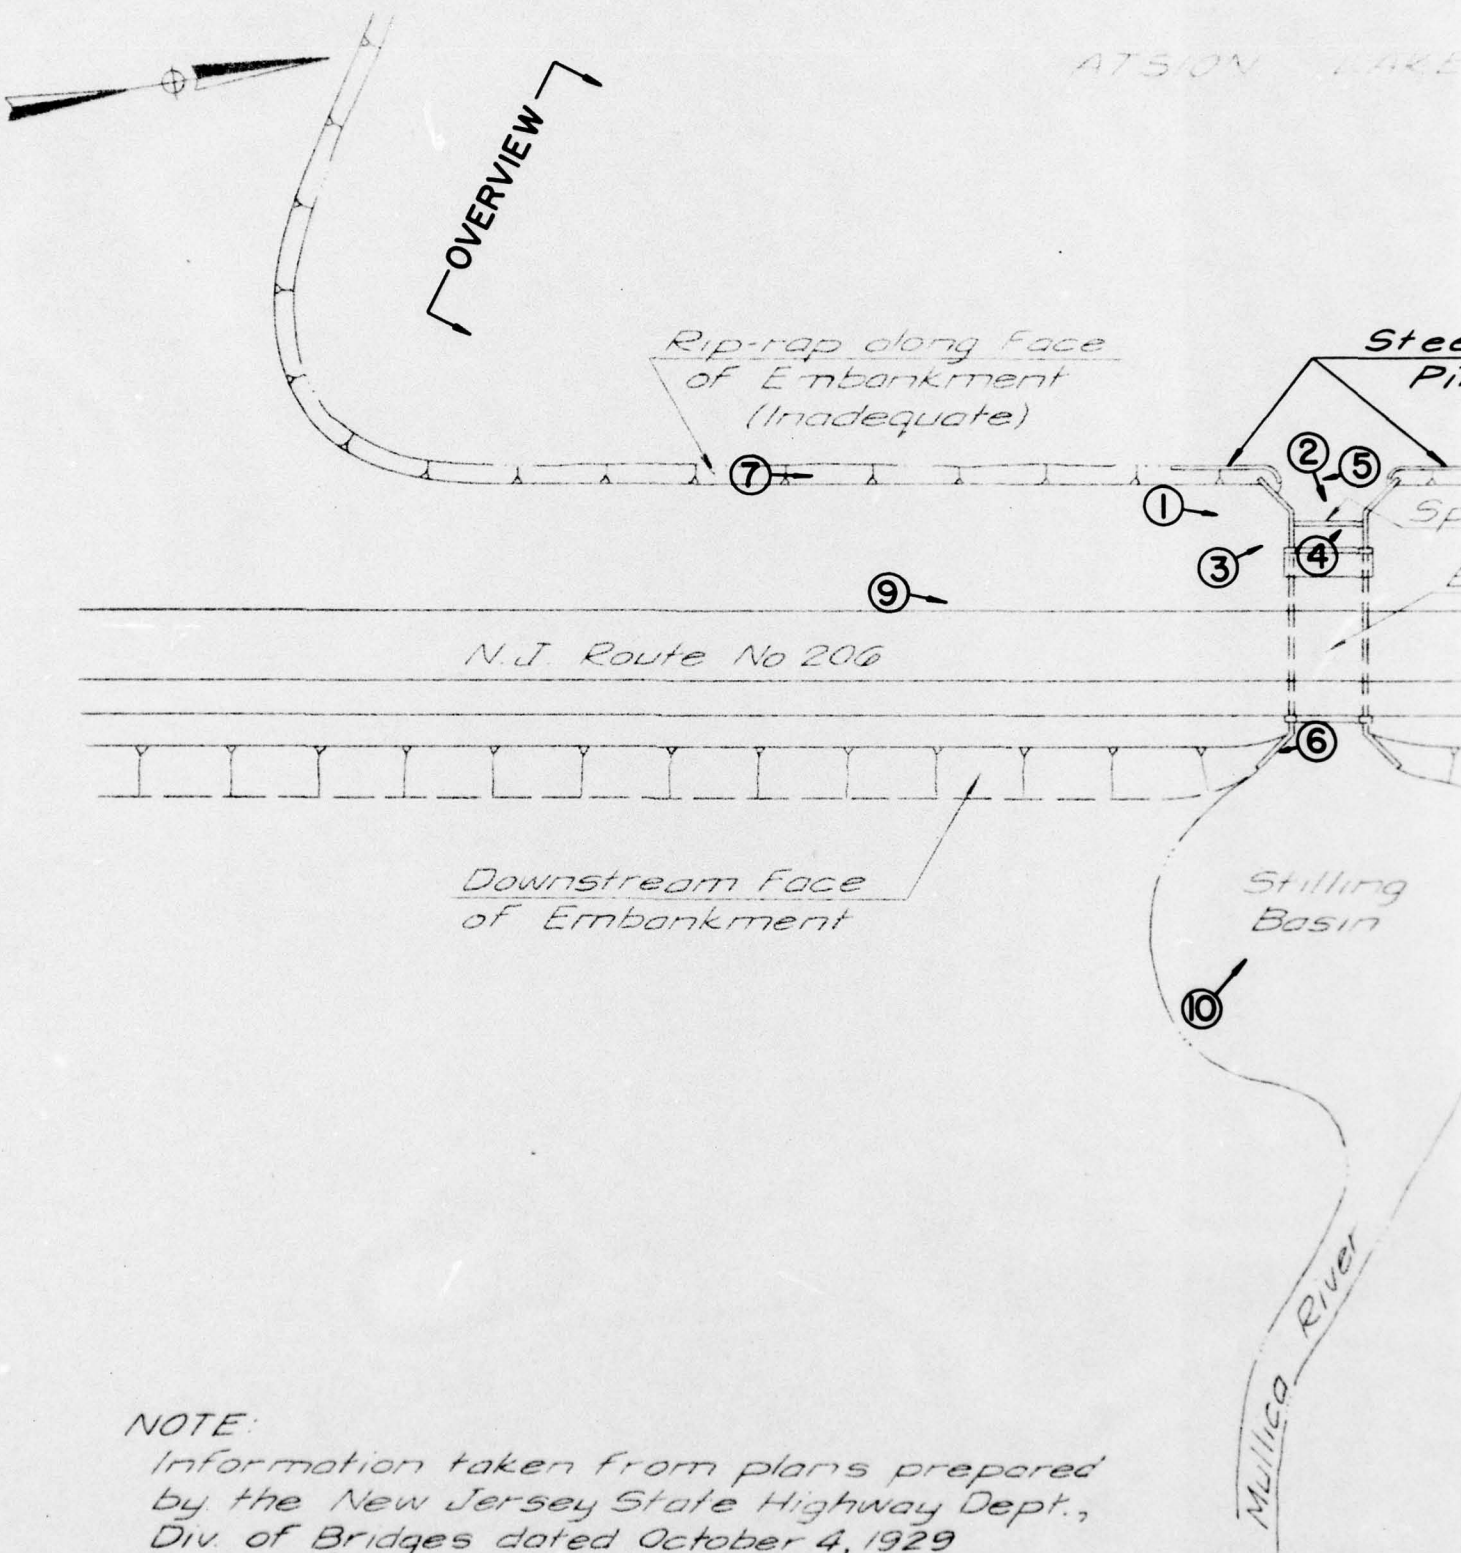
OVERVIEW

Riprap was observed along most of the upstream face of embankment. The riprap appeared to be composed of rocks and debris lacking in durability and therefore was assessed as being unsatisfactory.

Rip-rap along Face of Embankment (Inadequate)

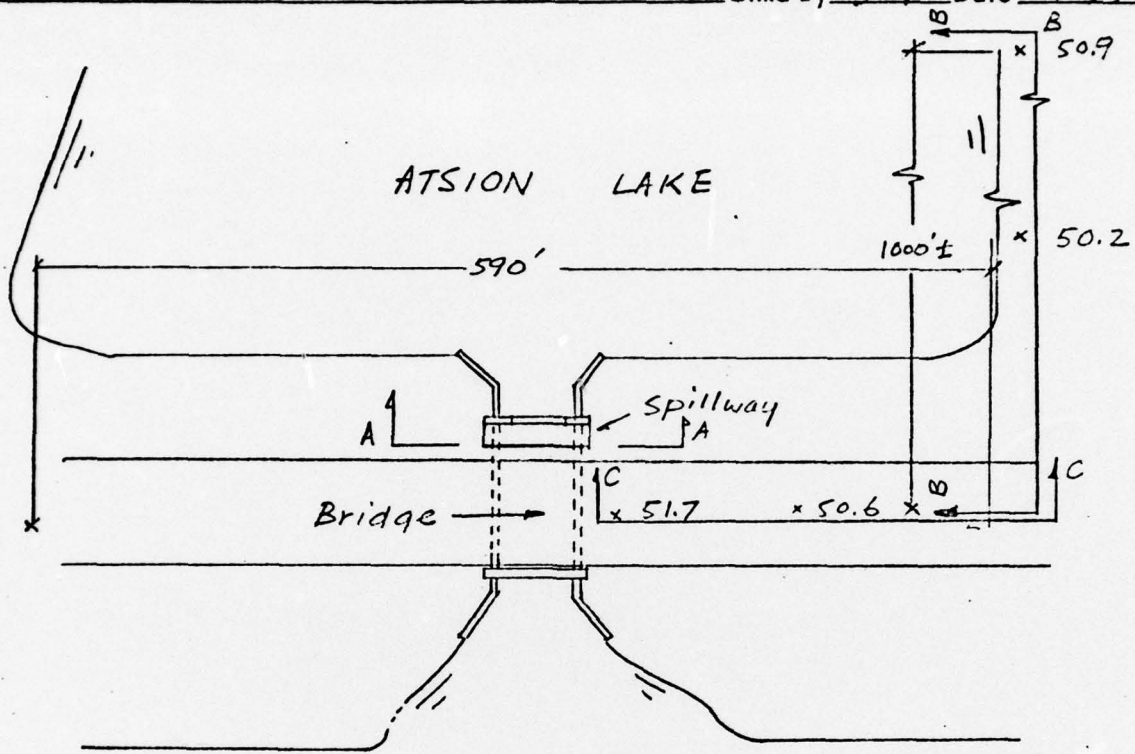
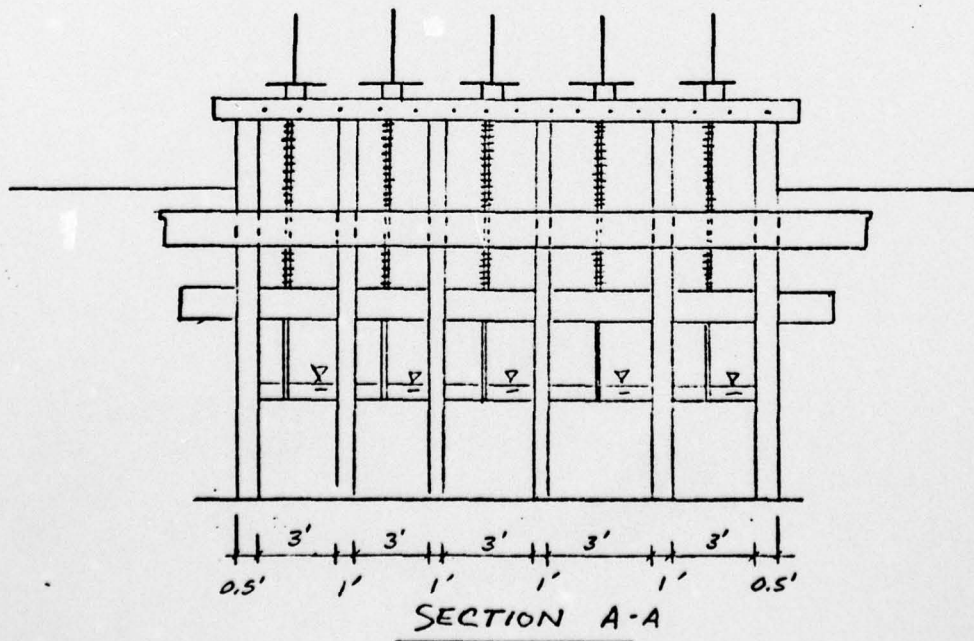
Low area along north shore  
of lake adjacent to dam

Dam embankment is assumed to be level at EL 51.7 for 310' and drops down to EL. 50.5 in 280'.

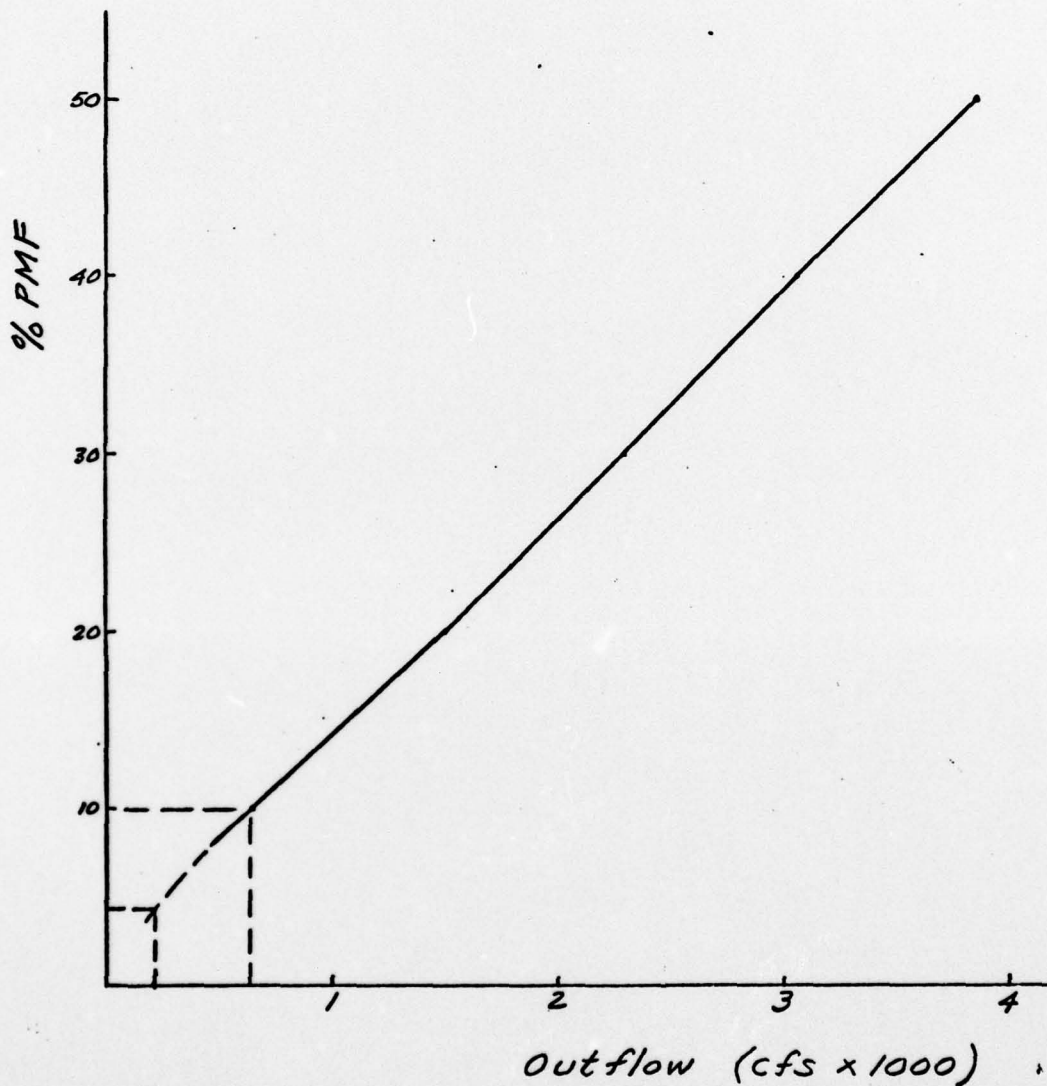
OVERTOPPING POTENTIAL

Overtopping of low area occurs at elev. 50.2  
with  $Q = 220$  c.f.s. ( $\sim 4\%$  PMF)

Overtopping of dam occurs at elev. 50.5  
with  $Q = 445$  c.f.s. ( $\sim 10\%$  PMF)
