PASSAIC RIVER BASIN
RAMSEY BROOK
BERGEN COUNTY
NEW JERSEY

**CRYSTAL SPRING
LAKE
NJ 00231**

**PHASE 1 INSPECTION REPORT
NATIONAL DAM SAFETY PROGRAM**

May, 1979

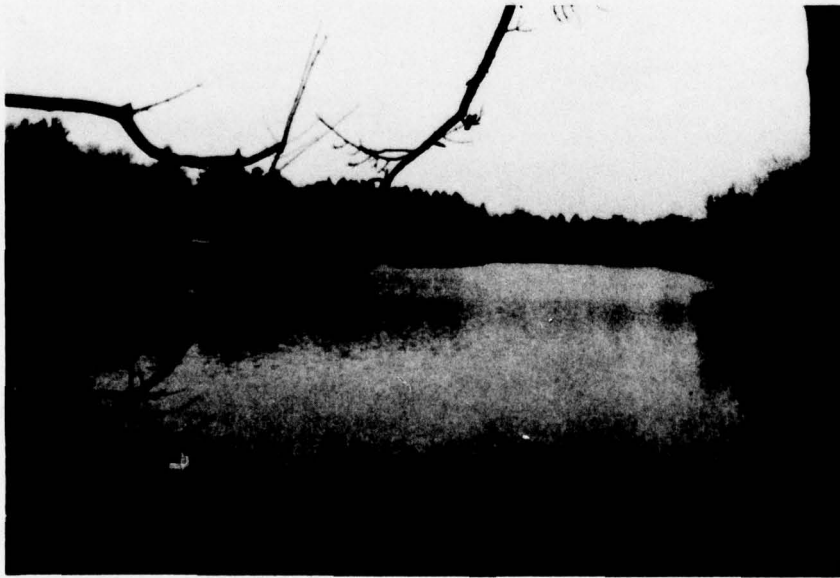
Slopes around the reservoir are gentle and wooded (Photo 7). Numerous houses face the reservoir on the surrounding roadways.

Photo 7 - Reservoir area, looking north.
(November 30, 1978)

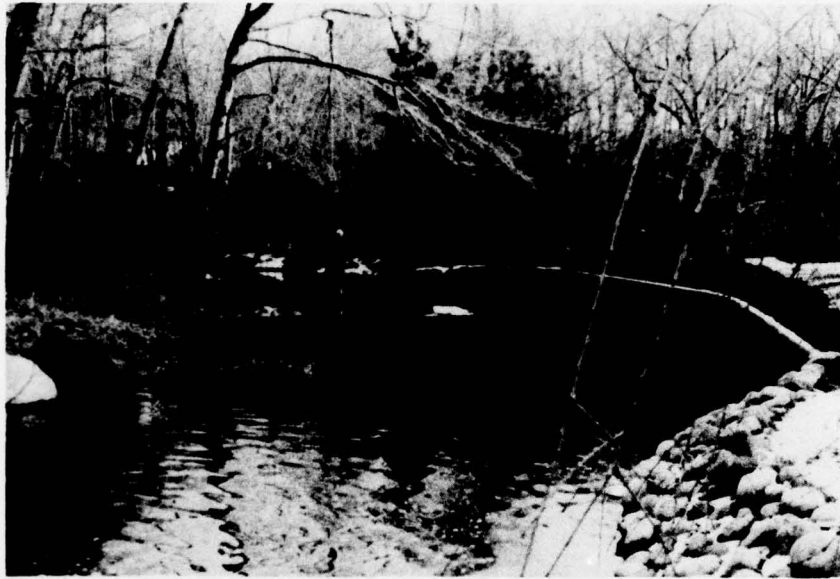
A concrete lined channel with vertical block and masonry training walls extends about 70 feet downstream from the toe of the spillway apron, terminating at a low weir (Photo 8). A house is located on the right bank of the lined channel (Photo 9) and there is another house in the flood plain downstream. Below the lined channel, the natural stream meanders considerably and the flow channel is not well defined in places. The overbank flood channel has moderate slopes and is heavily wooded.

Photo 8 - Concrete weir at end of lined
channel downstream of the spillway.
(November 30, 1978)

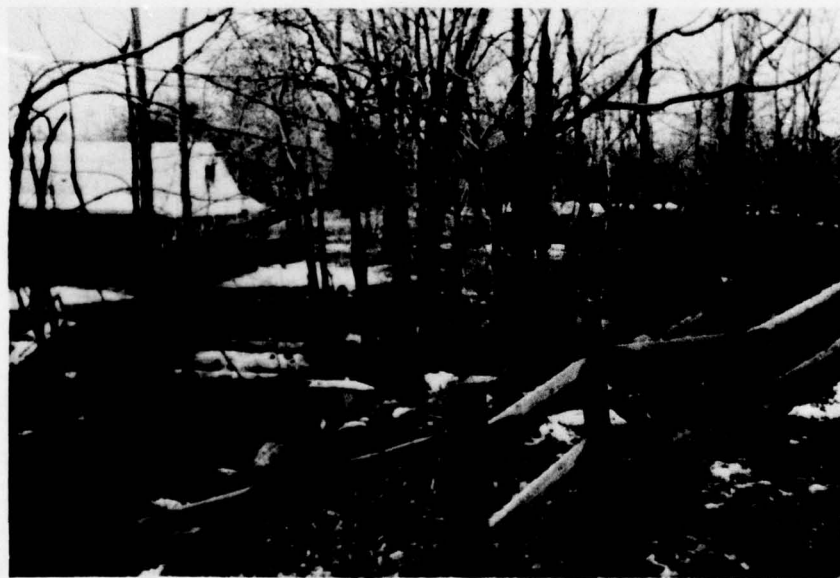
Photo 9 - House on right side of lined
channel downstream of spillway.
(November 30, 1978)
