PASSAIC RIVER BASIN
SHEPARD BROOK, PASSAIC COUNTY
NEW JERSEY

SKYLINE LAKE DAM NO. 2 NJ 00200

PHASE 1 INSPECTION REPORT NATIONAL DAM SAFETY PROGRAM

May, 1979

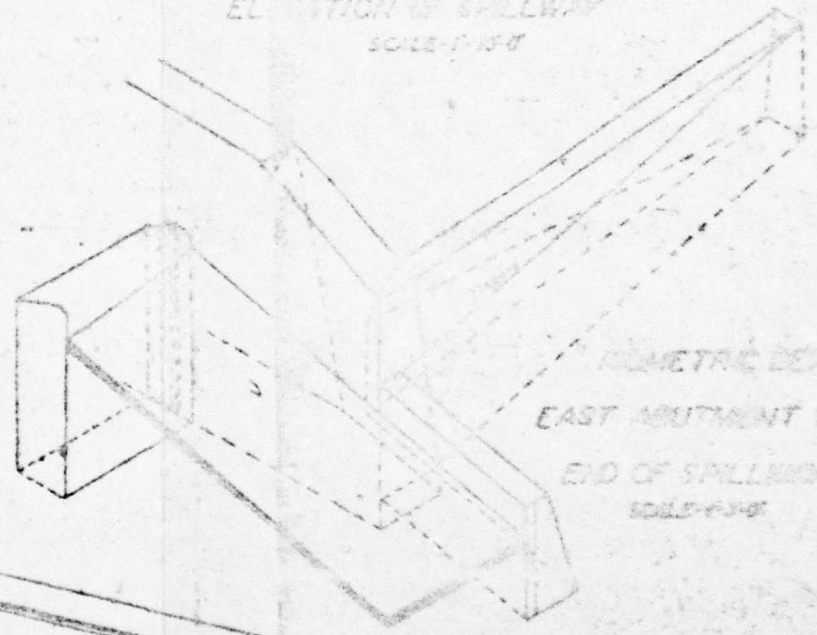
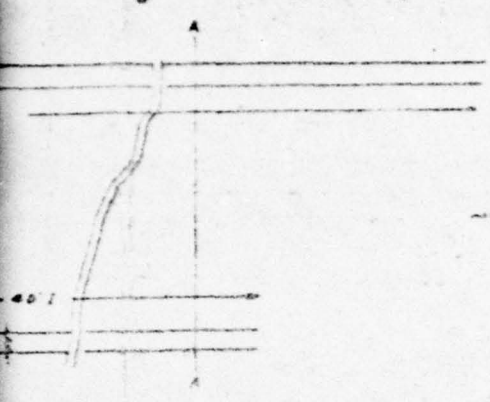
ELEVATION OF SPILLWAY
SCALE 1/16"

The spillway is a 50 foot wide chute. The crest is a 2-foot wide and 6.5-foot high concrete wall extending between side walls of the spillway which retain the embankment at 4 feet above spillway crest (Plate 3). The discharge channel is a 40 to 50 foot long asphalt macadam pavement between concrete training walls extending downstream to the discharge end at the normal lake level of Skyline Lake Dam No. 1, about elevation 268 MSL. The spillway design flood was reported as 300 cfs/sq. mi. based on 125% Central New Jersey Curve for a drainage area of 2.8 square miles.

Inspection reports prepared during the dam construction indicate that the dam was constructed generally as shown on the available drawings and in accordance with the specifications. However, the present inspection indicates that the spillway cross-section is horizontal and not concave as shown on Plate 3, Section A-A.

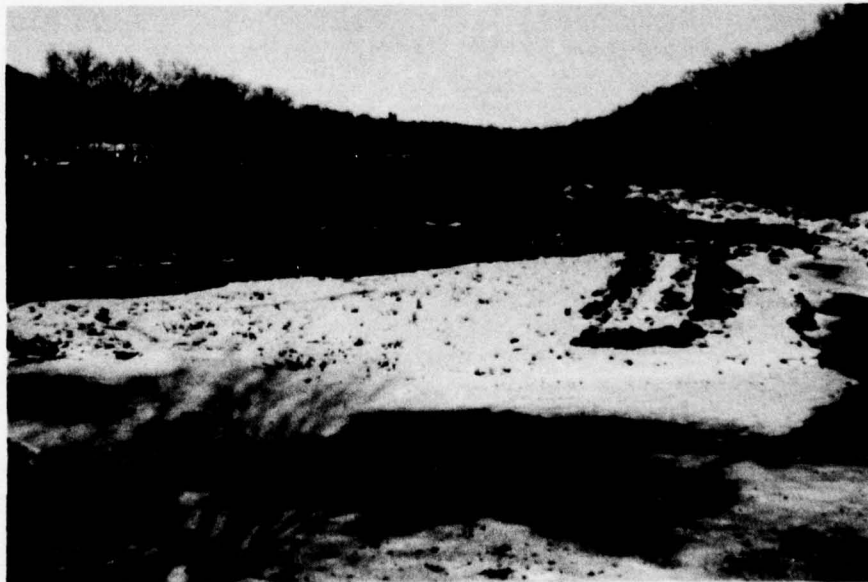
Photo 10 View looking upstream from dam

The reservoir was empty at the time of both inspection (Photo 10) and the water flowing into the

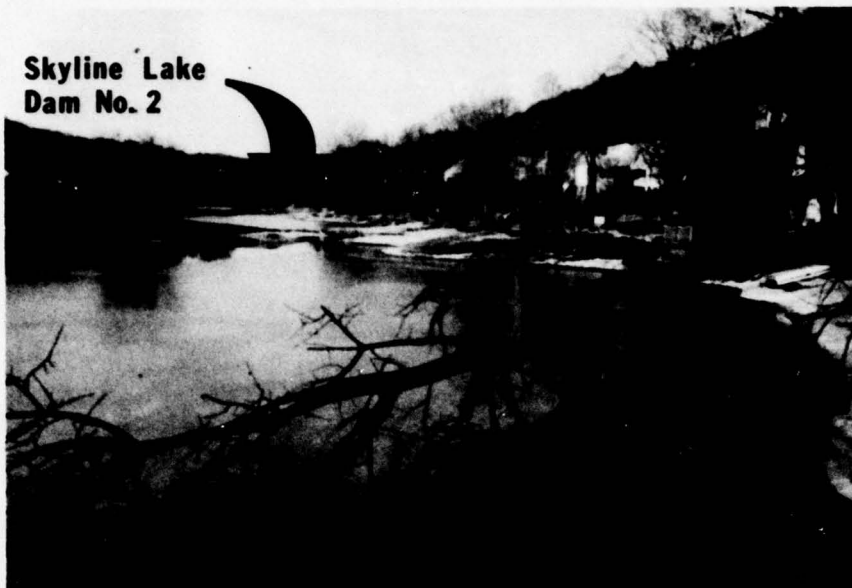
Photo 11 View of downstream reservoir area looking upstream from Dam #1

Flow over the spillway empties into Reservoir No. 1, located immediately downstream from the dam. The perimeter of this reservoir is similar to Reservoir No. 2, described above (Photo 11).
