NSWC/DL-TR-3904

| REPORT DOCUMENTATION PAGE | | READ INSTRUCTIONS<br>BEFORE COMPLETING FORM |
|---|---|---|
| 4. TITLE (and Subtitle)<br>FABRICATION AND ASSEMBLY OF A SHIPBOARD MULTI-<br>FUNCTIONAL WASTE INCINERATOR (MFI). PHASE II | 5. TYPE OF REPORT & PERIOD COVERED<br>Final rept. | |
| 11. CONTROLLING OFFICE NAME AND ADDRESS<br>Naval Sea Systems Command<br>Washington, DC 20362 | 12. REPORT DATE<br>April 1979 | |

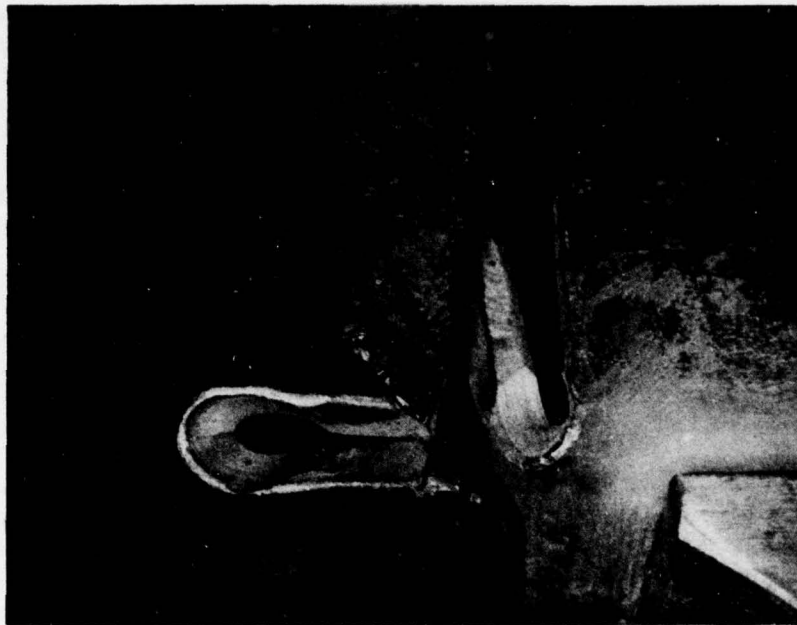
The side and end panels were fabricated by drop-shearing a 1/4-in. mild steel plate to include sufficient material for flanges. Corners were drilled at intersections of the flange ends, and the corner pieces were removed using a saw-cut. The 90° flanges were bent to approximately a 3/8-in. inside radius using a Cincinnati press brake with a 1/4-in. radius upper die and a 3/4-in. radius lower die. The resulting corner prior to welding is shown in Figure 1. All sharp edges were rounded to relieve high-stress areas that occur during the bending. The sewage chamber panels were fabricated in the same fashion.

Figure 1. Detail of Corner Fabrication

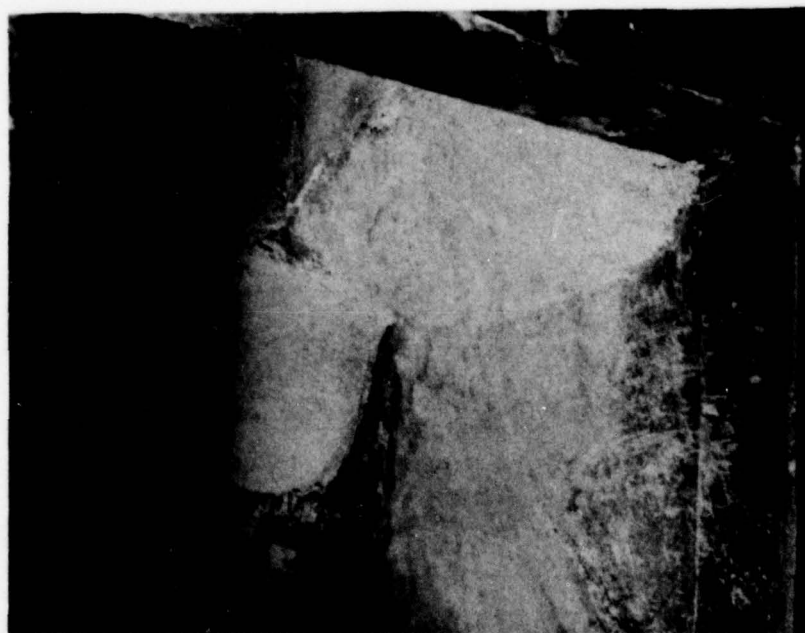
Assembly of the unit was begun upon completion of the sewage chamber enclosure. Figure 10 illustrates the unit with the cooling jacket installed. The Jade Pak plastic refractory used on the sewage nozzle billet and the rear wall of the sewage chamber to alleviate deterioration by droplet impaction is shown in Figure 11, and the entrance to the afterburner section and the interior of the afterburner section is shown in Figure 12. Additional application of Greencast 97 refractory was made to the lower portion of the afterburner section as illustrated by Figure 13.

Figure 13. Dressing of Refractory Edge at Afterburner Section Outlet
