PASSAIC RIVER BASIN
WANAQUE RIVER, PASSAIC COUNTY
NEW JERSEY

LAKE INEZ DAM
NJ 00228

PHASE 1 INSPECTION REPORT
NATIONAL DAM SAFETY PROGRAM

May, 1979

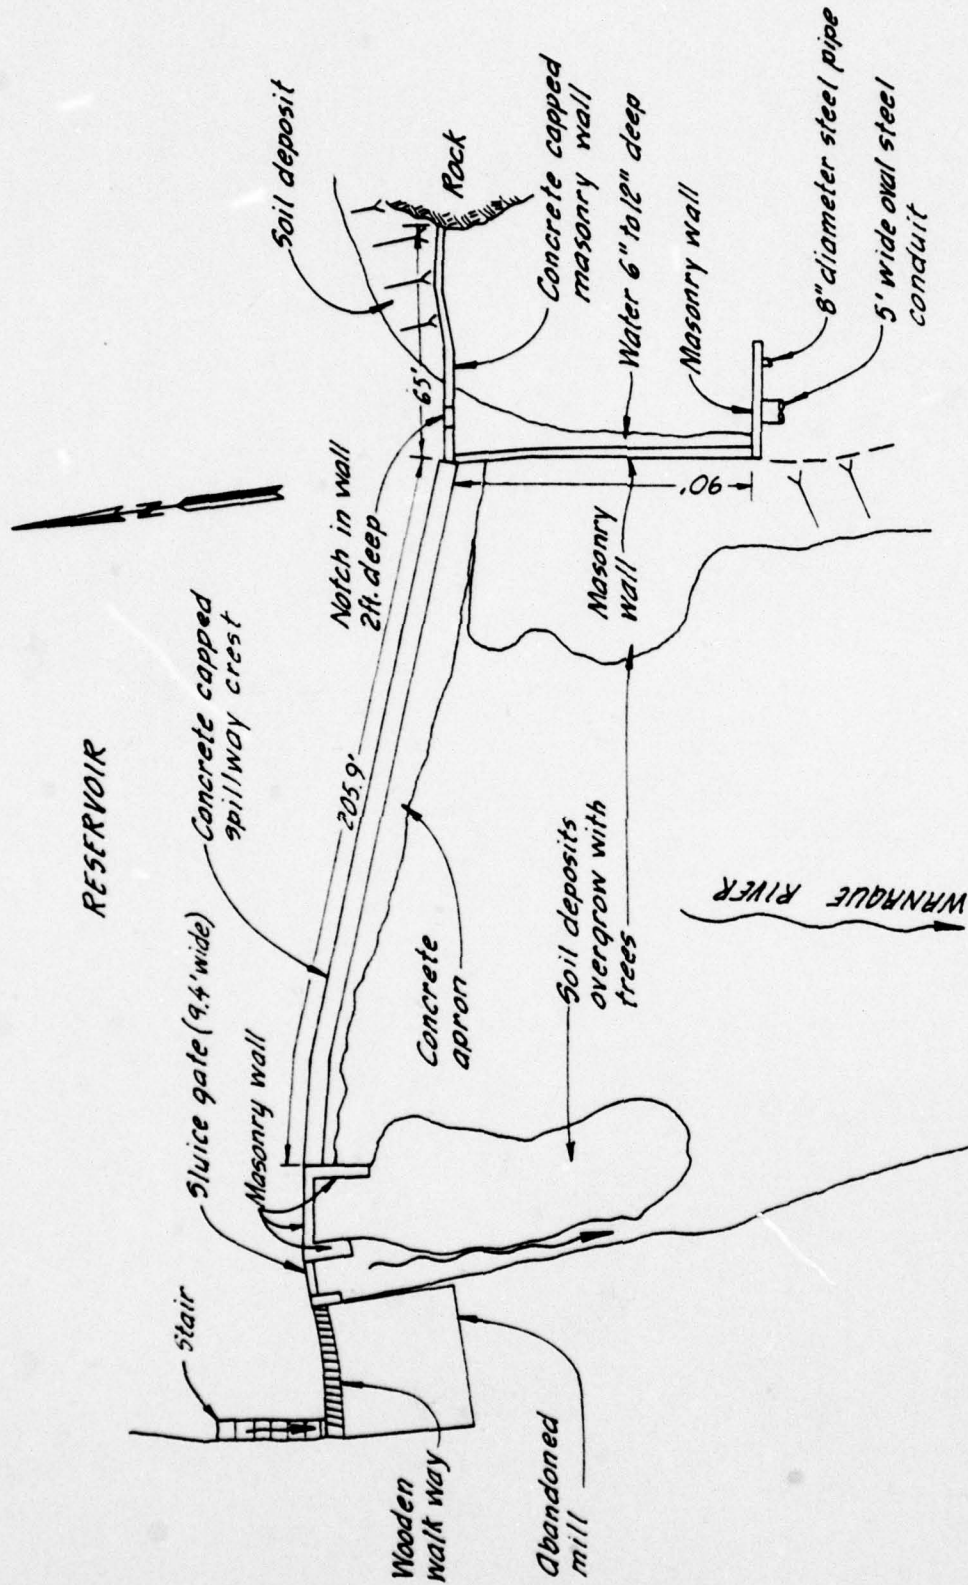
Severe cracking and separation between the concrete cap and masonry were observed at the junction of the left side of the spillway and the dam (Photo 2). Water from the reservoir is leaking through these cracks at an estimated rate of 5 gpm, forming a pond 6 to 12 inches deep. (Plate 2). There is a notch in the left side of the dam approximately 2 feet deep and 6 feet long which may have been associated with the penstock which appears to pass beneath the dam at this location.

An abandoned 5-foot wide steel, oval penstock and an 8-inch diameter steel pipe were observed on the downstream side of the left abutment of the dam (Plate 2 and Photo 8). Water was leaking through both these outlets at a rate of about 10 gpm. There is presently no indication of a power plant or other similar structure in the vicinity

A 9.4-foot wide sluice gate consisting of 4-inch by 8-inch boards is located to the left of the mill at the right side of the dam. The gate controls are inoperable and there is serious leakage between the boards (Photo 9). A small tree growing in the masonry wall adjacent to the sluice is shown in Photo 9. The discharge from the sluice flows adjacent to the old mill and joins the main channel downstream as shown in Plate 2.

GENERALIZED PLAN BASED ON VISUAL INSPECTION, DECEMBER 3, 1978
