SWEET ARROW LAKE DAM

NDI NO. PA-00680

**PHASE I INSPECTION REPORT
NATIONAL DAM INSPECTION PROGRAM**

BY
Berger Associates, Inc.
Harrisburg, Pennsylvania

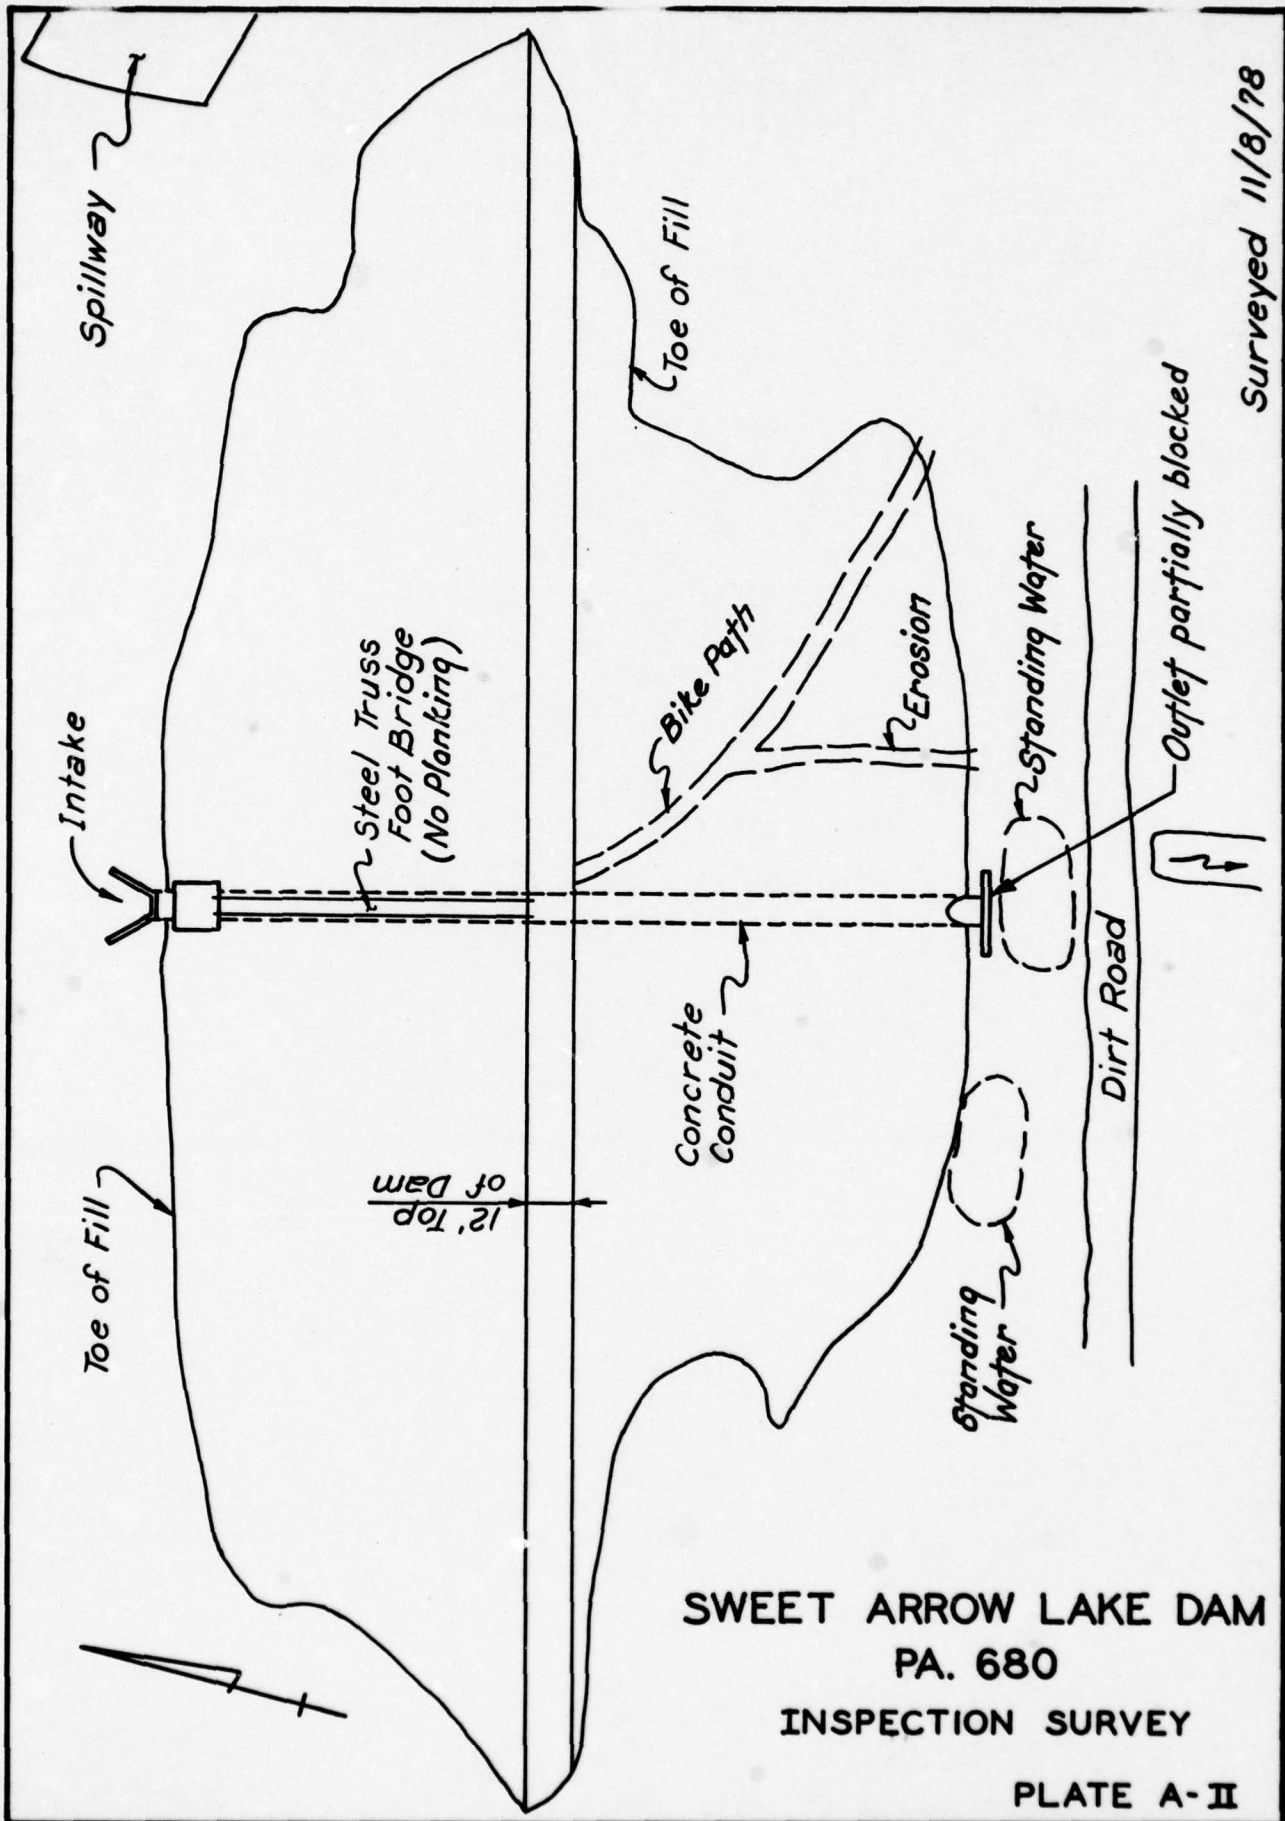
SWEET ARROW LAKE DAM
 PA. 680
 INSPECTION SURVEY

Surveyed 11/8/78

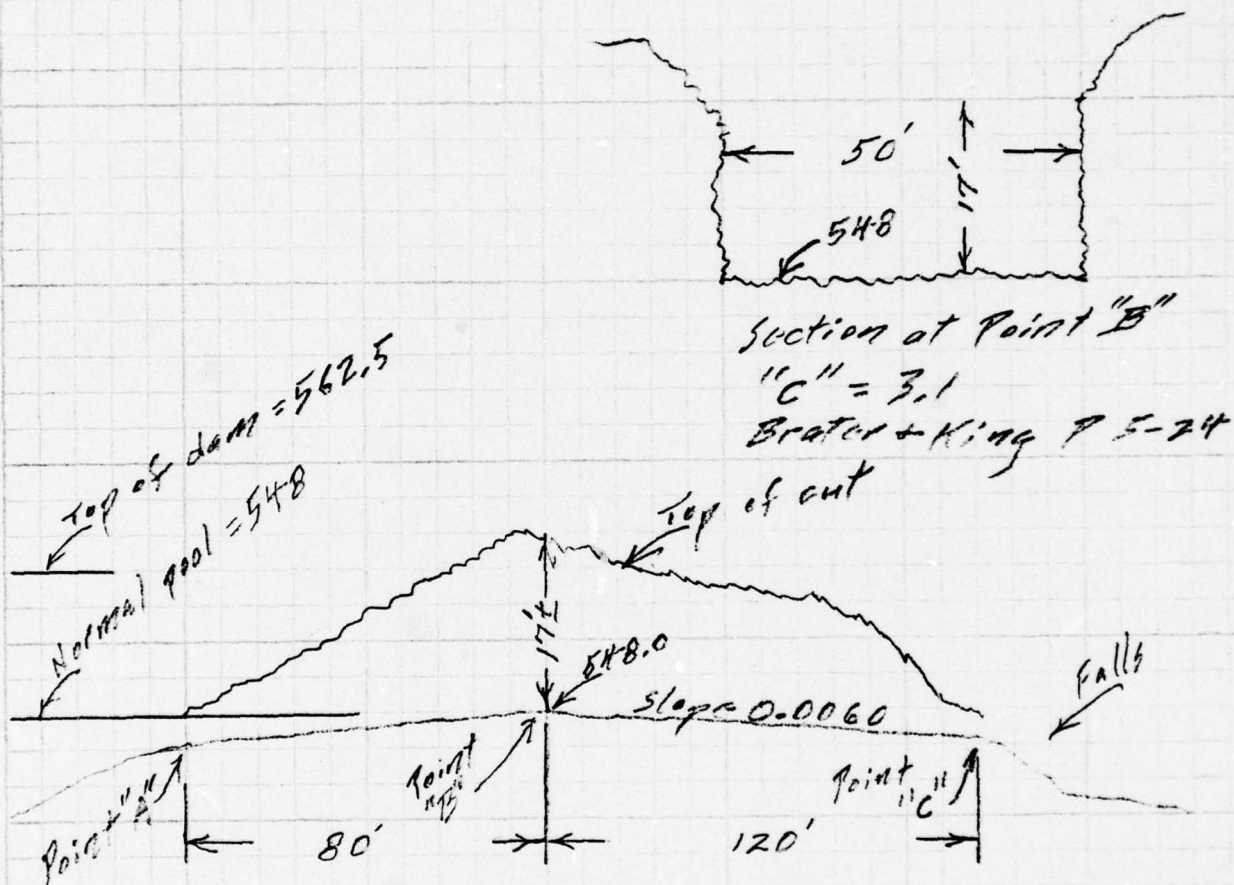
Spillway is unlined, rectangular cut through rock ridge 120 feet from left end of dam. Width 50 feet, crest elevation 548.0

Profile along cut.
