National Dam Inspection Program,
Carbondale Number 4 Dam (NDI ID Number
PA-00384, DER ID Number 35-13),
Susquehanna River Basin, Racket Brook,
Lackawanna County, Pennsylvania.

Phase I Inspection Report.

NDI ID No. PA-00384
DER ID No. 35-13

PENNSYLVANIA GAS AND WATER COMPANY

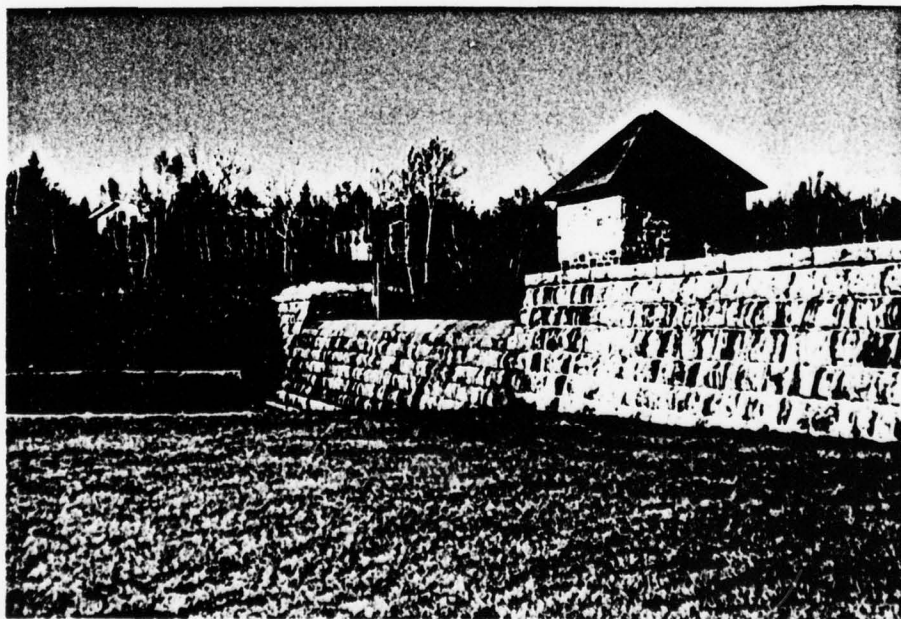
B. Downstream Face and Spillway

b. Design Features. The dam and appurtenances are described in Paragraph 1.2a. The design features are shown on the Plates at the end of the report and on the Photographs in Appendix D. Plate 2 shows a plan of the dam. Plate 3 and Photographs A and B show the profile and a section of the masonry. This plate was drawn before the 1945 modifications to the dam and it shows the original spillway at the left abutment. Plate 4 and Photographs C, D, and E show a profile of the existing spillway and outlet works. The outlet works pipe is extended further, as shown on Plate 2. The extension is noted as a 30-inch diameter pipe; the extension is actually 36-inches in diameter. The other pipe, parallel to the outlet works pipe on Plate 2, apparently connects to a drain from the valve house.
