# SENECA FALLS DAM

PHASE I INSPECTION REPORT  
NATIONAL DAM SAFETY PROGRAM

Name of Dam: Seneca Falls Dam  
County and State: Seneca County, New York State  
Inventory Number: NY 00708

Name of Dam: Seneca Falls Dam  
State Located New York  
County Located Seneca  
Stream Seneca River  
Date of Inspection June 5, 1978

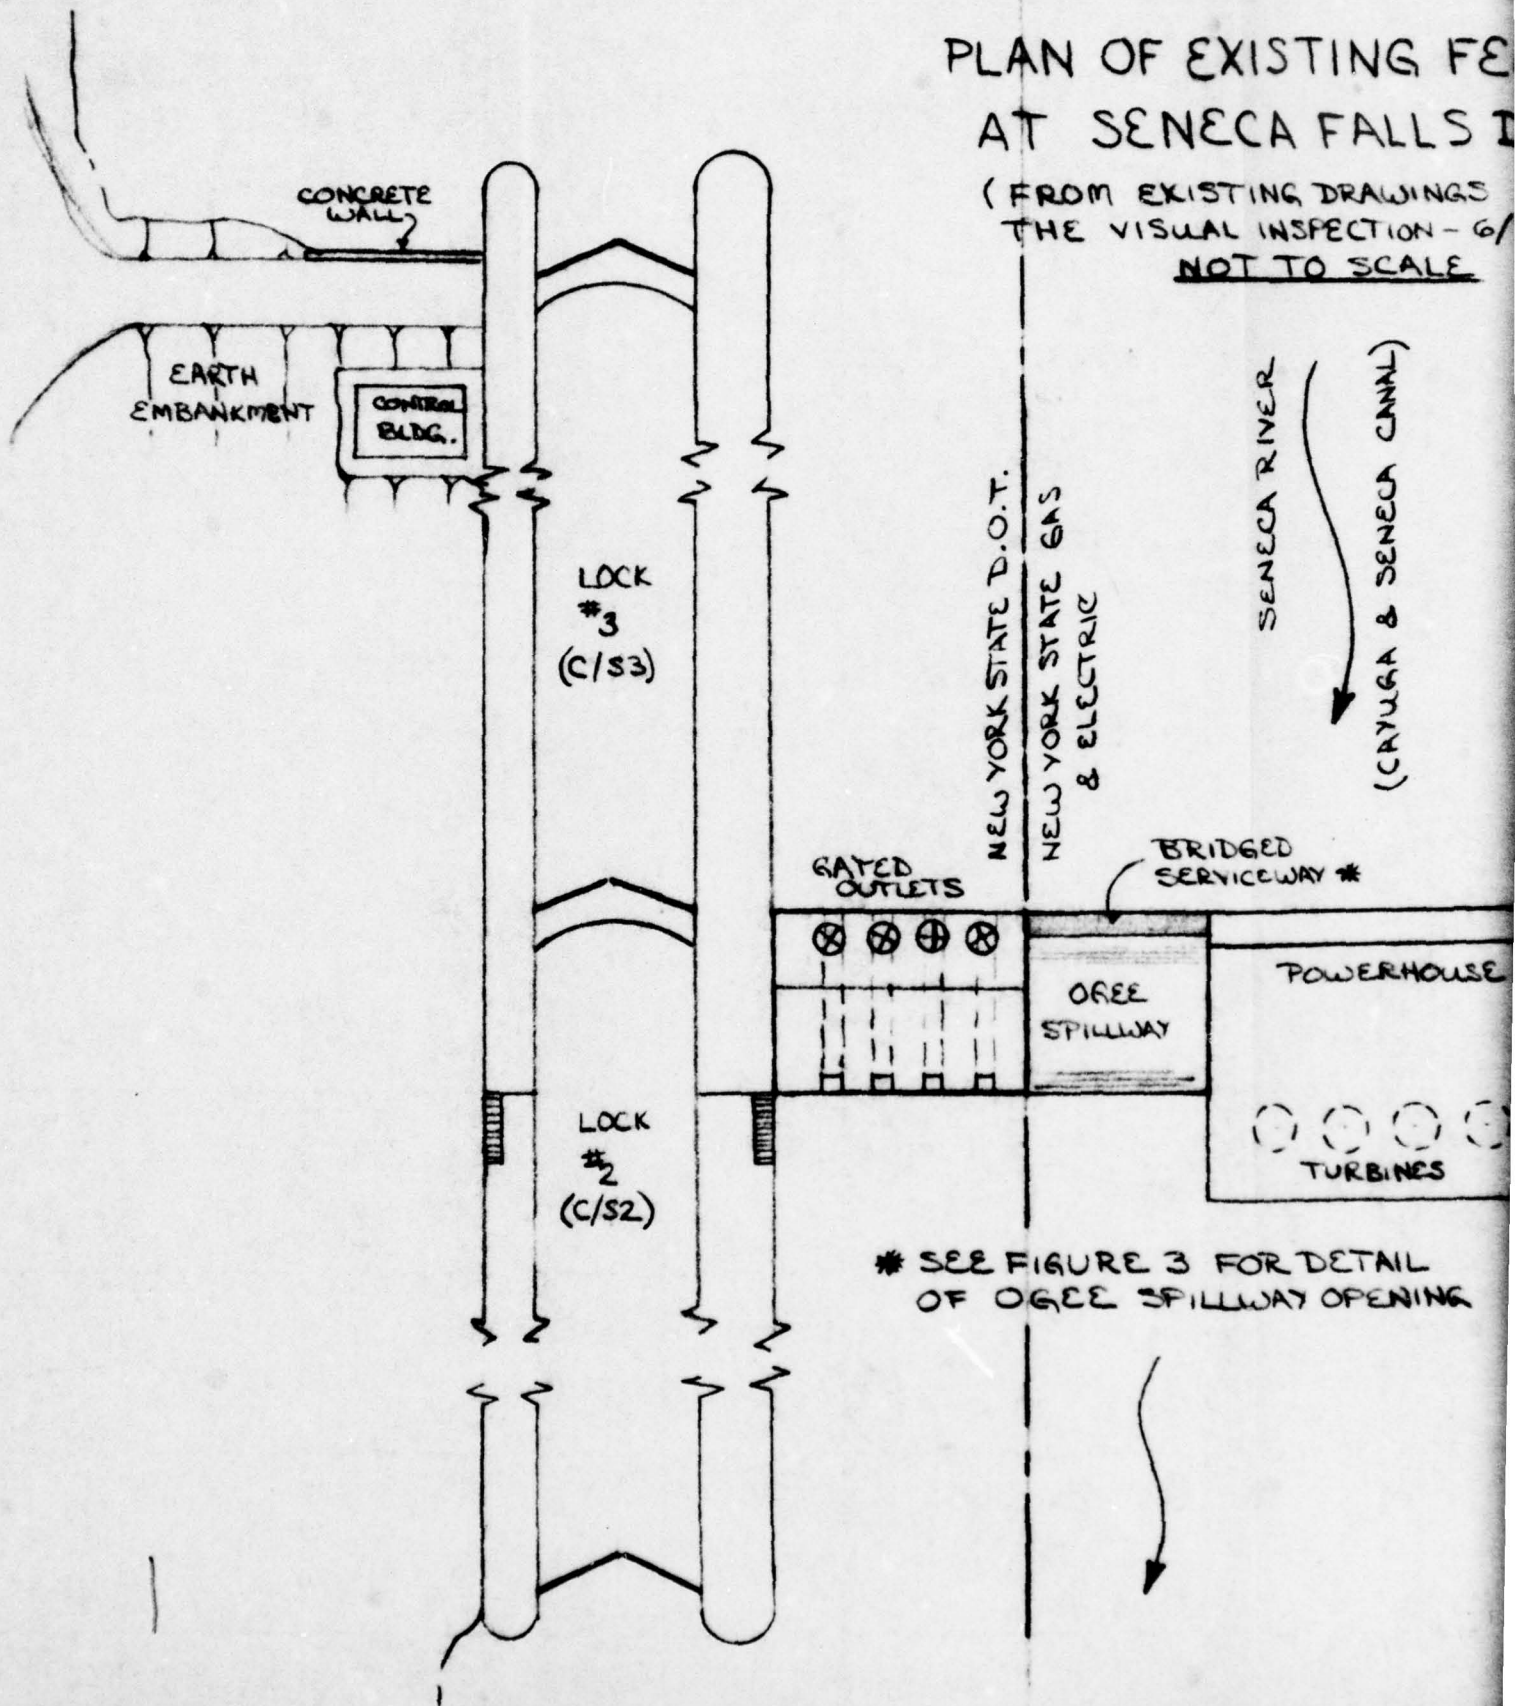
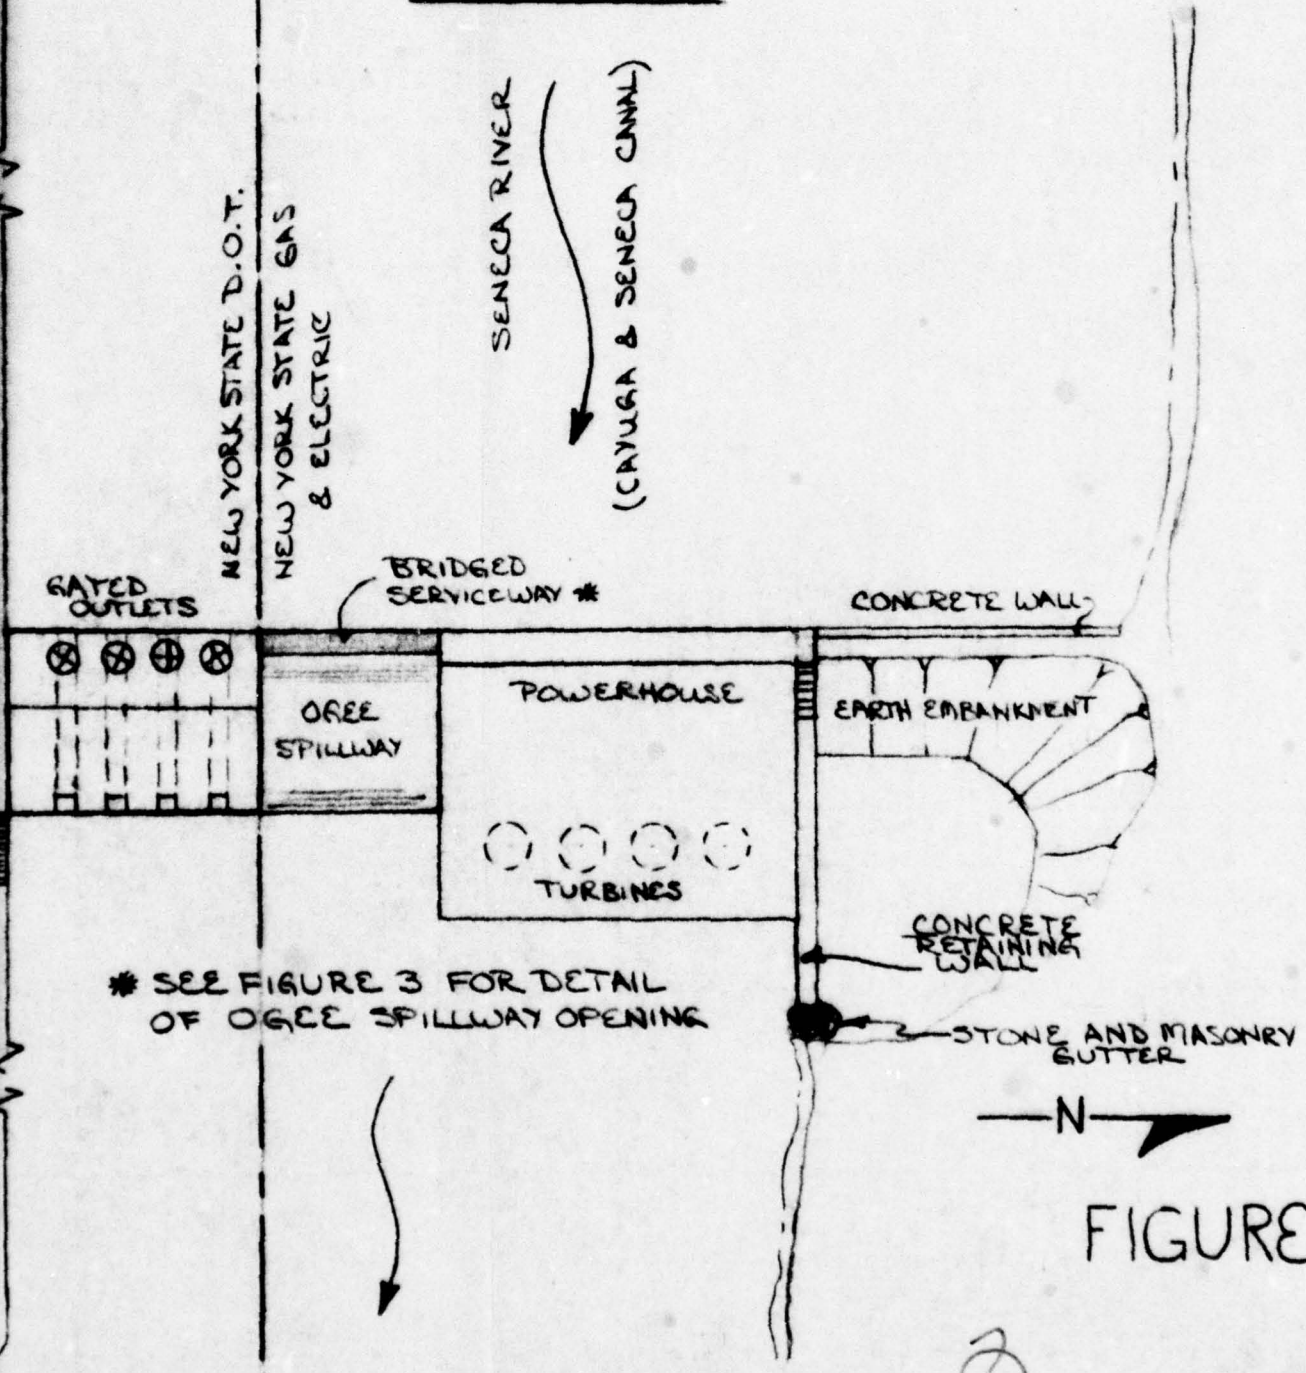
FIGURE 2

b. Dam - The Seneca Falls Dam consists of a series of connected structures (See Figure 2). The south embankment extends from the south abutment to the south wall of the upper lock. A concrete retaining wall is constructed along the upstream face of the embankment from the lock wall for a distance of about 50 feet. The depth of the concrete wall could not be determined. Stone riprap covers the upstream slope of the embankment for the remainder of its length. The upstream slope on this portion of the embankment is about 2:1 (horizontal to vertical). The downstream slope of the embankment is about 2:1 for approximately 15 feet, followed by a wide earth fill area. The top of the embankment is a gravel roadway to the lock control building, which is adjacent to the lock wall. The embankment is grass covered and appears to be stable, due in part to the wide fill zone on the downstream side.

The concrete spillway is located between the non-overflow section and the powerhouse. A steel beam clear-span serviceway bridges the spillway. The spillway is blocked except for narrow stoplog controlled openings at each end, used for discharging debris over the dam (See Figure 3). The concrete surface of the spillway appears to be in good condition. No cracking or spalling of the concrete was detected.

The powerhouse is a massive concrete structure with a brick superstructure. A walkway at the upstream side of the powerhouse appears to have been resurfaced with macadam recently. The concrete trash rack supports have also been recently resurfaced. A concrete retaining wall extends about 75 feet downstream of the powerhouse. The wall is badly spalled and cracked, especially at the downstream end. Weep holes were observed in the retaining wall about midway from the powerhouse to the end of the wall. About one gallon per minute of clear water was discharging from a weep hole at the base of the wall. The weep holes at about 15 feet and at about 30 feet above the tailwater pool were dry.

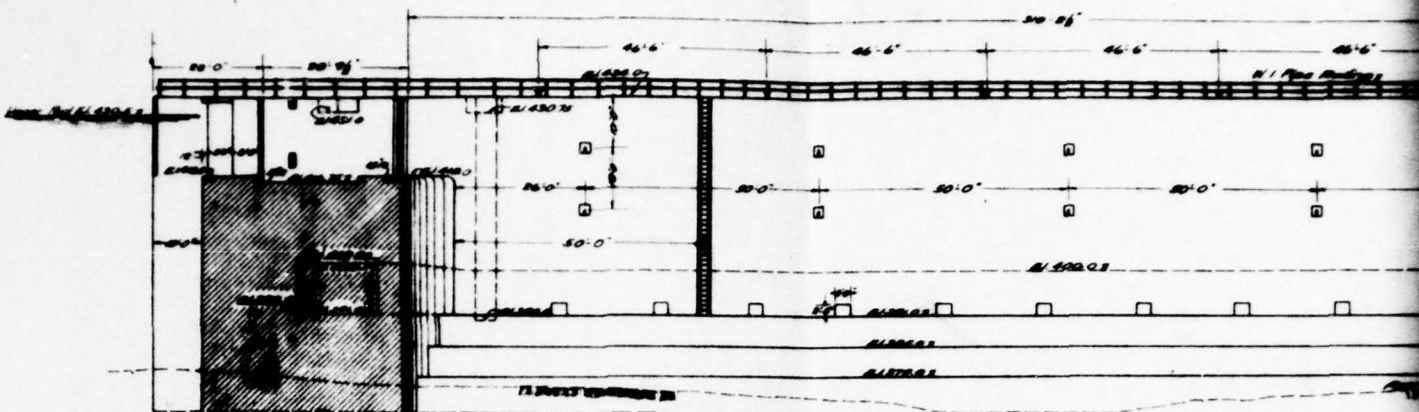
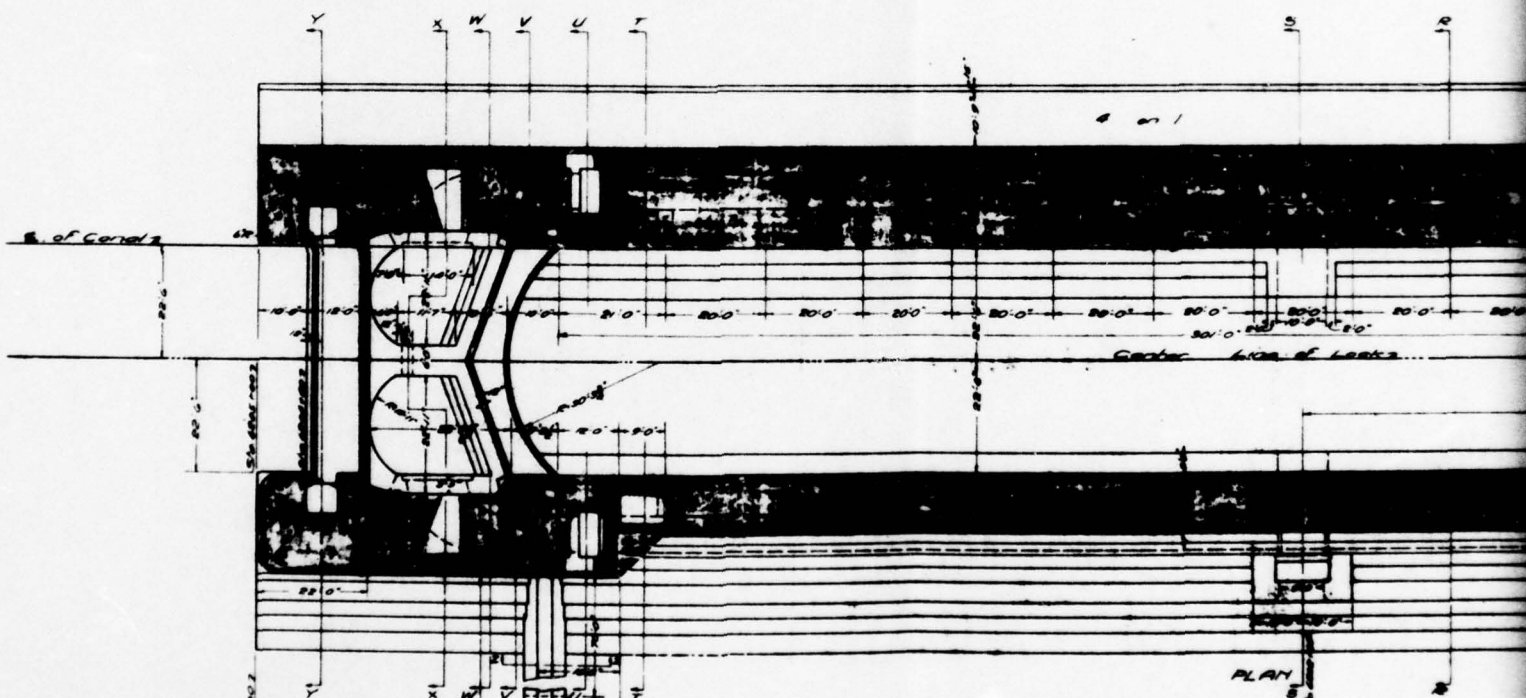
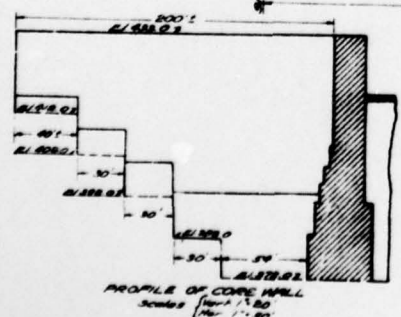
**Contract C.**  
 OAYUGA AND SENECA CANAL, SEC. I.  
 For constructing locks, dam etc., at Seneca Falls.  
**PLAN & ELEVATION LOCK 2**  
 Scale: 16 feet to the inch

The lock structures (See Figures 4 and 5) appear to be in excellent condition. Operating personnel stated that extensive remedial work on the lock structures was completed in November, 1977. According to Mr. Michael LaVere, lock operator, the top 6 to 12 inches of concrete was removed from all of the lock structures, followed by resurfacing. Viewing the north lock wall from the concrete gravity section of the dam, some of the older concrete of the wall was observed to be exposed below the extent of resurfacing. Some aggregate is exposed, but the concrete appears to be in good condition. All steel walkways, railings, and structures have been recently painted. The lock system was operated during the inspection visit, and was found to be in excellent condition. The lock gates can be operated from any of three control panels located on the south walkway, or from the control building.

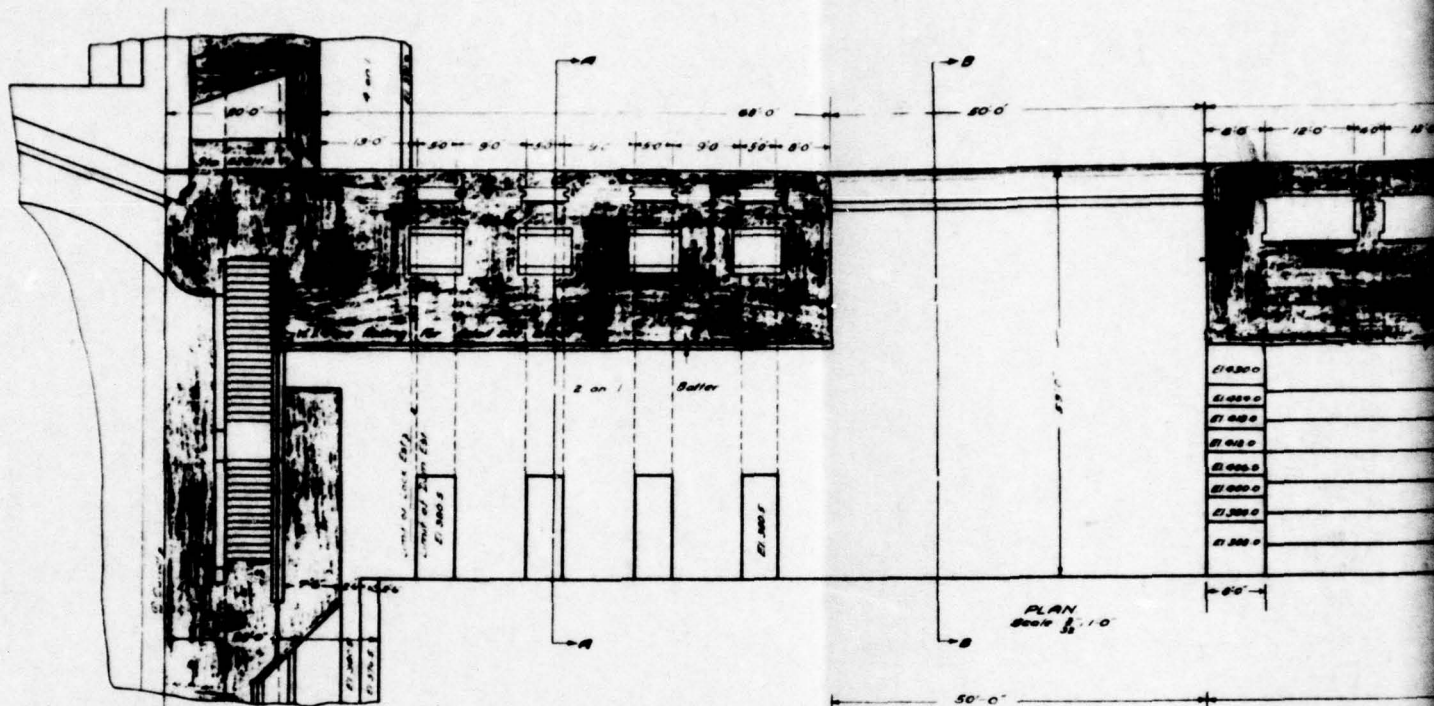
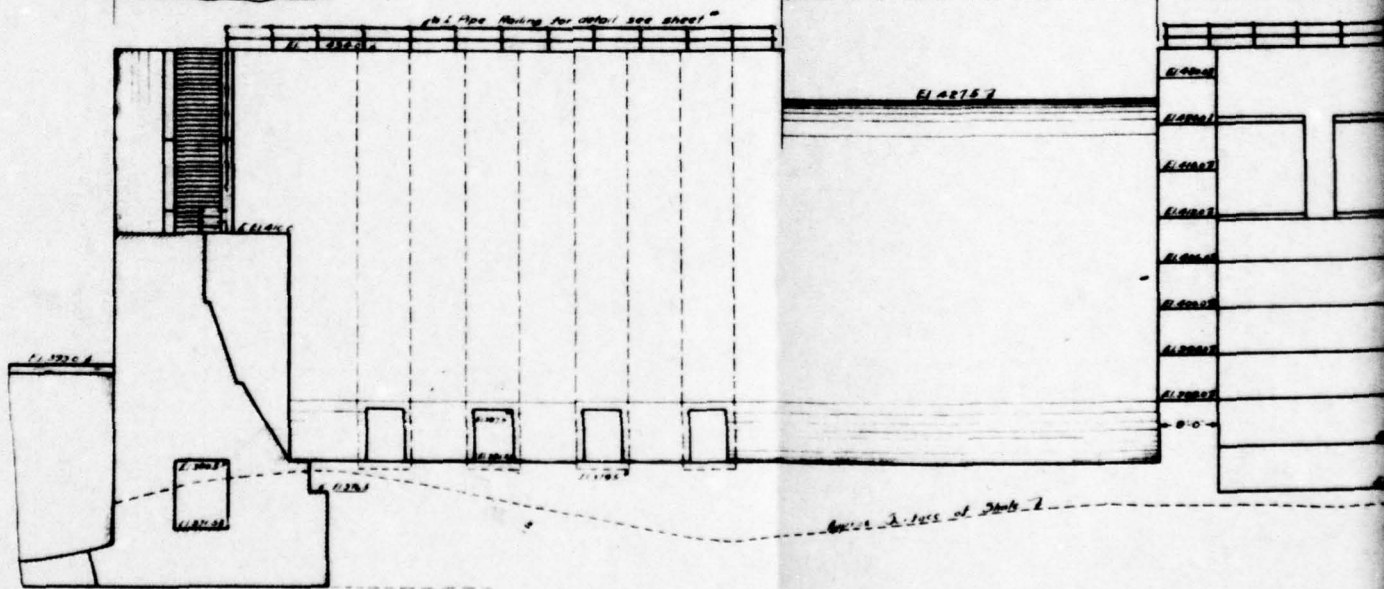
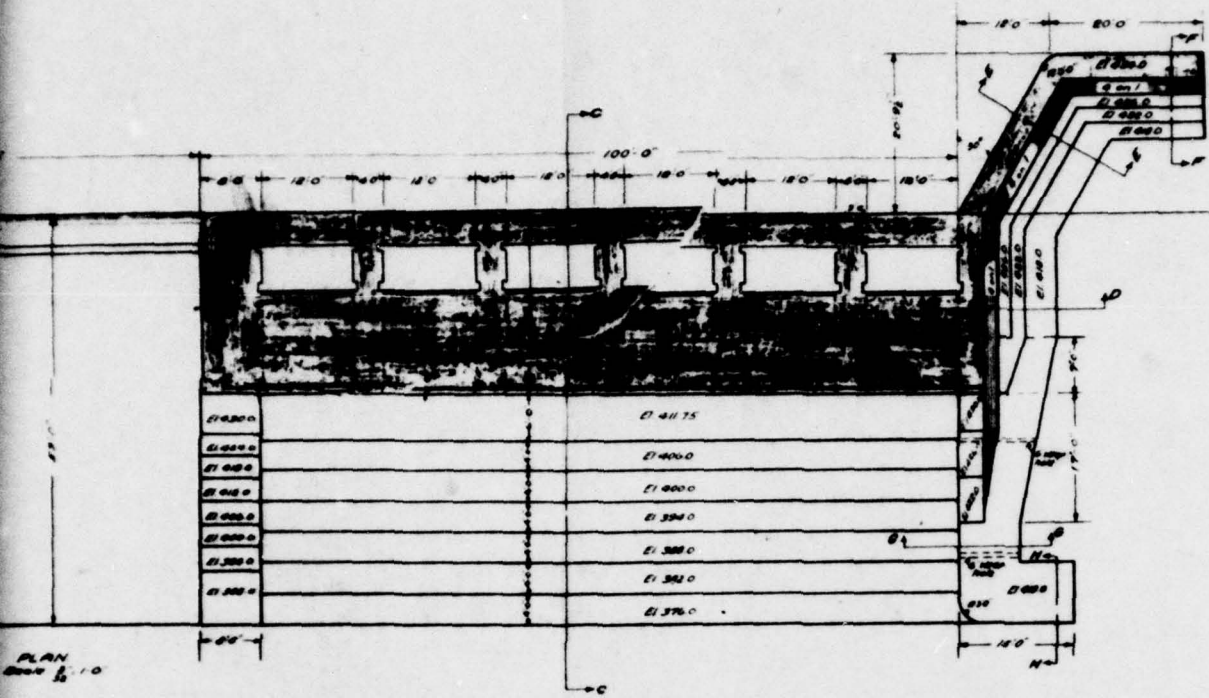
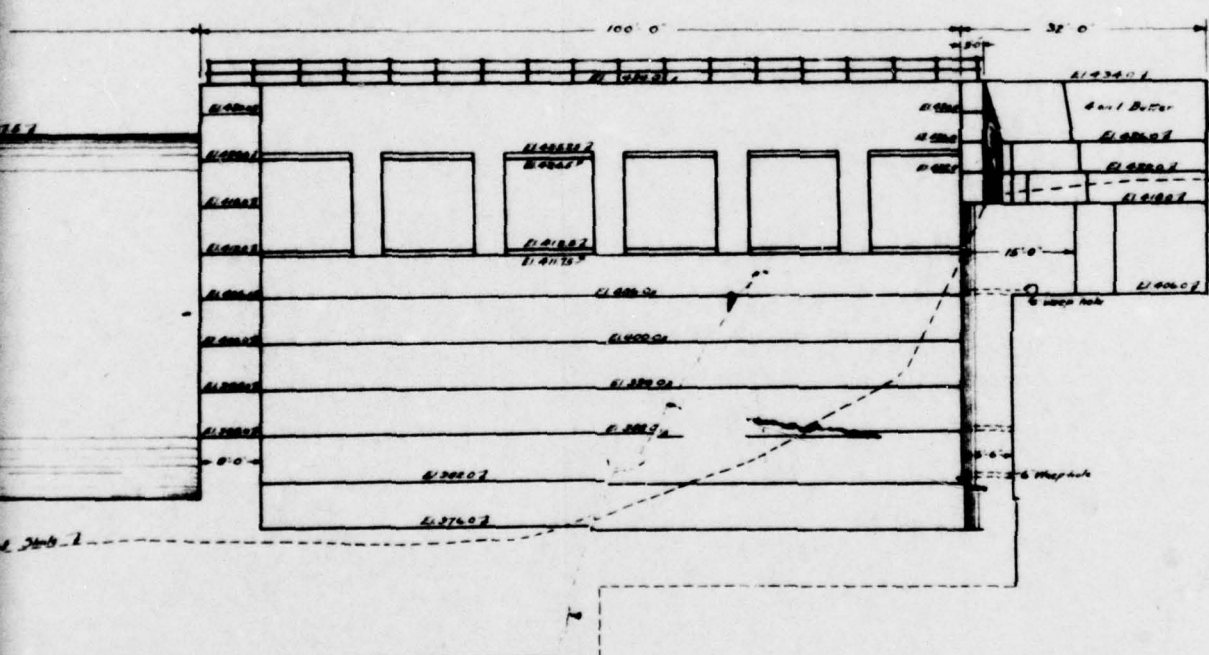
# FIGURE 7 Contract C.

Thinly bedded shales were noted as outcrops on the south valley wall. Figure 7 indicates that the foundation material is shale.
