LAKE TIORATI DAM
PHASE I INSPECTION REPORT
NATIONAL DAM SAFETY PROGRAM

NY 00043

Name of Dam: Lake Tiorati Dam
County and State: Orange County, State of New York
Inventory Number: NY 43

PHASE I INSPECTION REPORT
NATIONAL DAM SAFETY PROGRAM

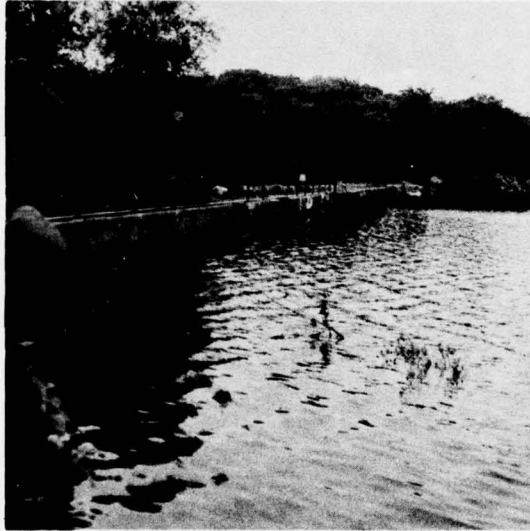
OVERALL VIEW OF DAM

No detrimental findings were made during the visual inspection of the dam to render an unsafe assessment. However, small amounts of seepage were observed at the downstream toe of the earth embankment, and spalling and deterioration of the upstream face of the concrete structure are evident.

Remedial work should be performed on the upstream face of the concrete structure in order to reduce leakage and prevent further damage due to frost action.
