WILSON CREEK DAM

NDI - PA 00318
PA DER 52-154
SCS PA - 440

PHASE I INSPECTION REPORT NATIONAL DAM INSPECTION PROGRAM

MAY 1979

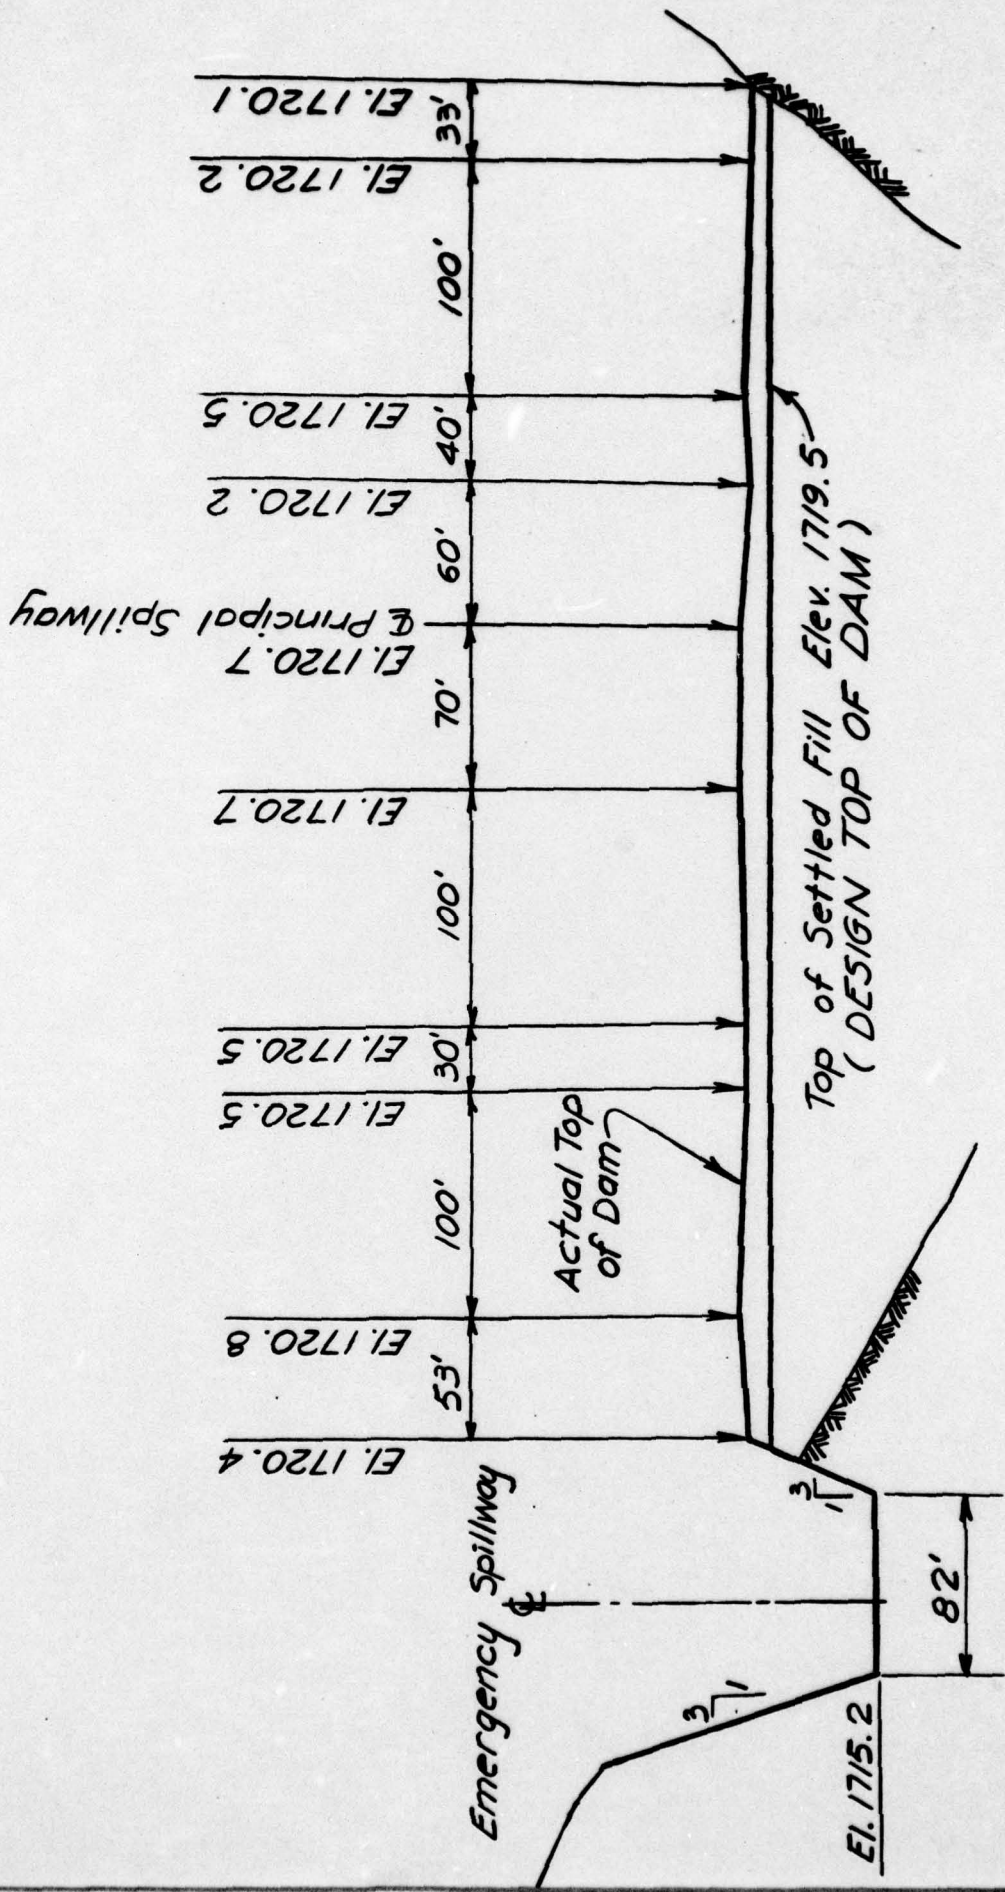
TOP OF DAM PROFILE

- b. Dam. The dam is in good condition. There are minor undulations (+ 0.5 feet) along the top of the dam and along both the upstream and downstream earth embankment slopes. There is slight seepage on the downstream earth embankment slope around the principal spillway conduit.
