PHASE I INSPECTION REPORT NATIONAL DAM INSPECTION PROGRAM

Name of Dam: Hemlock Lake Dam

Inventory Number: PA 00399

6 National Dam Inspection Program.
Hemlock Lake Dam (NDI-PA 00399,
PA DER 52-71), Delaware River Basin,
Tributary Bush Kill Creek, Pike
County, Pennsylvania. Phase I Inspection Report.

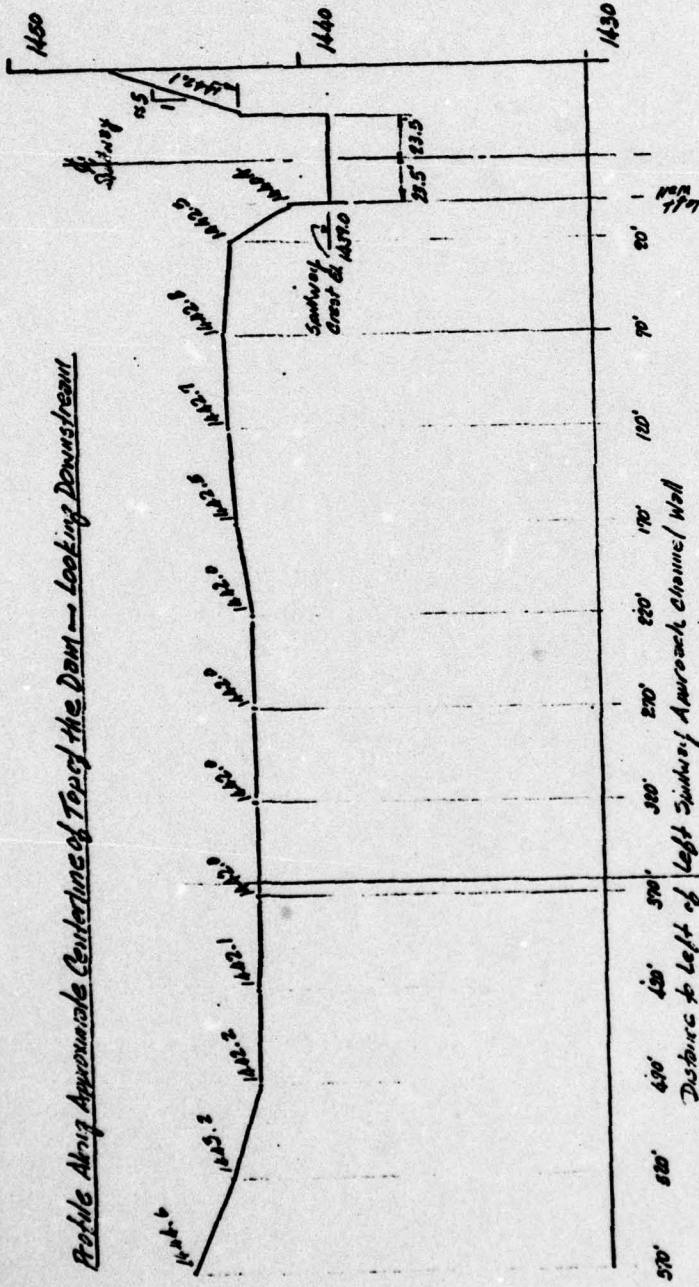
HEMLOCK LAKE DAM
PROFILE ALONG APPROX. CENTERLINE OF CREST OF DAM
FROM FIELD INSPECTION NOTES
FIELD INSPECTION DATE: NOV. 21, 1978
PLATE NO. 4

Profile Along Approximate Centerline of Top of the Dam - Looking Downstream
