TAYLOR POND DAM

NDI - PA 00315
PA DER 52-152
SCS - PA-446

PHASE I INSPECTION REPORT NATIONAL DAM INSPECTION PROGRAM

MAY 1979

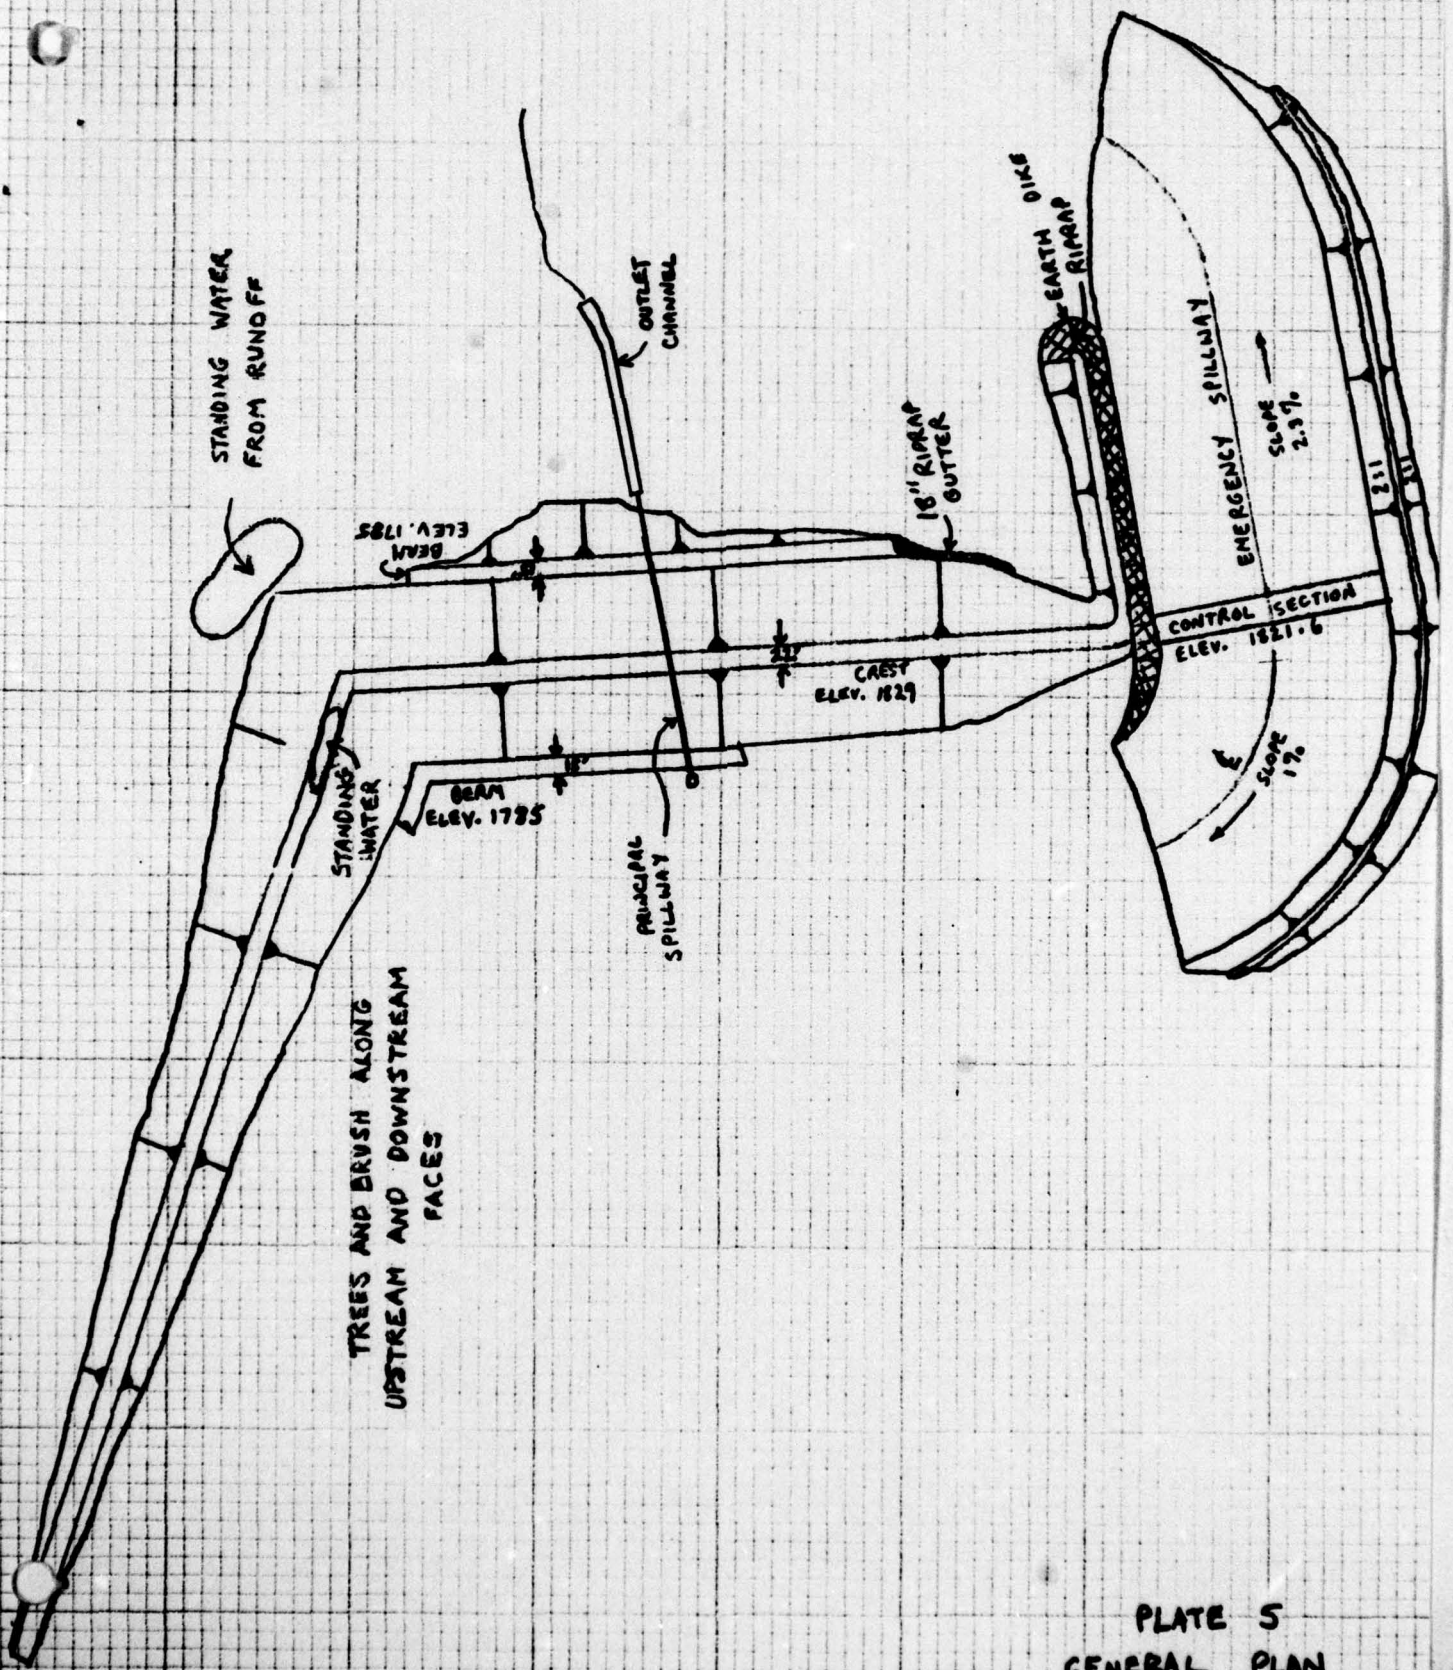
PLATE 5
 GENERAL PLAN
 DRAWING

On the date of the inspection, brush and small trees with trunks as thick as 6 inches in diameter were observed growing on both faces of the embankment.

Larger trees are located immediately upstream of the dam, toward the left abutment. These trees are 40 to 50 feet in height and are founded on natural ground, a few feet above the reservoir surface.

During the inspection, running water was observed along the downstream toe from the left abutment to the drop inlet closed conduit spillway outlet channel. This flowing water appears to be surface runoff, as the natural ground downstream of the dam slopes toward the embankment, creating a channel along the downstream toe. In the area of the change in alignment of the dam, some standing water was observed. Several localized areas of standing water along the top of the dam were also noted during the inspection.
