CONESTOGA RIVER BASIN
NEW HOLLAND RESERVOIR DAM
NO. NO. PA-00346
SER. NO. 55-241
LANCASTER COUNTY, PENNSYLVANIA

PHASE I INSPECTION REPORT
NATIONAL DAM INSPECTION PROGRAM

BY
Sargent Associates, Inc.
Harrisburg, Pennsylvania
JULY 1979

OVERVIEW
NEW HOLLAND RESERVOIR DAM

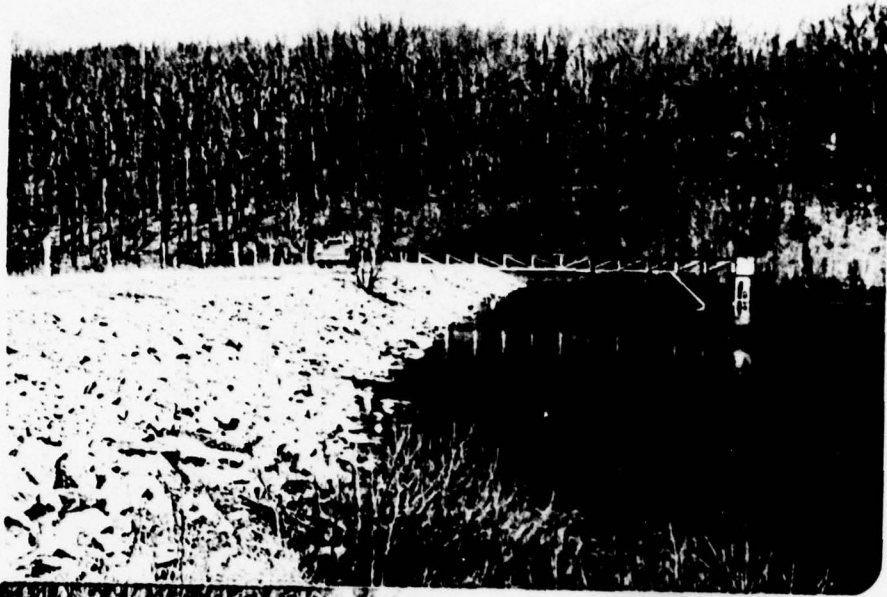
The visual inspection of the embankment did not reveal any structural distress or seepage conditions on this structure. The upstream slope cover consists of dumped riprap, about 12-inch maximum size. With the exception of two small trees or bushes on this area, the slope is clear. The downstream slope cover is field grass, weeds and brush. The brush was not dense at the time of this inspection. A moderate stand of trees, 6 inches to 8 inches in diameter, is situated on the embankment slope adjacent to the left spillway channel wall. These trees could become troublesome to the walls as well as the slope and should be removed.

Upstream Slope
and
Intake Tower

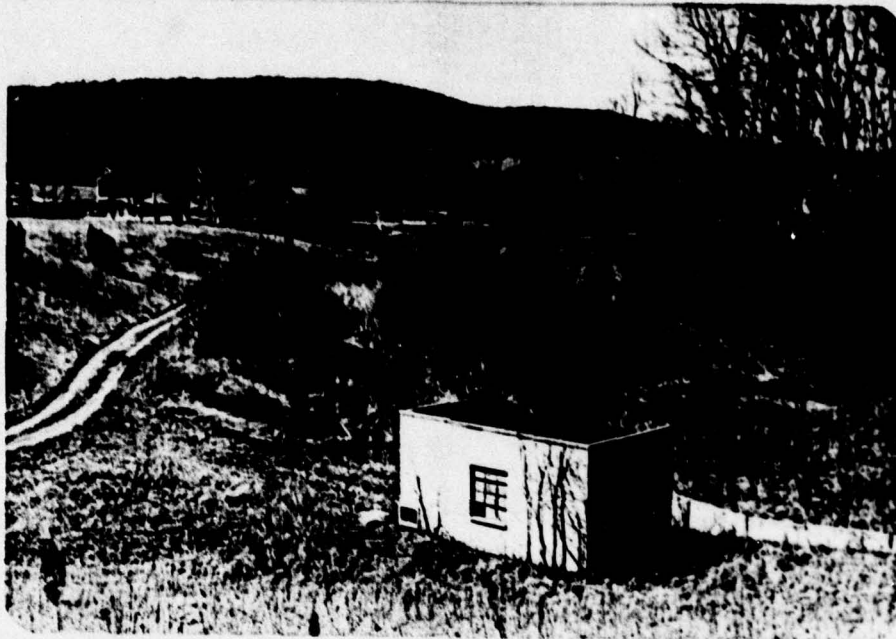
Downstream Channel & Valve House
