6 National Dam Inspection Program.
Strack's Dam (NDI Number PA-00596,
DER Number 38-20), Delaware River Basin,
Lebanon County, Pennsylvania. Phase I
Inspection Report.

PHASE I REPORT
NATIONAL DAM INSPECTION PROGRAM
BRIEF ASSESSMENT OF GENERAL CONDITIONS
AND RECOMMENDATIONS

Name of Dam: STRACK'S DAM, NDI NO. PA-00596
State & State No: PENNSYLVANIA, 38-20
County: LEBANON
Stream: TRIBUTARY TO TULPEHOCKEN CREEK
Date of Inspection: April 6, 1979

STRACK'S DAM

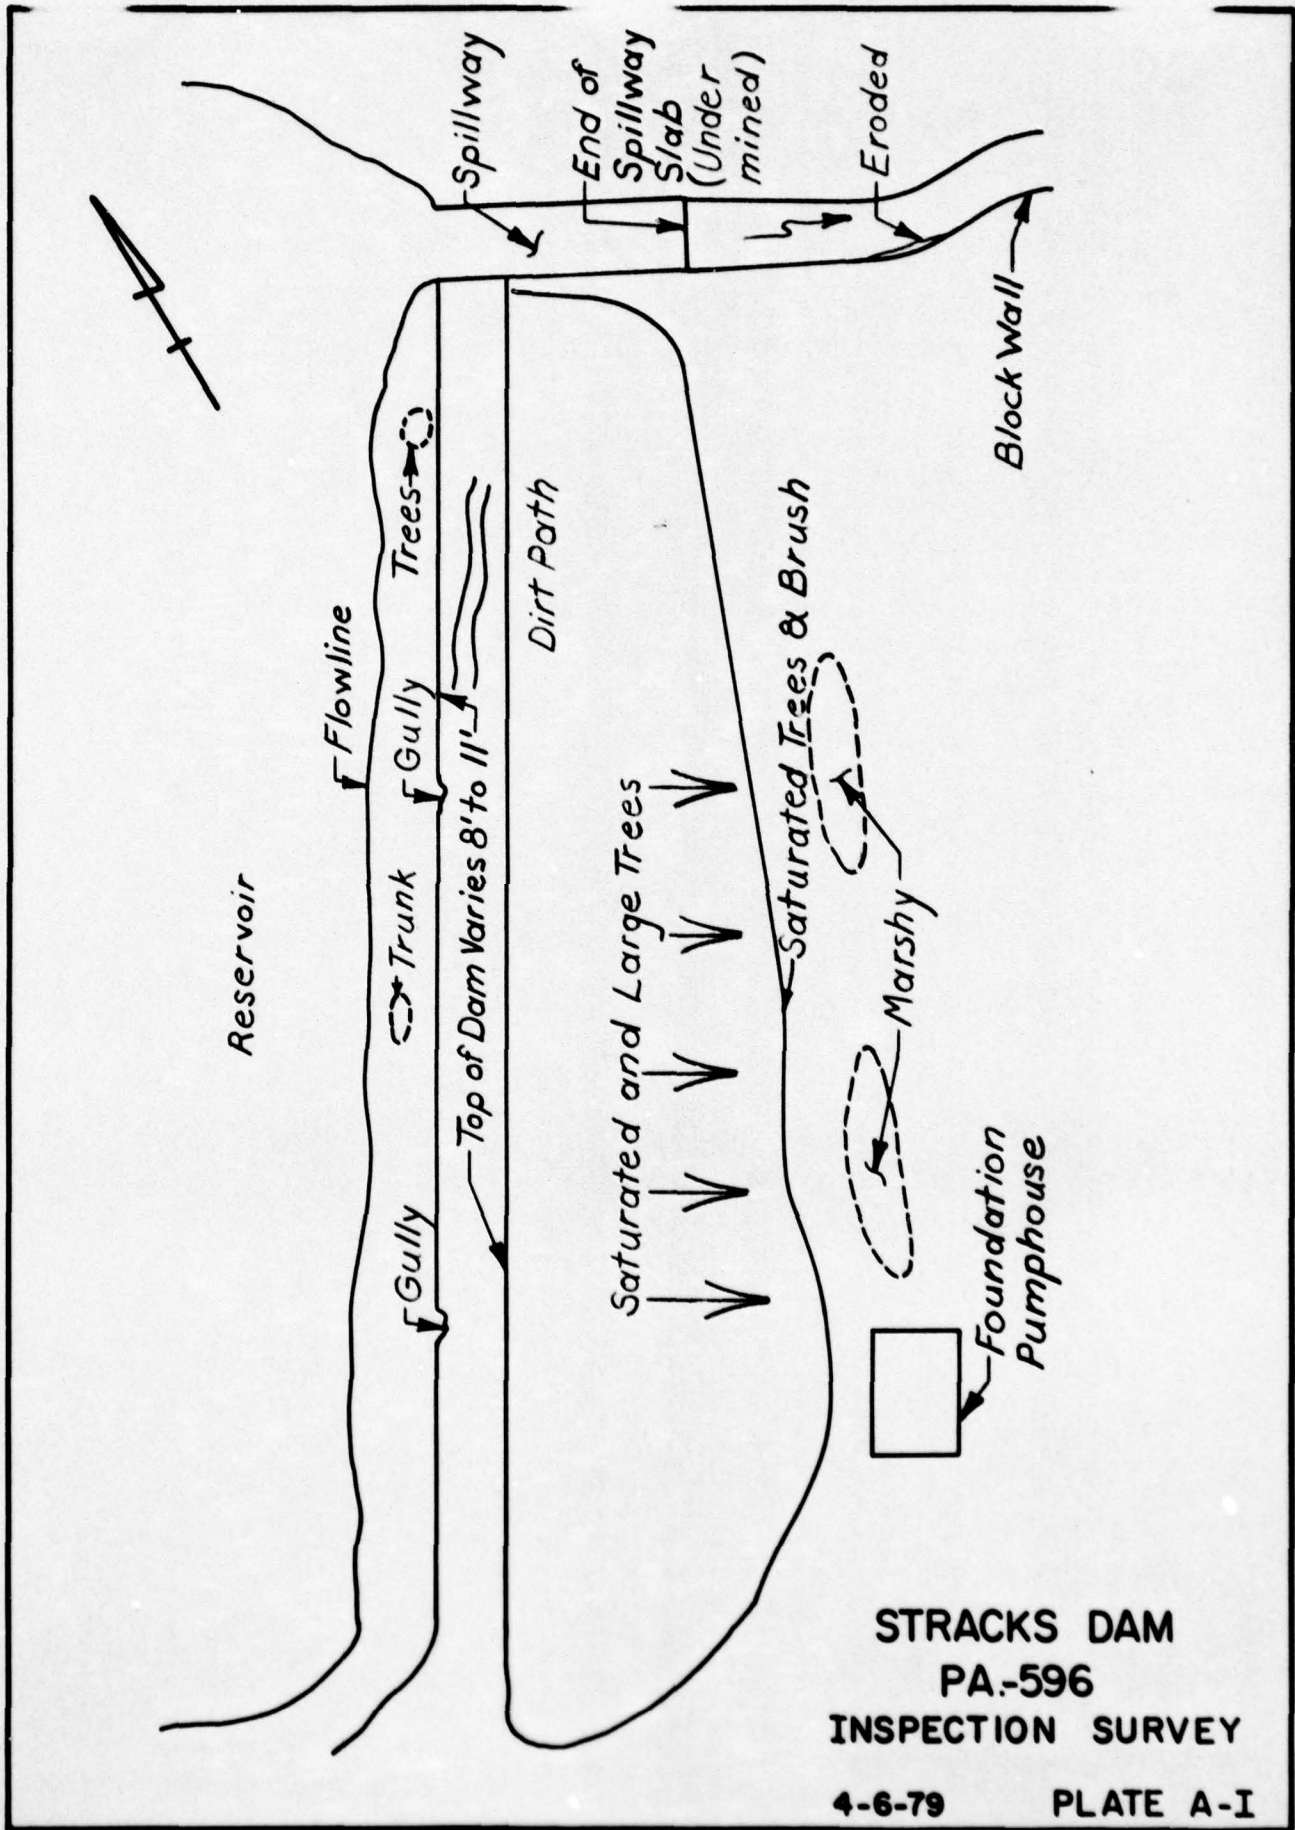
**STRACKS DAM
PA-596
INSPECTION SURVEY**

The upstream slope of the dam was in fair condition and appears to be stable. Several gullies were evident at the top and several trees on the slope should be removed. Old stumps of previously cut trees indicate that many large trees were on this slope. The top of the dam has some light brush and a dirt footpath, indicating that the breast is extensively used by fishermen. The profile of the crest was surveyed (see Plate A-II, Appendix A) and appears to be below the design elevation.

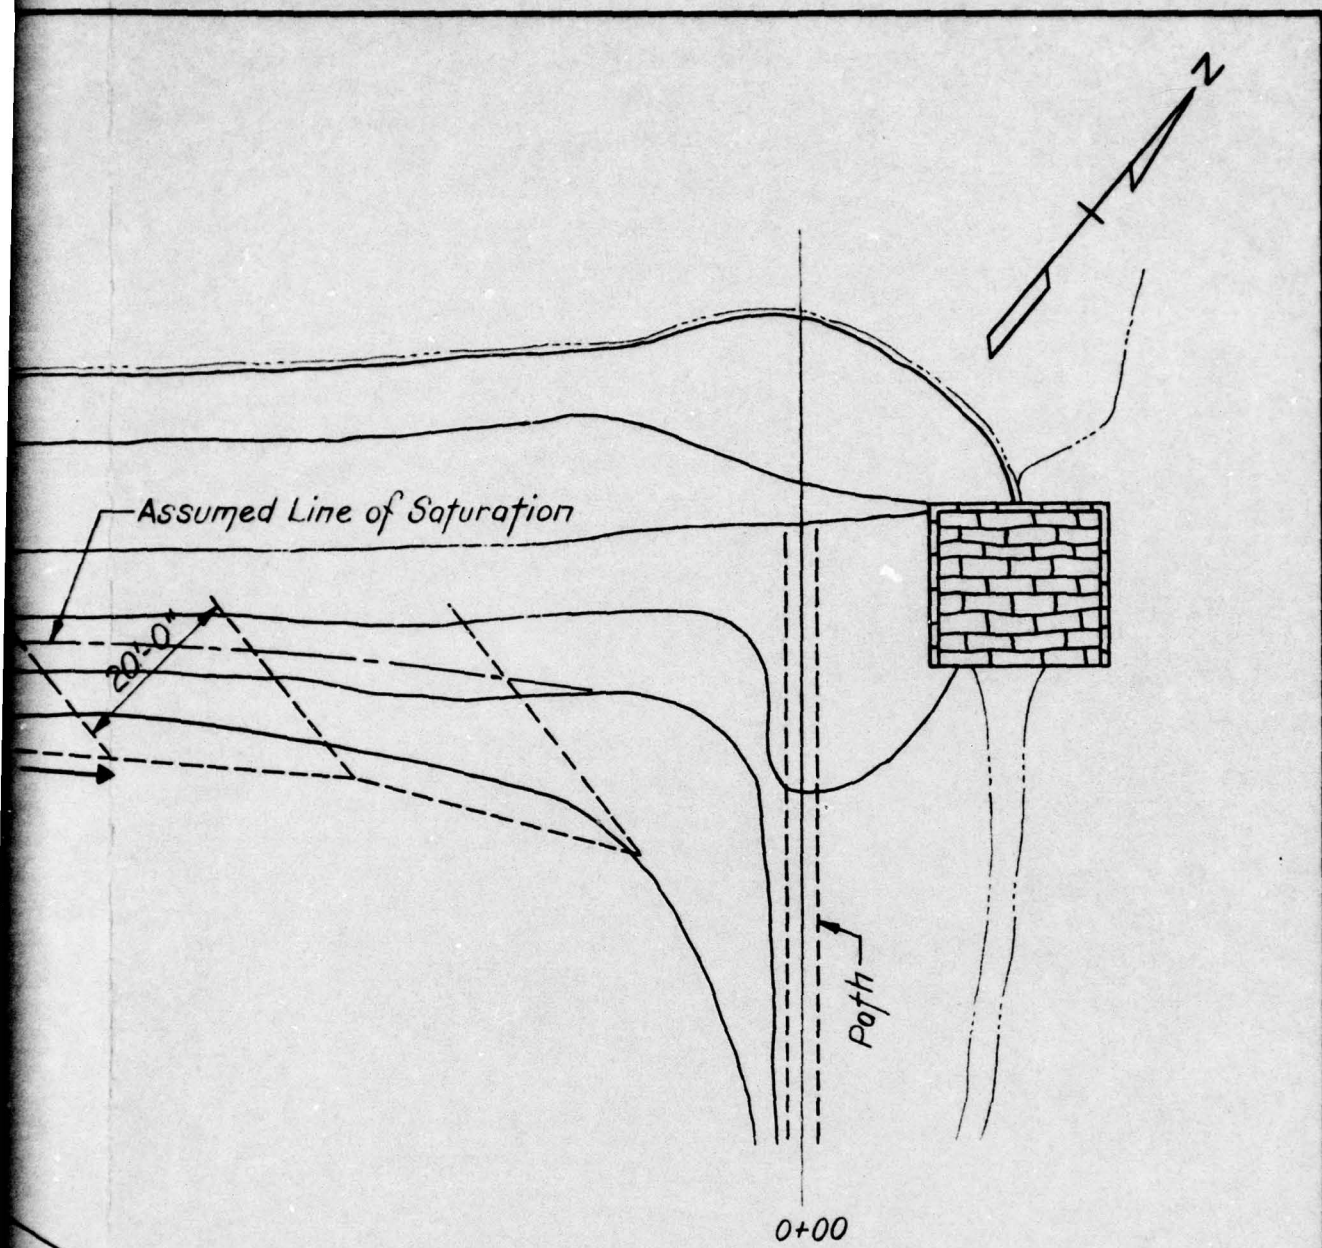
The downstream slope has a dense growth of brush and trees, with trees up to 18 inches in diameter. The brush prevents close observation of the slope and sloughage or slippage areas were not noticed. The slope is, however, saturated and soft over most of its height. At the toe and downstream of the toe, the ground is totally saturated, marshy and soft. The soft condition of the slope has caused some trees to be uprooted and it is feared that additional uprooting of trees could occur. The subsurface drainage system installed on the downstream slope and in the toe is not functioning properly.

*Traced from Drainage System for Embankment
Strack Dam, by American Water Works
Construction Company Engineers and
Contractors Dated 3/17/38.*
