FAWN LAKE DAM

PHASE I INSPECTION REPORT
NATIONAL DAM INSPECTION PROGRAM

NDI PA 00309
PA DER 52-168

Name of Dam: Fawn Lake Dam ID # PA 00309
State Located: Pennsylvania
County Located: Pike
Stream: Tributary to West Falls Creek
Coordinates: Latitude 41° 30.2' Longitude 75° 04.0'
Date of Inspection: November 20, 1978

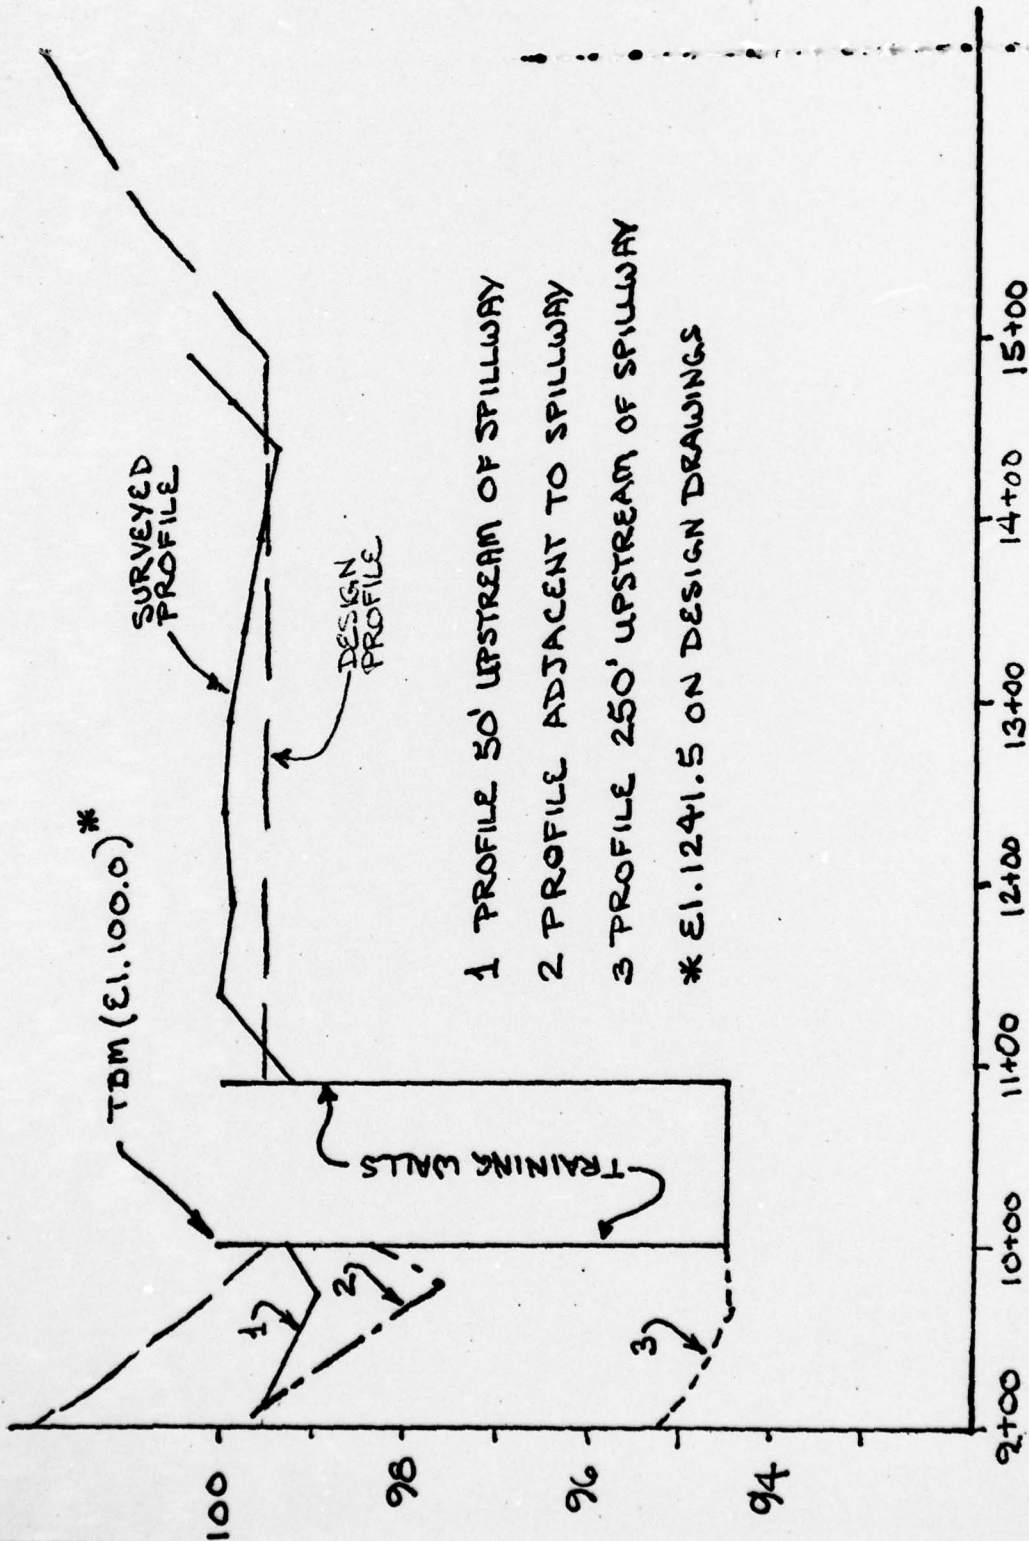
PLATE 6

- 1 PROFILE 50' UPSTREAM OF SPILLWAY
- 2 PROFILE ADJACENT TO SPILLWAY
- 3 PROFILE 250' UPSTREAM OF SPILLWAY
- * E1.1241.5 ON DESIGN DRAWINGS
