4 GREENE DREHER DAM
WAYNE COUNTY, PENNSYLVANIA

NDS I.D. NO. PA 00174
DER I.D. NO. 64-174

5
6 PHASE I INSPECTION REPORT
NATIONAL DAM INSPECTION PROGRAM,
NDS I.D. Number PA-00174.
DER I.D. Number 64-174.
Delaware River Basin, Greene Dreher
Dam, Wayne County, Pennsylvania.
Phase I Inspection Report.

WOODWARD-CLYDE CONSULTANTS
5120 Butler Pike
Plymouth Meeting, Pennsylvania 19462

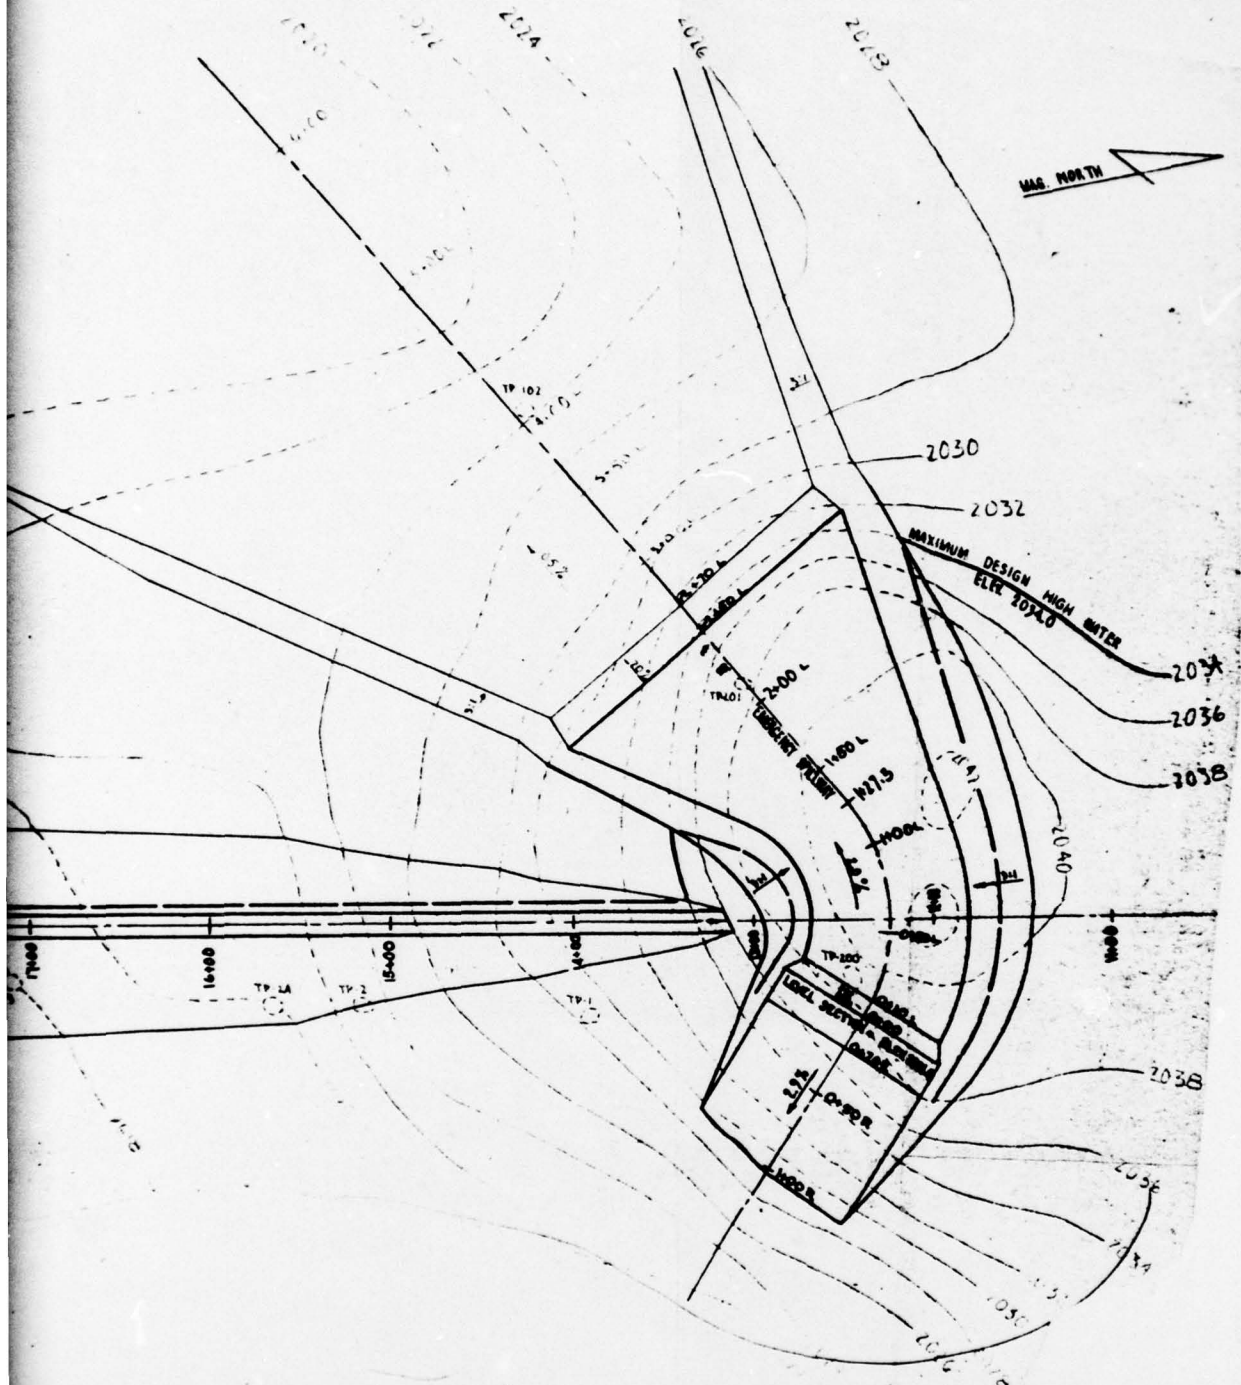
PLATE 2

Water is normally discharged through the principal spillway. A drop inlet riser is located at the upstream toe of the embankment at approximately Station 19 + 56, as shown on Plate 2. Water overflows the riser weir at elevation 2,024.0 or through a low stage inlet at elevation 2,019.5, and
