4 WARRINGTON DAM, BUCKS COUNTY
PENNSYLVANIA

2 NDS I.D. NO PA 00221
DER I.D. NO. 9-174
SCS PA 611

5
6 PHASE I INSPECTION REPORT
NATIONAL DAM INSPECTION PROGRAM.

WOODWARD-CLYDE CONSULTANTS
5120 Butler Pike
Plymouth Meeting, Pennsylvania 19462

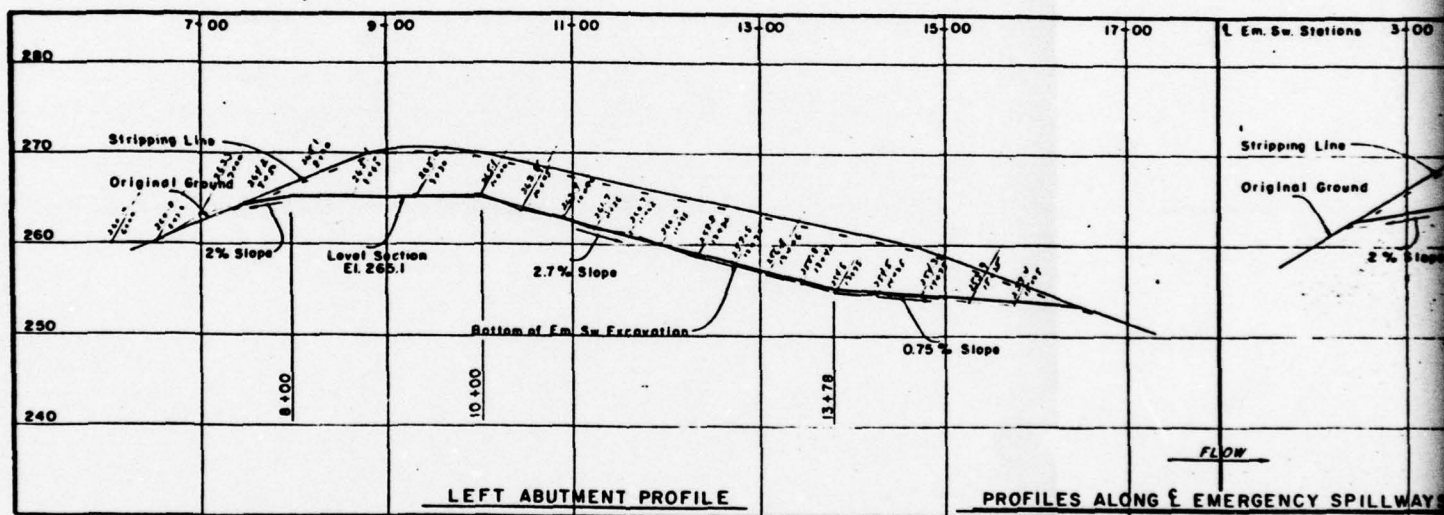
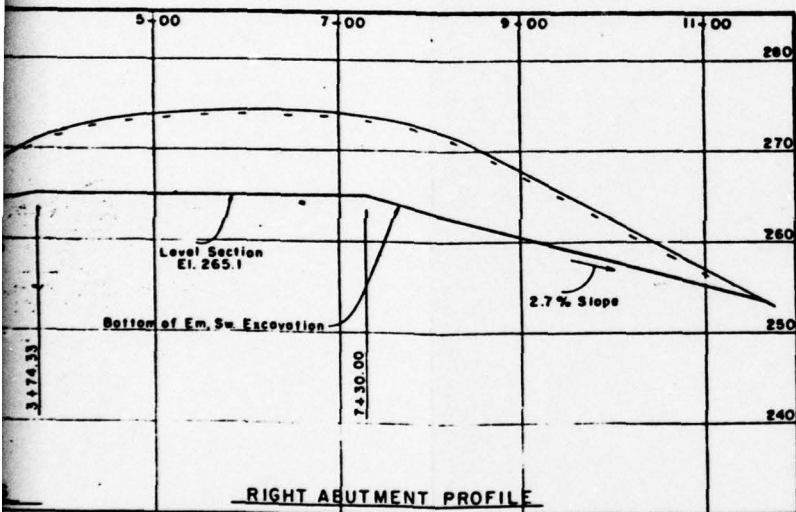
PLATE 10

Due to construction constraints and local topography, Warrington Dam was constructed with two emergency spillways, one located at each end of the embankment. These spillways are shown on Plate 2 and typical profiles are shown on Plate 10, Appendix E. Both spillways are excavated in weathered rock and have some grass growing on the side slopes and bottoms. Both spillways have a level control section located at elevation 265.1. The spillway on the left abutment is 450 feet wide and the abutment spillway is 150 feet wide.

**LEFT AND RIGHT ABUTMENT SPILLWAY PROFILES
WARRINGTON DAM**
