DELAWARE RIVER BASIN  
LEAVITT BRANCH, BRODHEAD CREEK  
MONROE COUNTY, PENNSYLVANIA

NDS ID PA. 00634  
DER ID 45-71

# SKYTOP DAM (MOUNTAIN LAKE)

PHASE I INSPECTION REPORT  
NATIONAL DAM INSPECTION PROGRAM

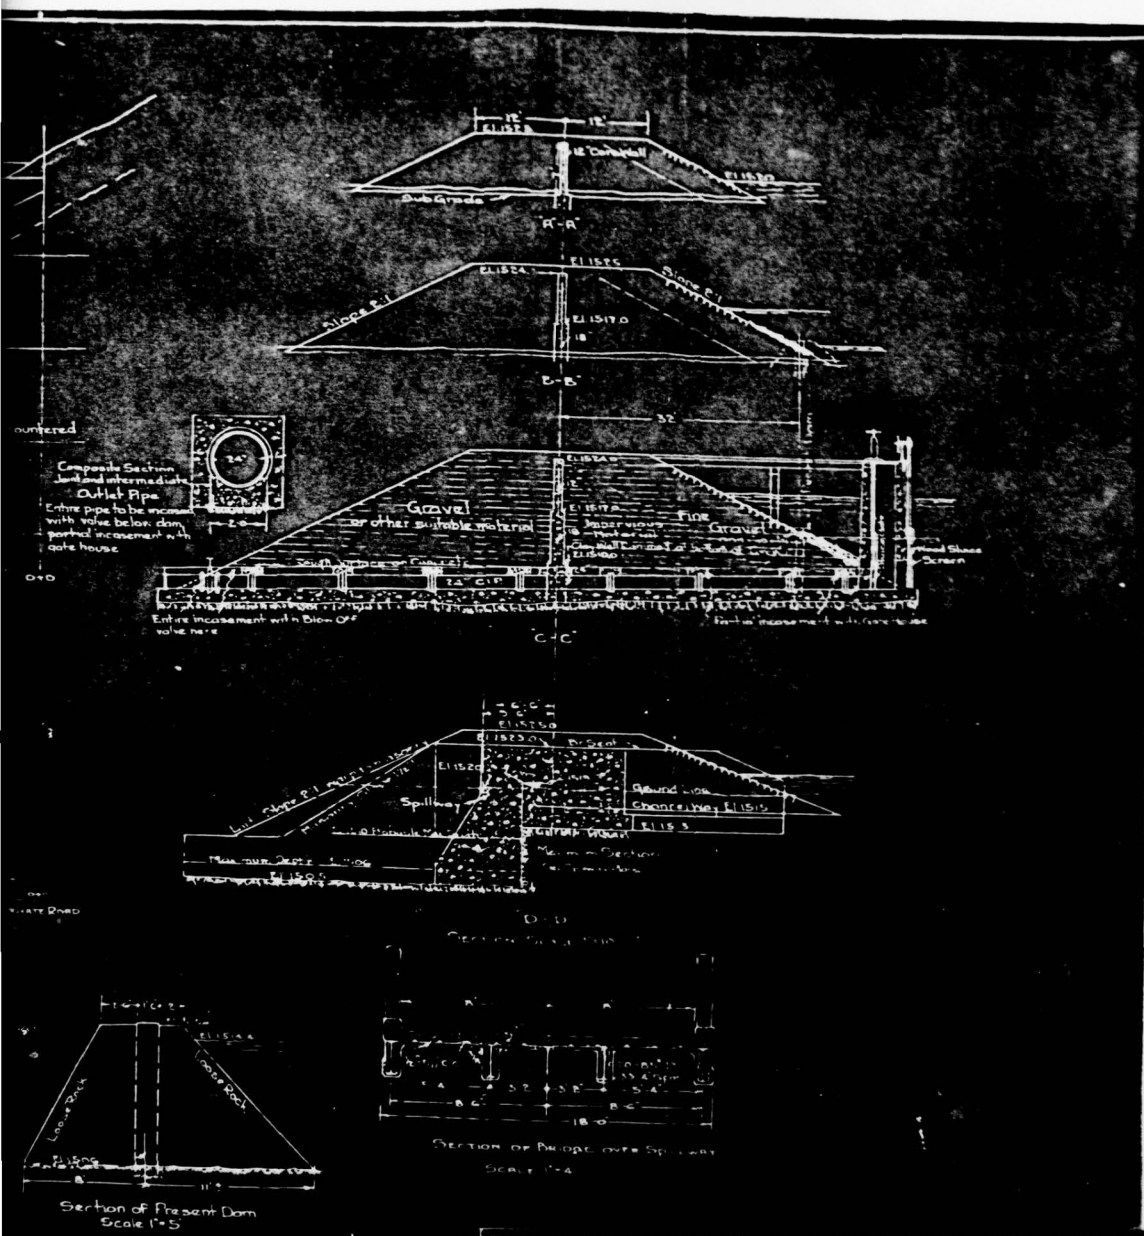
PLATE 3

a. Dam and Appurtenances. Skytop Dam is a 19 foot high zoned embankment with an 18 foot high concrete core wall. The dam impounds a 68-acre reservoir. The embankment downstream of the core wall is composed of a porous gravelly material. The downstream slope is 2H:1V. Immediately upstream of the core wall is a triangular-shaped impervious zone. The remaining portion of the upstream zone is composed of a "dirty" gravel and protected with hand-placed riprap. The upstream slope is 2H:1V. The crest is 24 feet wide. ~~Typical embankment sections can be seen on Plate 3, Appendix E.~~

Since the embankment stability calculations are not available, the stability evaluation was based on an assessment of the geometric configuration of the embankment and an assessment of the engineering properties of the materials native to this area. This assessment indicates that the cross-section presented on Plate 3, Appendix E, appears reasonable.
