National Dam Inspection Program. Lake
Rene Dam (Lake Rene) (NDI PA-426, DER
17-102), Ohio River Basin, Tributary of
Narrows Creek, Clearfield County,
Pennsylvania. Phase I Inspection Report.

PHASE I REPORT
NATIONAL DAM INSPECTION PROGRAM

NAME OF DAM: Lake Rene Dam
STATE LOCATED: Pennsylvania
COUNTY LOCATED: Clearfield County
STREAM: Narrows Creek, a tributary of Sandy Lick Creek
DATE OF INSPECTION: April 2, 1979 and May 4, 1979

LAKE RENE DAM
NDI I.D. NO. PA-426
APRIL 2, 1979

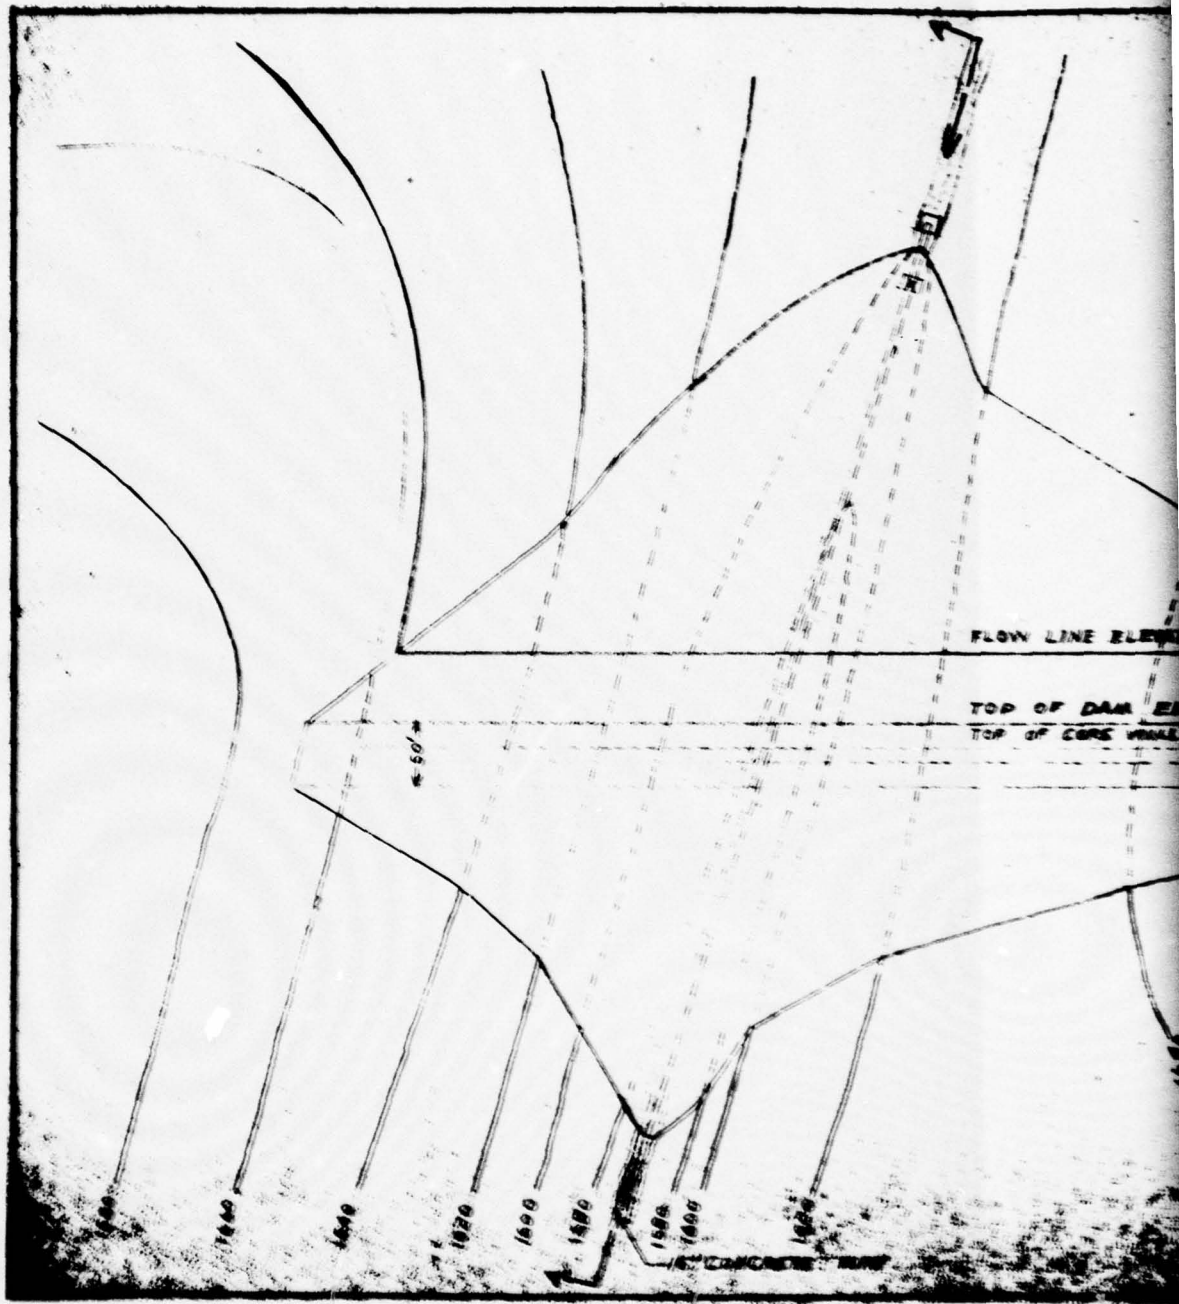
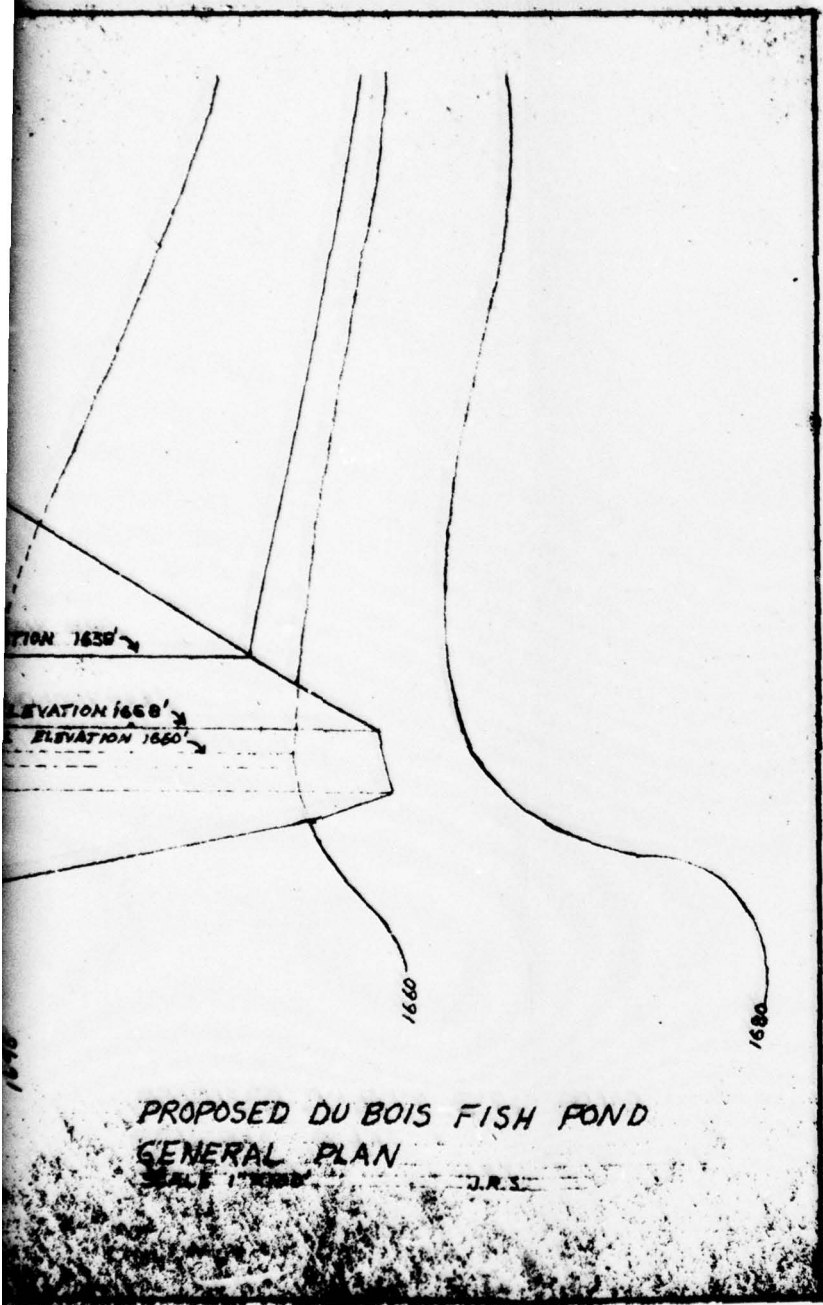
PLATE 2

(1) Embankment. As shown in a design sketch (Plate 2), the dam is a zoned embankment (Plate 3) consisting of a central impervious core with shale sections downstream and upstream and a rock-fill section at the toe of the downstream slope. The impervious core section is shown to be 24 feet wide at the base of the dam and 12 feet wide at about Elevation 1660. The same drawing shows the downstream face of the dam to have a 3H to 1V slope, while the upstream face was shown to have a slope 6H to 1V. However, field observations suggest that the dam was not constructed according to this design sketch. The downstream face of the dam was found to be much steeper than 3H to 1V. No evidence of a rock fill at the downstream toe of the dam was found. As it exists, the downstream face of the dam is 1.3H to 1V from crest elevation to a point approximately 15 feet below the crest, 2H to 1V for another 15 feet and 3H to 1V for the rest of the downstream slope. The portion of the upstream slope above normal pool elevation was found to have a slope of 2.5H to 1V.

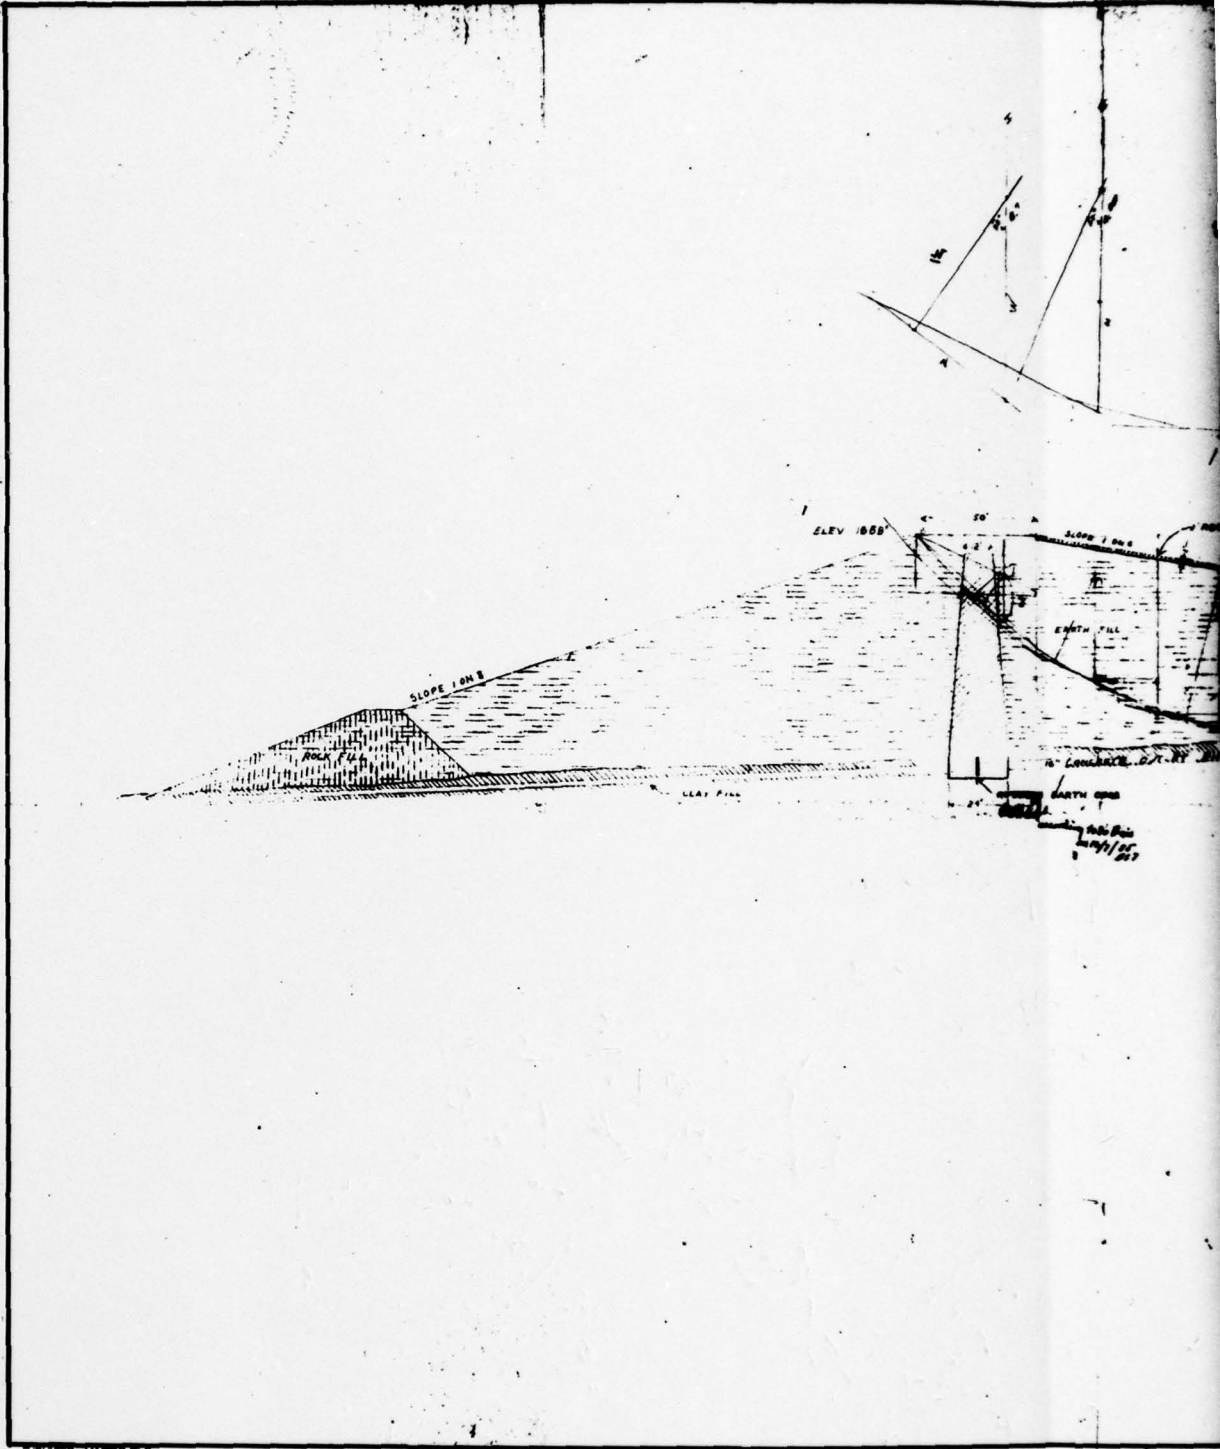
PLATE 3

ITEM	REMARKS
AS-BUILT DRAWINGS	The design drawings are available in the state files.
REGIONAL VICINITY MAP	See Plate 1.
CONSTRUCTION HISTORY	The dam was constructed by the original owner, Mr. J. D. DuBois, Jr., with completion in 1955. It appears that the dam was not formally engineered.
TYPICAL SECTIONS OF DAM	See Plate 3.
OUTLETS - PLAN - DETAILS - CONSTRAINTS - DISCHARGE RATINGS	See Plate 3.

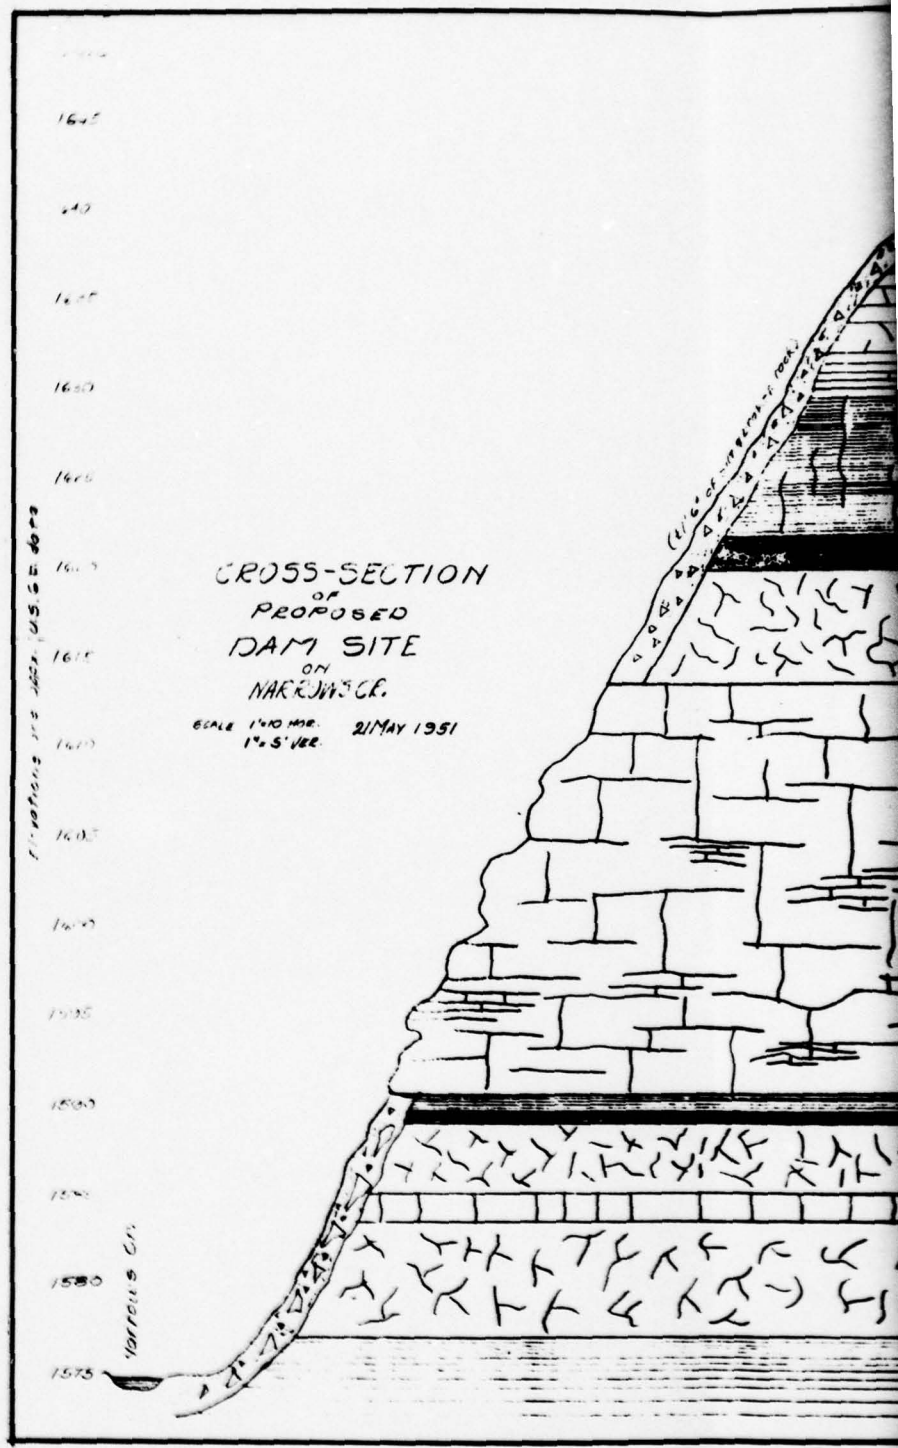
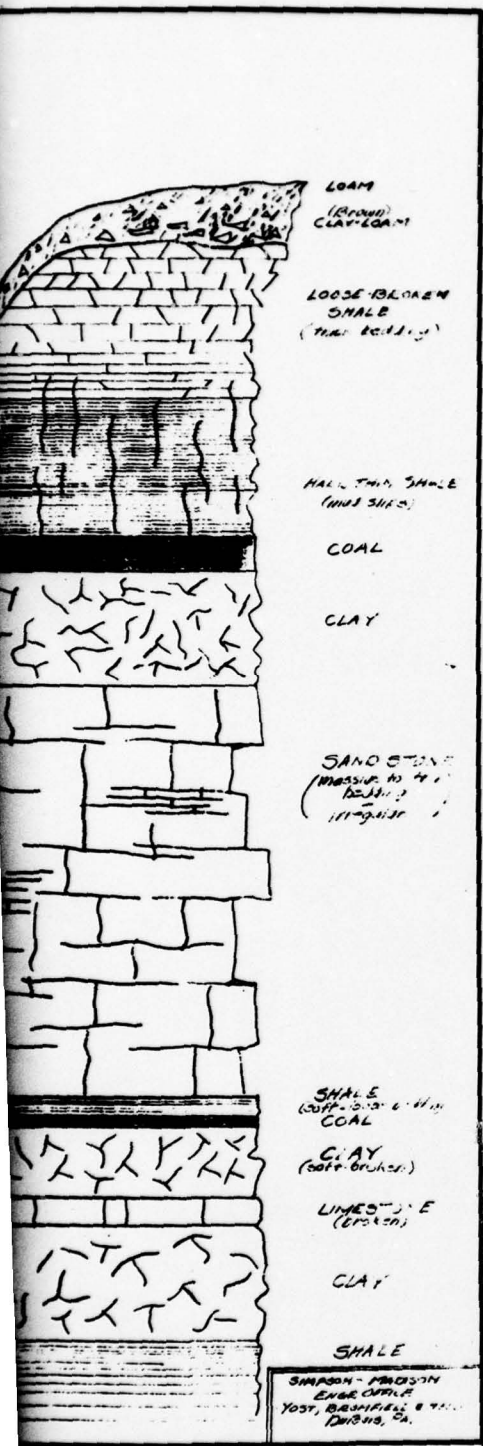
PLATE 5

(2) Embankment. Very limited engineering data are available on the design of the embankment. As shown on Plate 4, it appears that at least two borings were drilled for subsurface investigation. Plate 5 illustrates a geological profile for one of the abutments of the dam. However, the source of this information was not identified. A laboratory soils testing report prepared by Pittsburgh Testing Laboratory of Salt Lake City, Utah, indicates that laboratory soils tests included classification, compaction, and direct shear tests. The grain size distribution curve indicates that the material ranges from gravel to clay size with approximately 60 percent passing a 200 sieve. The liquid limit of the material was reported to be 32.5 percent with a plasticity index of 8. Direct shear tests were consolidated-undrained and the results were internal friction angle, $\phi = 32$ degrees, cohesion, $c = 0.05$ tons per square foot. As shown on Plate 2 and on other drawings included in the files, it appears that an attempt was made to analyze the stability of the slopes of the dam. However, no formal calculations or results of calculations were reported.
