PENNSYLVANIA
LEVEL 4
BERNHART DAM

PHASE I INSPECTION REPORT
NATIONAL DAM INSPECTION PROGRAM

Name of Dam: Bernhart Dam

Inventory Number: PA 00717

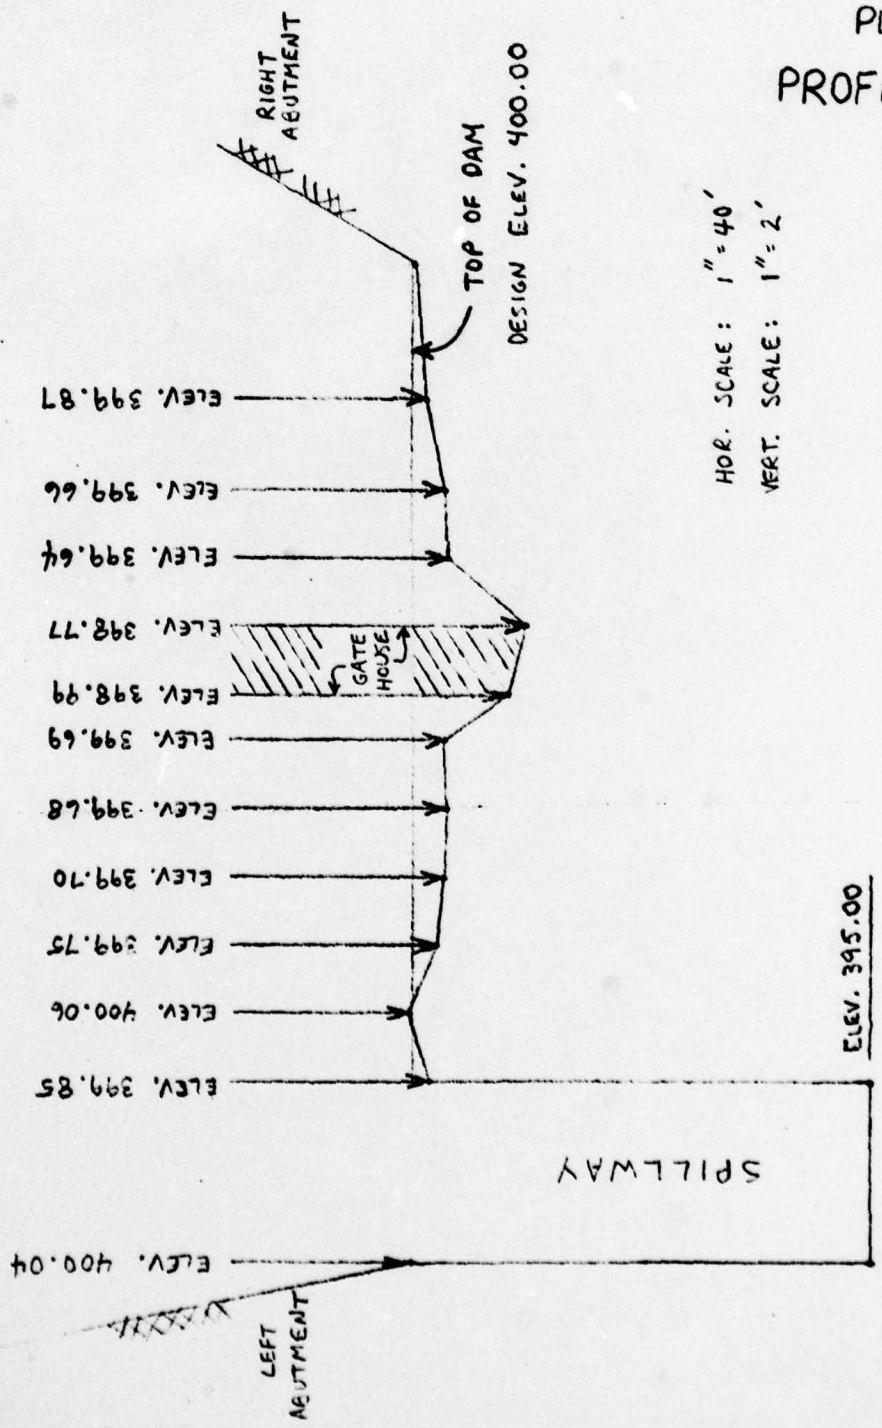
PLATE 5
PROFILE OF CREST
OF DAM

- b. Dam. The downstream face of the embankment appears to be in good condition. The only visible portion of the upstream face is the masonry wall which extends 5 feet above the reservoir surface. The masonry appears to be in good condition, but several small trees are growing from cracks in the upstream face of the wall. The grass cover has been eroded away and a path has formed along the crest and downstream slope at the spillway junction. This is apparently the result of pedestrian traffic and surface runoff.

1. The capacity of the spillway should be increased in accordance with the results of further hydrologic and hydraulic studies.
2. The top of the embankment and the masonry wall should be restored to design elevation as determined by a detailed survey.
3. The sluice gate which controls the 16-inch diameter blow-off pipe should be repaired and the pipe should be made operational.
4. The downstream spillway channel training walls should be repaired and replaced where necessary.
