**DELAWARE RIVER BASIN
LEAVITT BRANCH, BRODHEAD CREEK
MONROE COUNTY
PENNSYLVANIA
NDS ID PA. 00814
DER ID 45-250**

**SOIL CONSERVATION SERVICE DAM PA-463
(LEAVITT BRANCH DAM)**

**PHASE I INSPECTION REPORT
NATIONAL DAM INSPECTION PROGRAM**

MARCH 1979

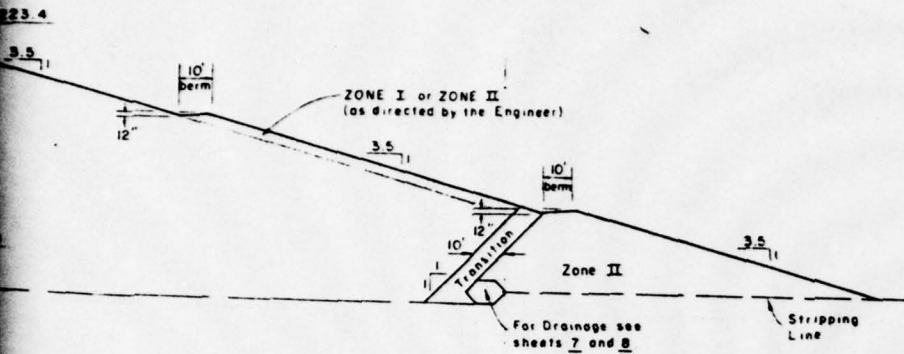
PLATE 3

→ The dam contains an unusual internal drainage system (see Plates 3 and 5). Drain fill material was placed on the downstream slope of the cutoff trench excavation. In addition, a trench drain was placed about two-thirds of the distance from the centerline to the downstream toe and a blanket drain is under a portion of the dam. Seepage collected in the drains outlets in the impact basin at the downstream toe or through one of the three pipes discharging at the downstream toe.

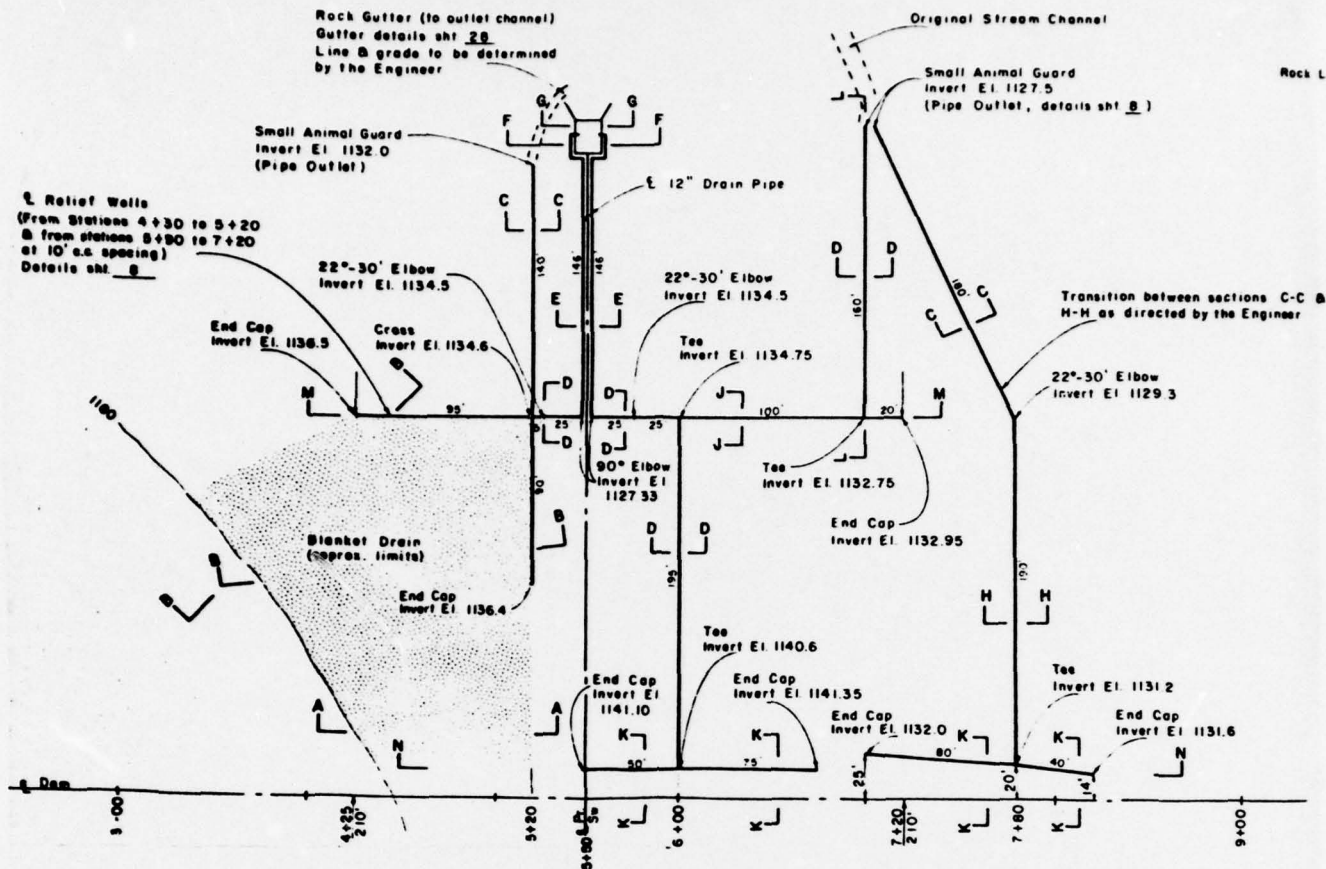
PLATE 5

As a result of a site visit on 16 April 1974 by SCS personnel from the State and regional offices, the original internal drainage design was questioned and a reevaluation was performed. Concern was expressed by the inspector as to whether fill material would pipe into the drain fill. Therefore, samples of the fill and drain material were taken from the embankment to determine if piping had actually taken place. As a result of this reevaluation, the internal drainage systems were redesigned to the configurations shown on Plates 5 and 5a, Appendix E.

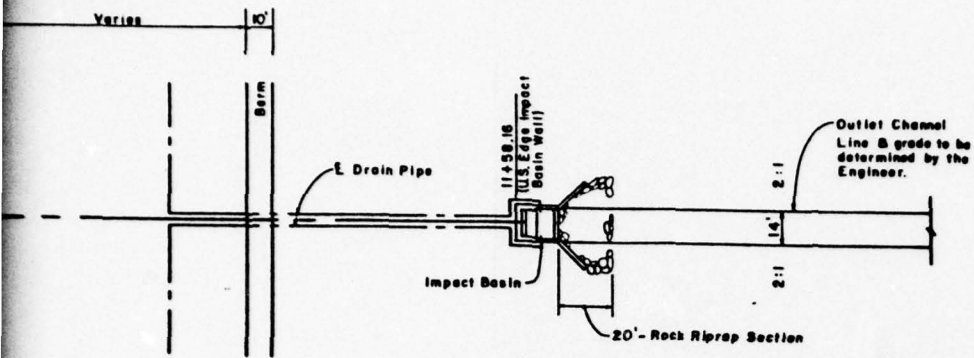
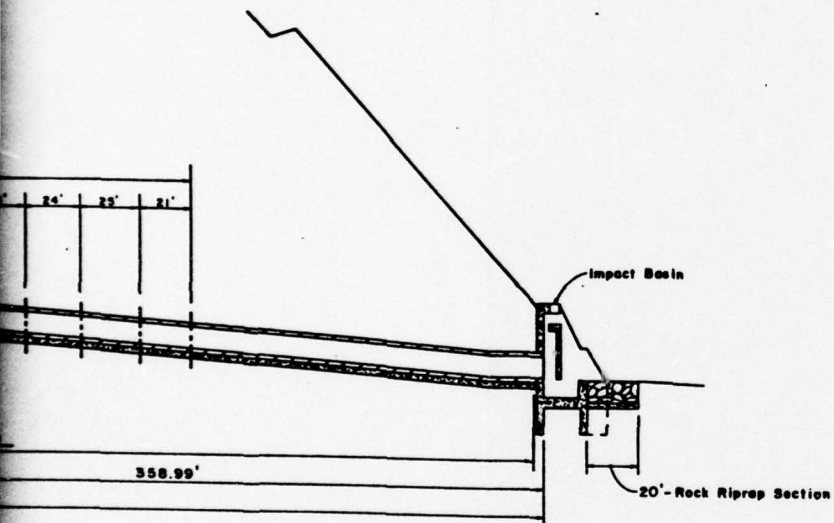
PLATE 7

Station 5 + 50, as shown on Plate 7. Water can enter the ungated reservoir drain at elevation 1,138 and also overflow weirs at elevation 1,158.9, discharging through a 30-inch diameter reinforced concrete pipe. The reservoir drain is about 52 feet long and has 2 anti-seep collars (see Plate 7). The concrete discharge pipe is located at the base of the dam and is founded on natural ground. The pipe is approximately 638 feet long and has 21 anti-seep collars. This pipe discharges into the impact basin at the downstream toe. The pipe outlet invert and the impact basin end sill are at elevation 1,125.0.
