DELAWARE RIVER BASIN
SANDO CREEK, MONROE COUNTY
PENNSYLVANIA
HDS ID PA. 00637
DER ID 45-155

EAST STROUDSBURG DAM

PHASE I INSPECTION REPORT NATIONAL DAM INSPECTION PROGRAM

APRIL 1979

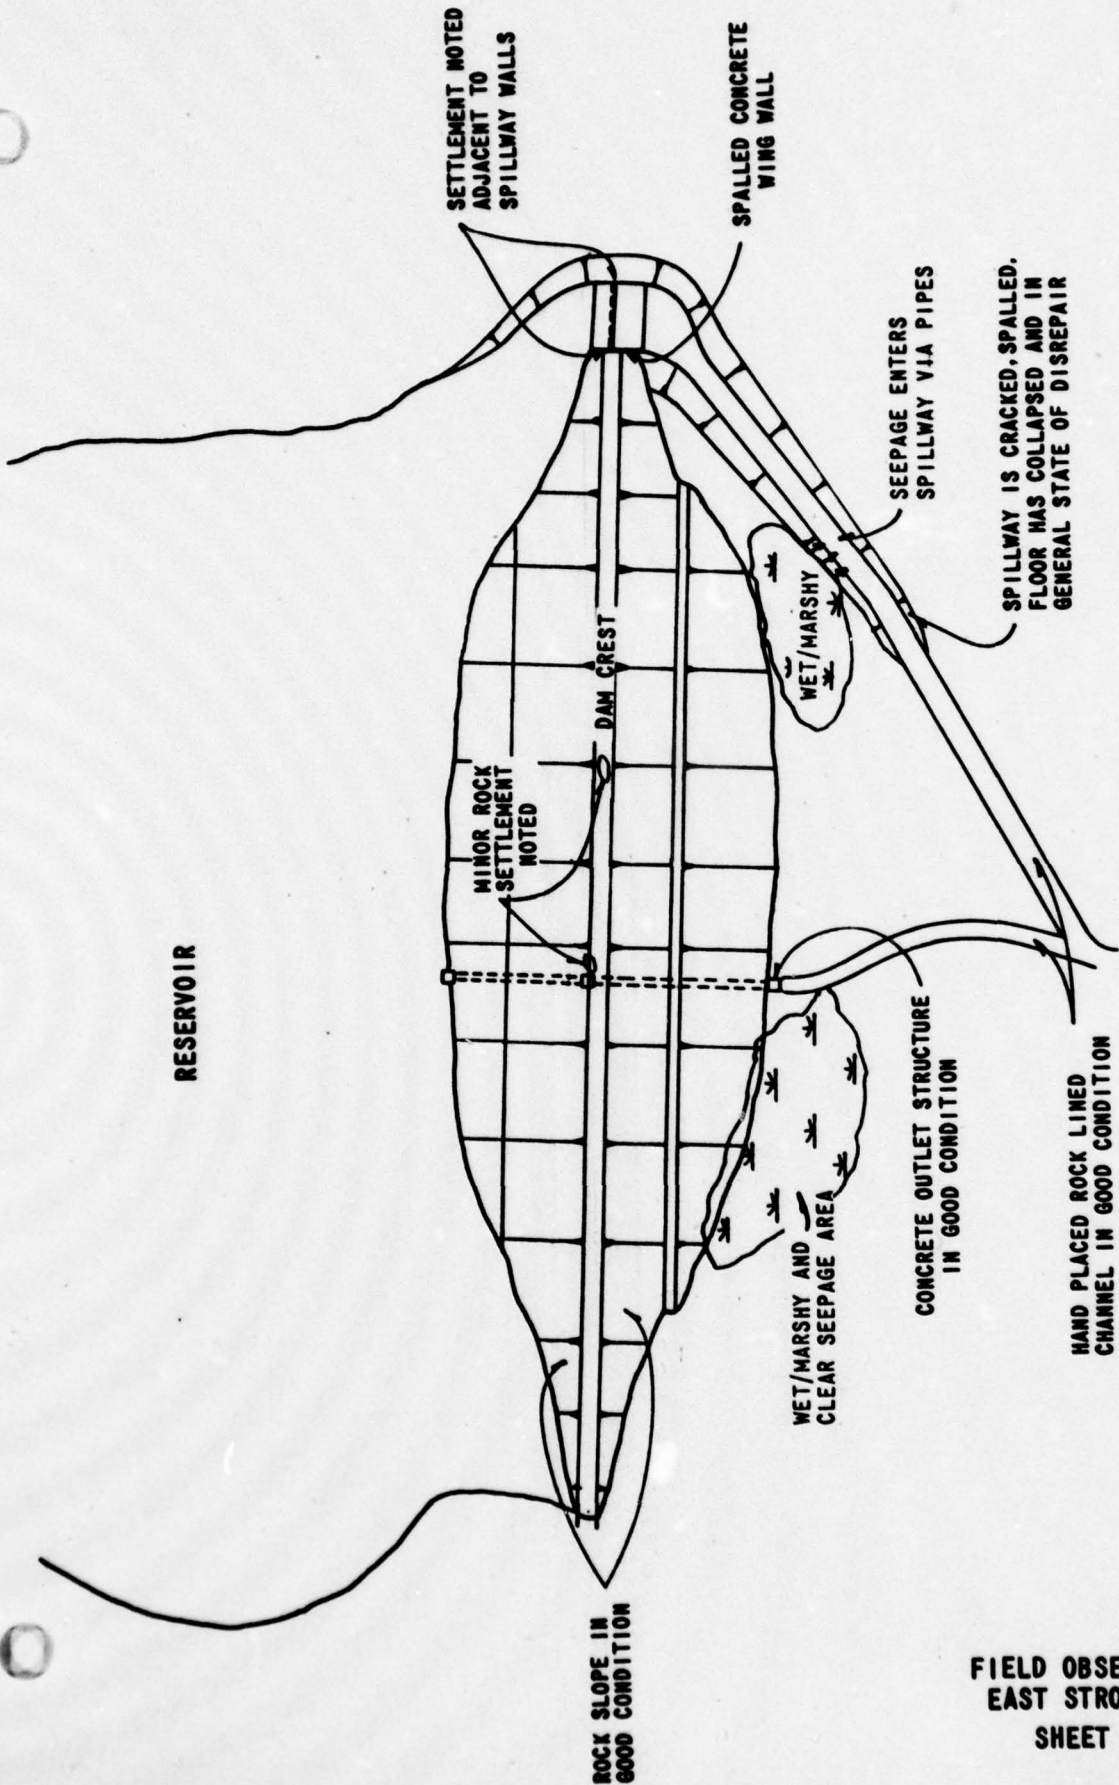
SETTLEMENT NOTED
ADJACENT TO
SPILLWAY WALLS

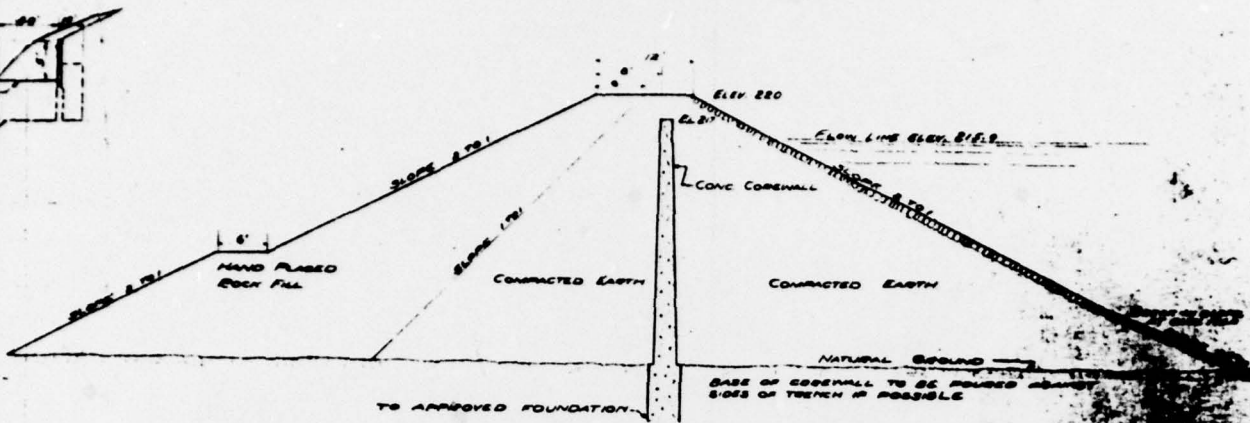
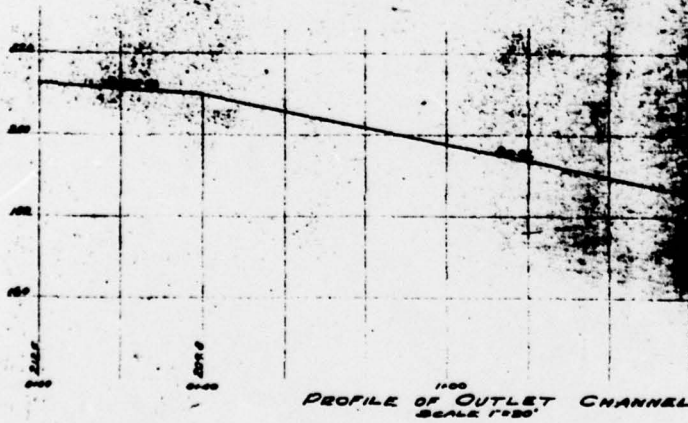
PLATE 3

zones. Additional excavations in the area revealed a large gravel layer, shown on the typical section enclosed herein as Plate 3. This gravelly and boulder ridden zone was a constant source of seepage and foundation construction problems. Seepage was controlled by a series of sumps and terra cotta drainage pipes. As the fill work proceeded, these terra cotta pipes were filled with concrete and sealed.

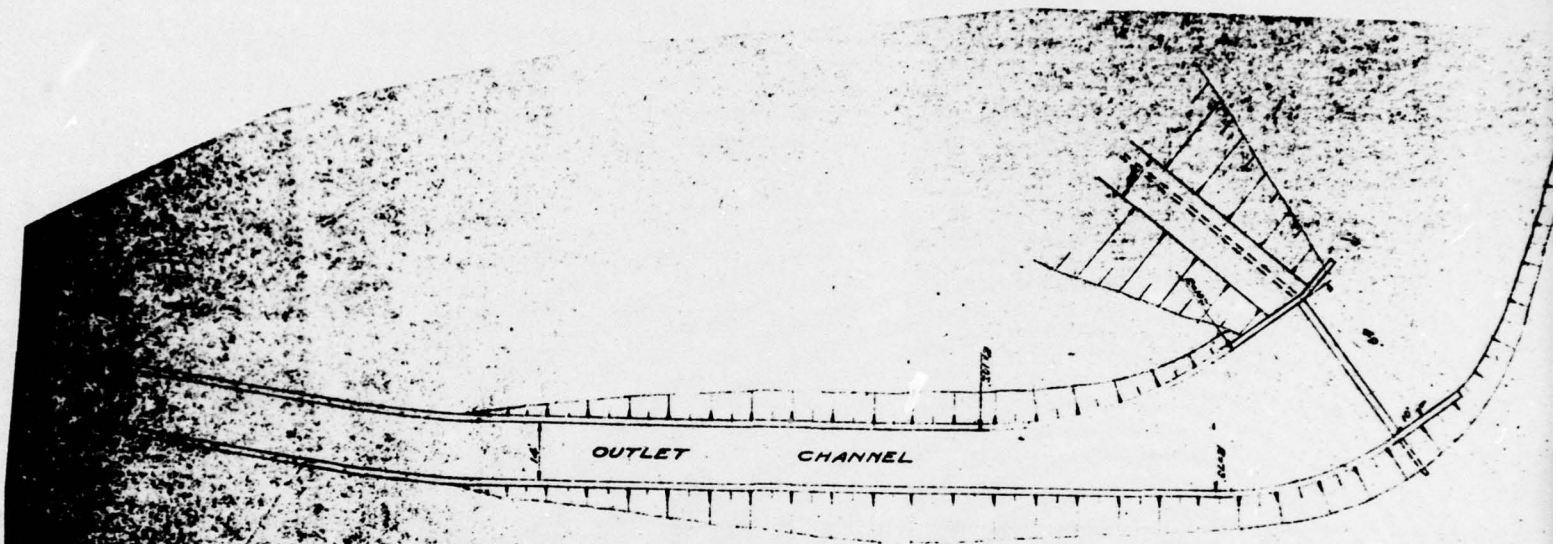
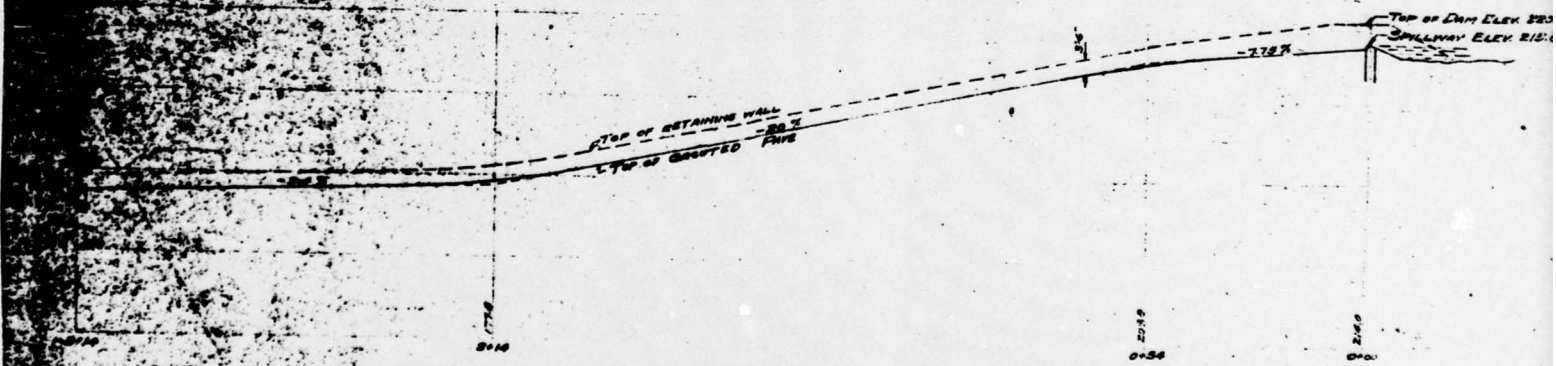
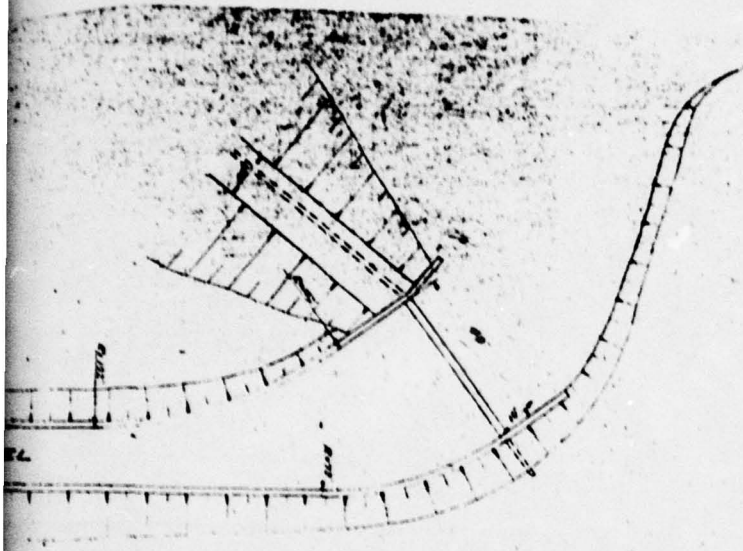
PLATE 4

Shortly after construction, several cracks were noted at the junction of the spillway weir with the retaining walls, which subsequently worsened and, in 1949, these were cited for repairs. Repair work began and was finished in that same year, in which the entire spillway system was rehabilitated. A plan and profile of the spillway are shown in Appendix E as Plate 4.

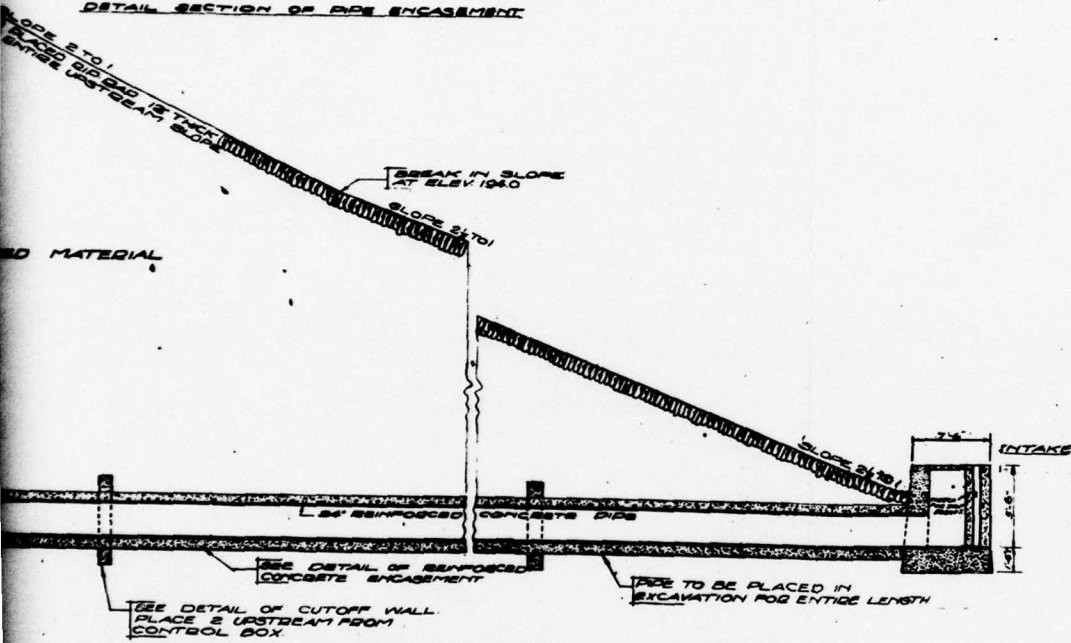
PLATE 5

The gatehouse is located about 320 feet from the right abutment. The best available section of this gatehouse is shown on Plate 5, Appendix E. The sluice gates are inside the gatehouse, one for the 24-inch intake pipe and one for the 24-inch discharge pipe. The intake is located at the upstream toe and the outlet discharges at the downstream toe into a rocklined channel.

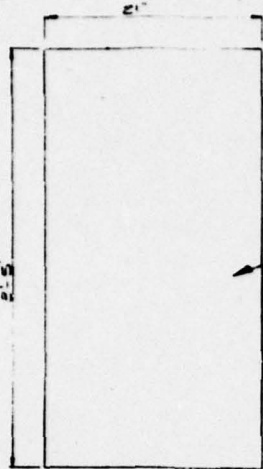
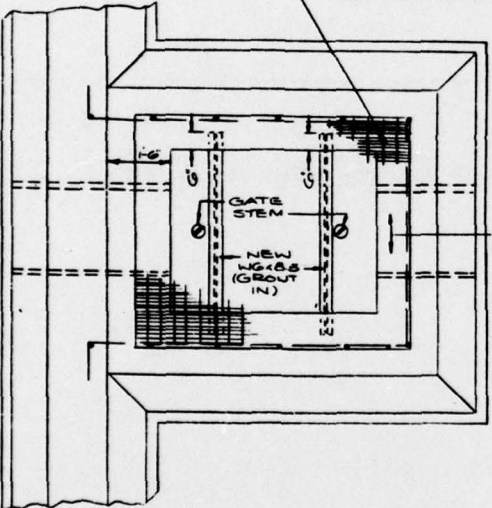
PLATE 6

VISUAL EXAMINATION OF	OBSERVATIONS	REMARKS OR RECOMMENDATIONS
CRACKING AND SPALLING OF CONCRETE SURFACES IN OUTLET CONDUIT	None observed. The tower was rehabilitated two years ago when the floor, roof and valve stems were replaced. See Plate 6 of Appendix E.	
INTAKE STRUCTURE	The tower appears to be in good condition. The inside of the tower below the reservoir level could not be inspected because safety equipment was not available.	
OUTLET STRUCTURE	The outlet pipe is embedded in the embankment and could not be inspected. However, the end of the pipe was exposed and is in good condition.	
OUTLET CHANNEL	Good condition.	
EMERGENCY GATE	The valve was exercised and found to be operable.
