6 National Dam Inspection Program. Saw Mill Dam (NDS ID PA 00324; DER ID 46-261), Delaware River Basin, Saw Mill Creek, Montgomery County, Pennsylvania. Phase I Inspection Report.

SAW MILL DAM, MONTGOMERY COUNTY PENNSYLVANIA

NDS I.D. NO. PA 00324
DER I.D. NO. 46-261

PHASE I INSPECTION REPORT
NATIONAL DAM INSPECTION PROGRAM

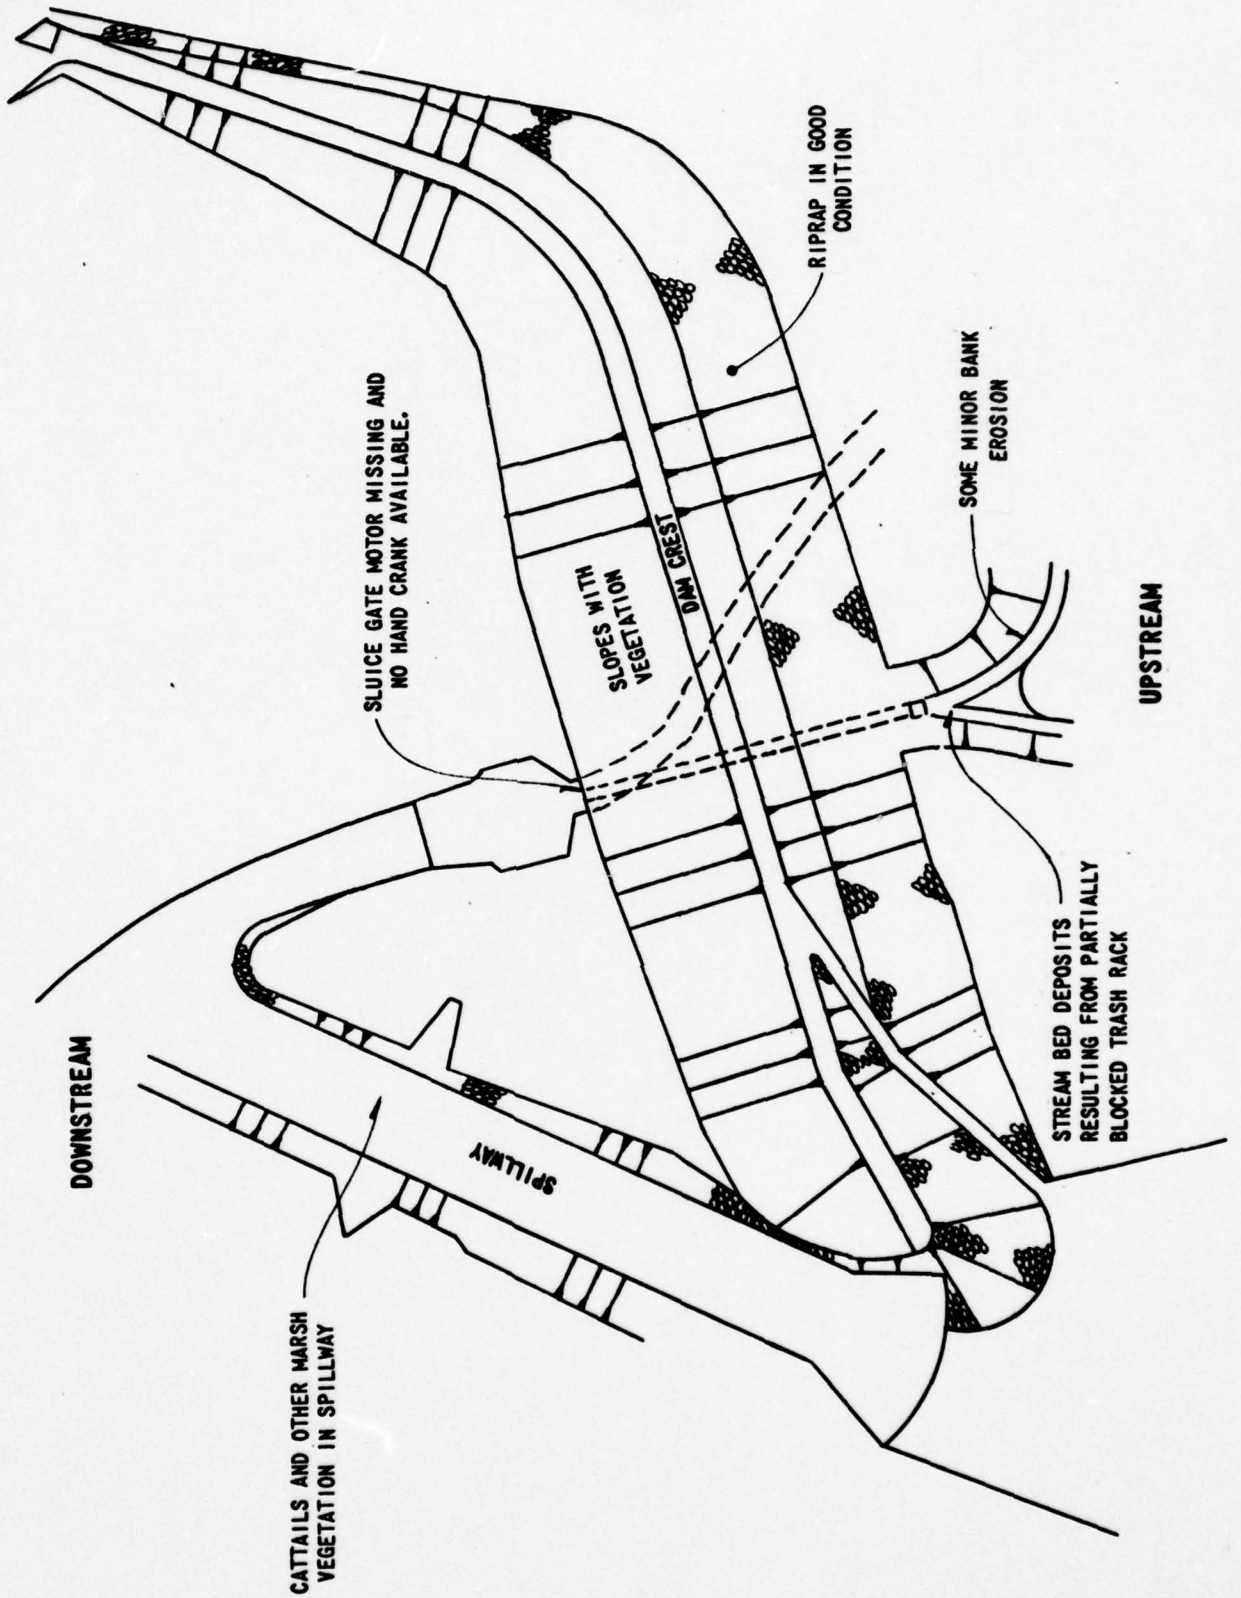
FIELD OBSERVATION PLAN
 SAW MILL DAM
 SHEET 5A OF 11

No failures but minor distortions and slope adjustments were observed.
