# POLE RUN DAM NO. 4

## PHASE I INSPECTION REPORT NATIONAL DAM INSPECTION PROGRAM

NDS I.D. NO. PA 00686  
DER I.D. NO. 54-36

WOODWARD-CLYDE CONSULTANTS  
5120 Butler Pike  
Plymouth Meeting, Pennsylvania 19462

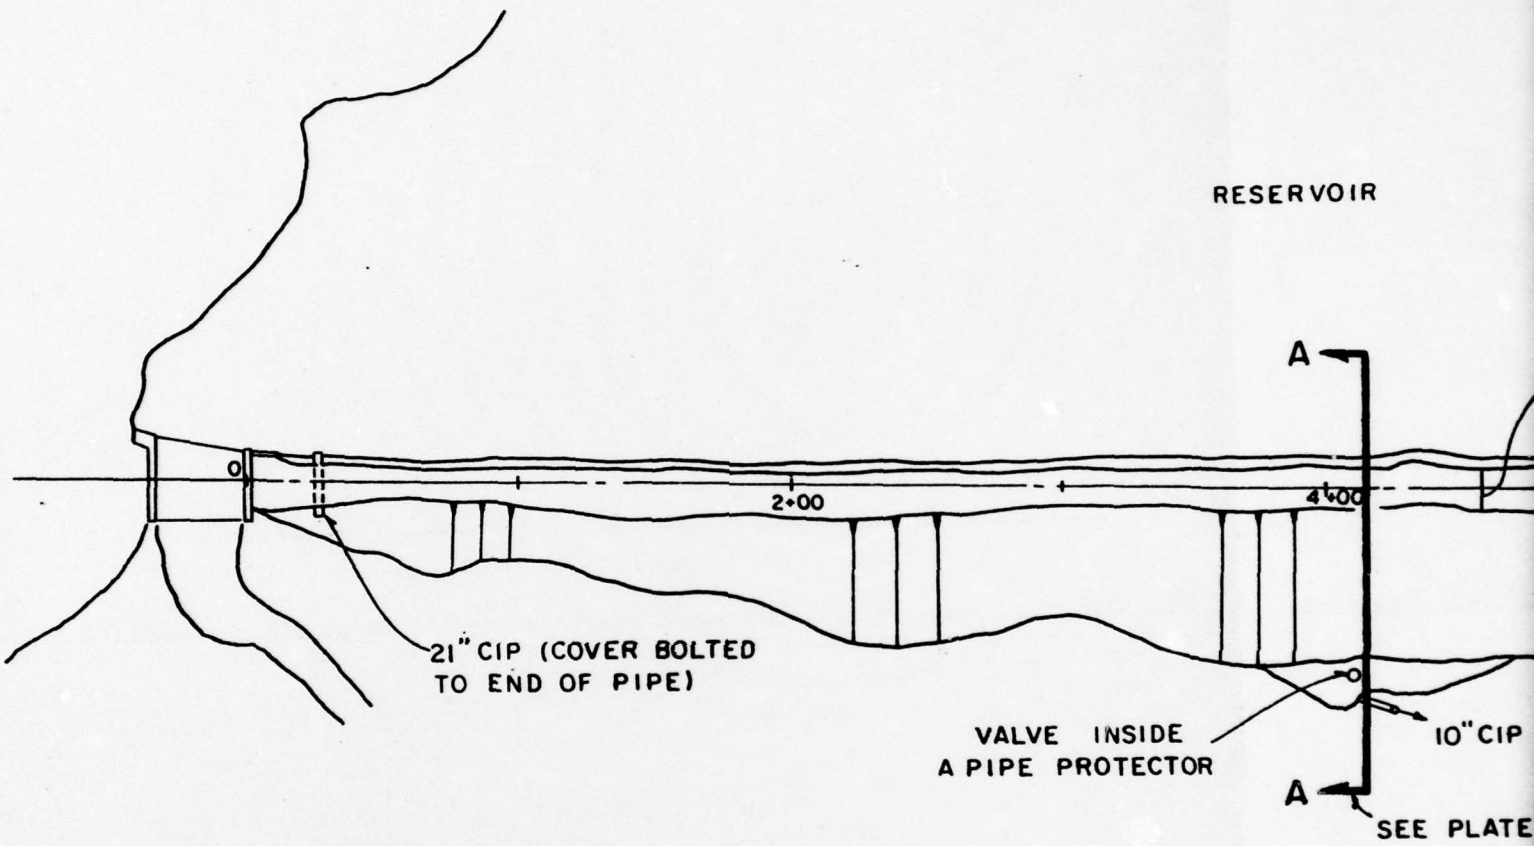
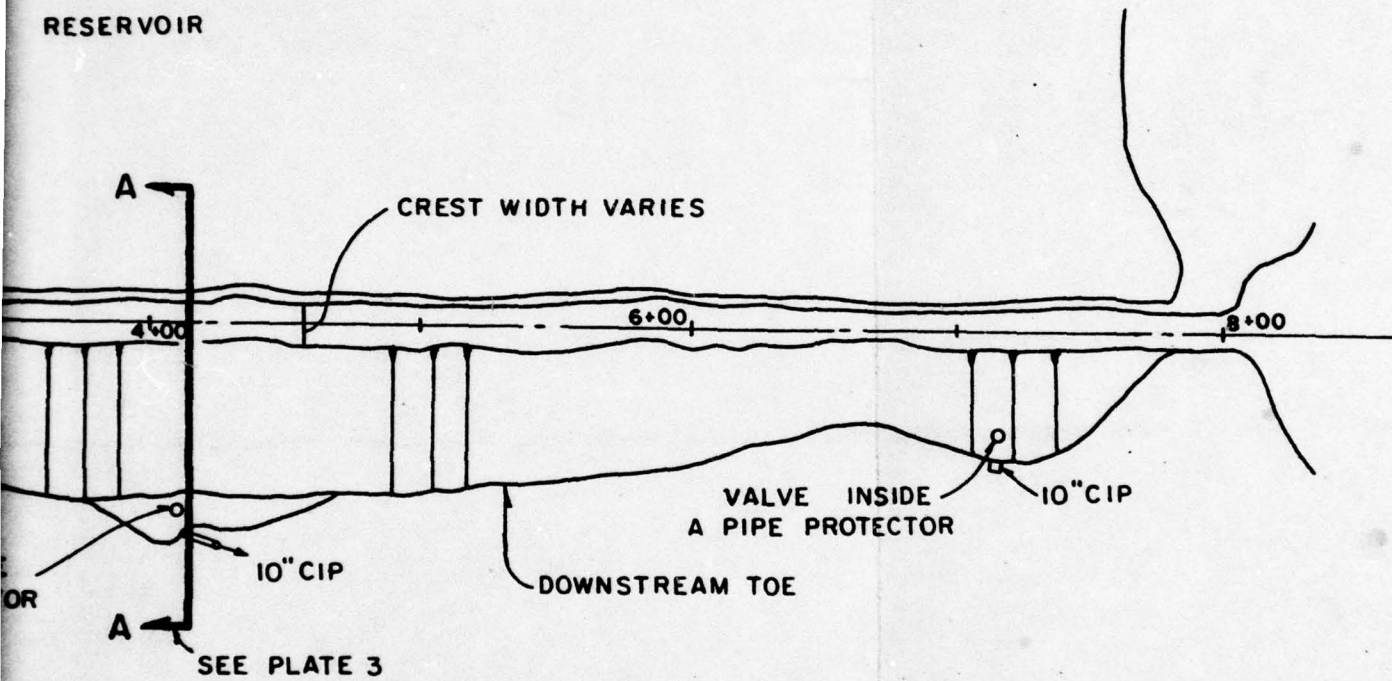
**PLAN OF DAM AND APPURTENANCES  
POLE RUN DAM NO. 4**

LOCAL DEPRESSION IN CREST  
(SEE SHEET 50 APPENDIX B AND  
PLATE 4)

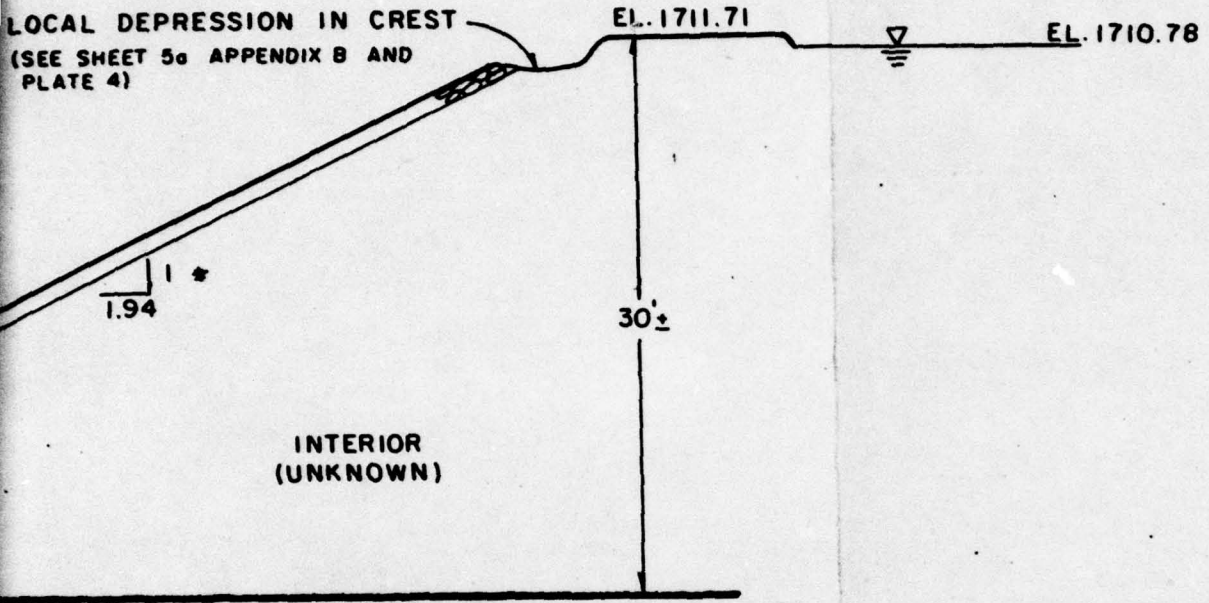
<b>EMBANKMENT PROFILE</b>	
<b>POLE RUN DAM NO.4</b>	
NAT.I.D.NO.PA.00686	SCHUYLKILL COUNTY
DATA OBTAINED FROM FIELD SURVEY, 10 APRIL, 1979	
PLATE 3

LOCAL DEPRESSION IN CREST  
(SEE SHEET 5c APPENDIX B AND  
PLATE 4)

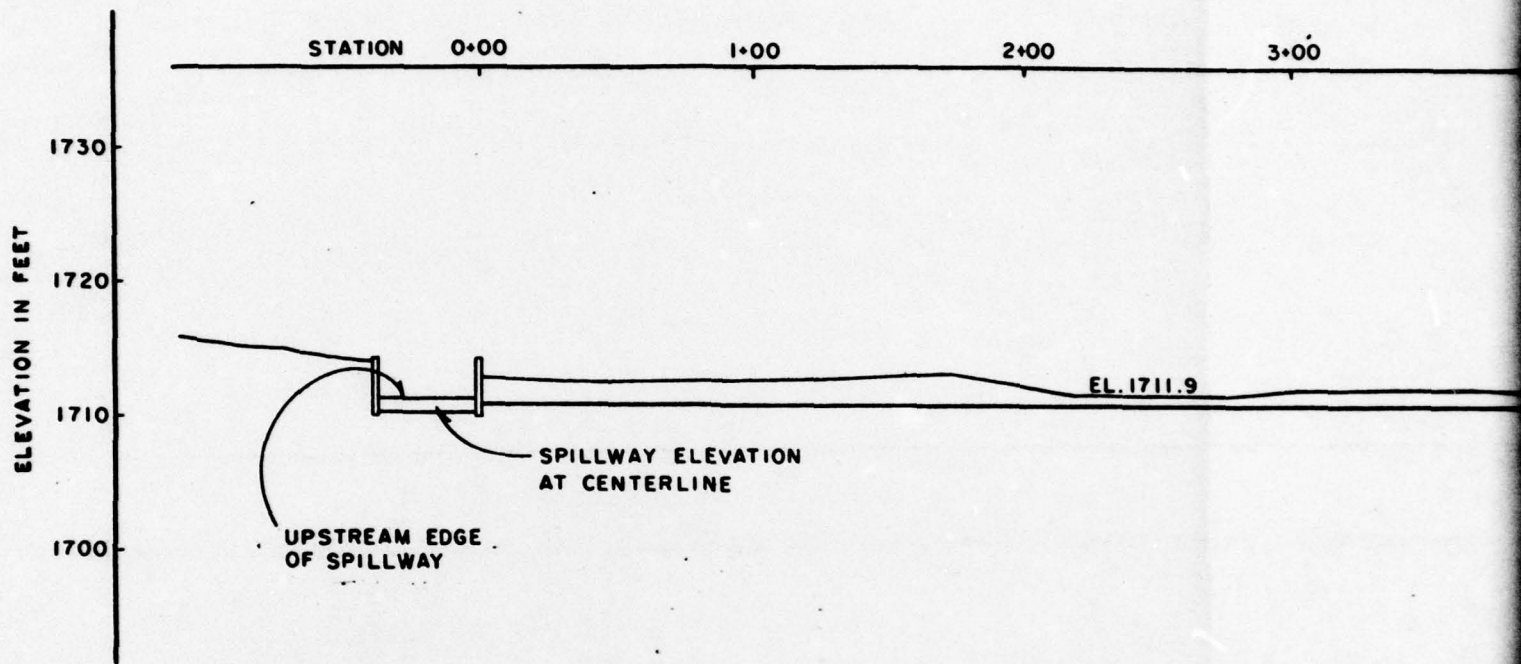
PLATE 4

b. Dam. The vertical alignment of the dam crest was checked and the profile is shown on Plate 4, Appendix E. The embankment is 0.4 feet below the left spillway wall and there is approximately seven inches of freeboard at normal pool. There was no discernible horizontal displacement or bulging noted along the crest, but slope undulations were prevalent along the full length of the dam. Longitudinal surface cracks were noted principally on the upstream side of the crest as shown on Sheet 5a and in Appendix D. These cracks appear to be surface cracks with no evidence found of embankment movement associated with them. Several small elliptical slope movements were noted near the toe, which appear to be scars from old shallow surface slides. Minor erosion was noted along the crest and at a few locations along the slope. One depressed area on the crest, as shown on Sheet 5a, appears to have resulted from concentrated surface runoff passing over the downstream slope.

c. Visual Observations. The only condition disclosed by the inspection that limits spillway capacity is the very small distance between the reservoir surface and the top of the dam, as shown on Plate 4, Appendix E. Other observations regarding the condition of the downstream channel, spillway and reservoir are located in Appendix B.

VISUAL EXAMINATION OF	OBSERVATIONS	REMARKS OR RECOMMENDATIONS
SURFACE CRACKS	<p>Yes. Horizontal surface cracks were noted mostly on the upstream side of the crest as shown on Sheet 5a, and in Appendix D. They appear to be surface cracks and there was no evidence found of embankment movement associated with these cracks.</p>	
UNUSUAL MOVEMENT OR CRACKING AT OR BEYOND THE TOE	<p>None observed but several small elliptical areas along the downstream toe were observed which appear to be scars of old shallow surface slides.</p>	
SLOUGHING OR EROSION OF EMBANKMENT AND ABUTMENT SLOPES	<p>Minor erosion was noted along the crest and at a few locations along the slope. One depressed area as shown on Sheet 5a, appears to be a place where surface runoff concentrates before passing over the downstream slope.</p>	
VERTICAL AND HORIZONTAL ALIGNMENT OF THE CREST	<p>Horizontal alignment appears to be good with no significant deviation when compared to old photographs. The vertical alignment undulates as shown on Plate 4, Appendix E.</p>
