GALION BAY DAM  
(LAKE RENE)  
NDI I.D. NO: PA-747  
DER I.D. NO: 17-107

PHASE I INSPECTION REPORT  
NATIONAL DAM INSPECTION PROGRAM

BY  
D'APPOLONIA CONSULTING ENGINEERS  
10 DUFF ROAD  
PITTSBURGH, PA. 15235  
JUNE 1979

NAME OF DAM: Galion Bay Dam  
STATE LOCATED: Pennsylvania  
COUNTY LOCATED: Clearfield  
STREAM: Gravel Lick, a tributary of Sandy Lick Creek  
DATE OF INSPECTION: April 4 and May 4, 1979

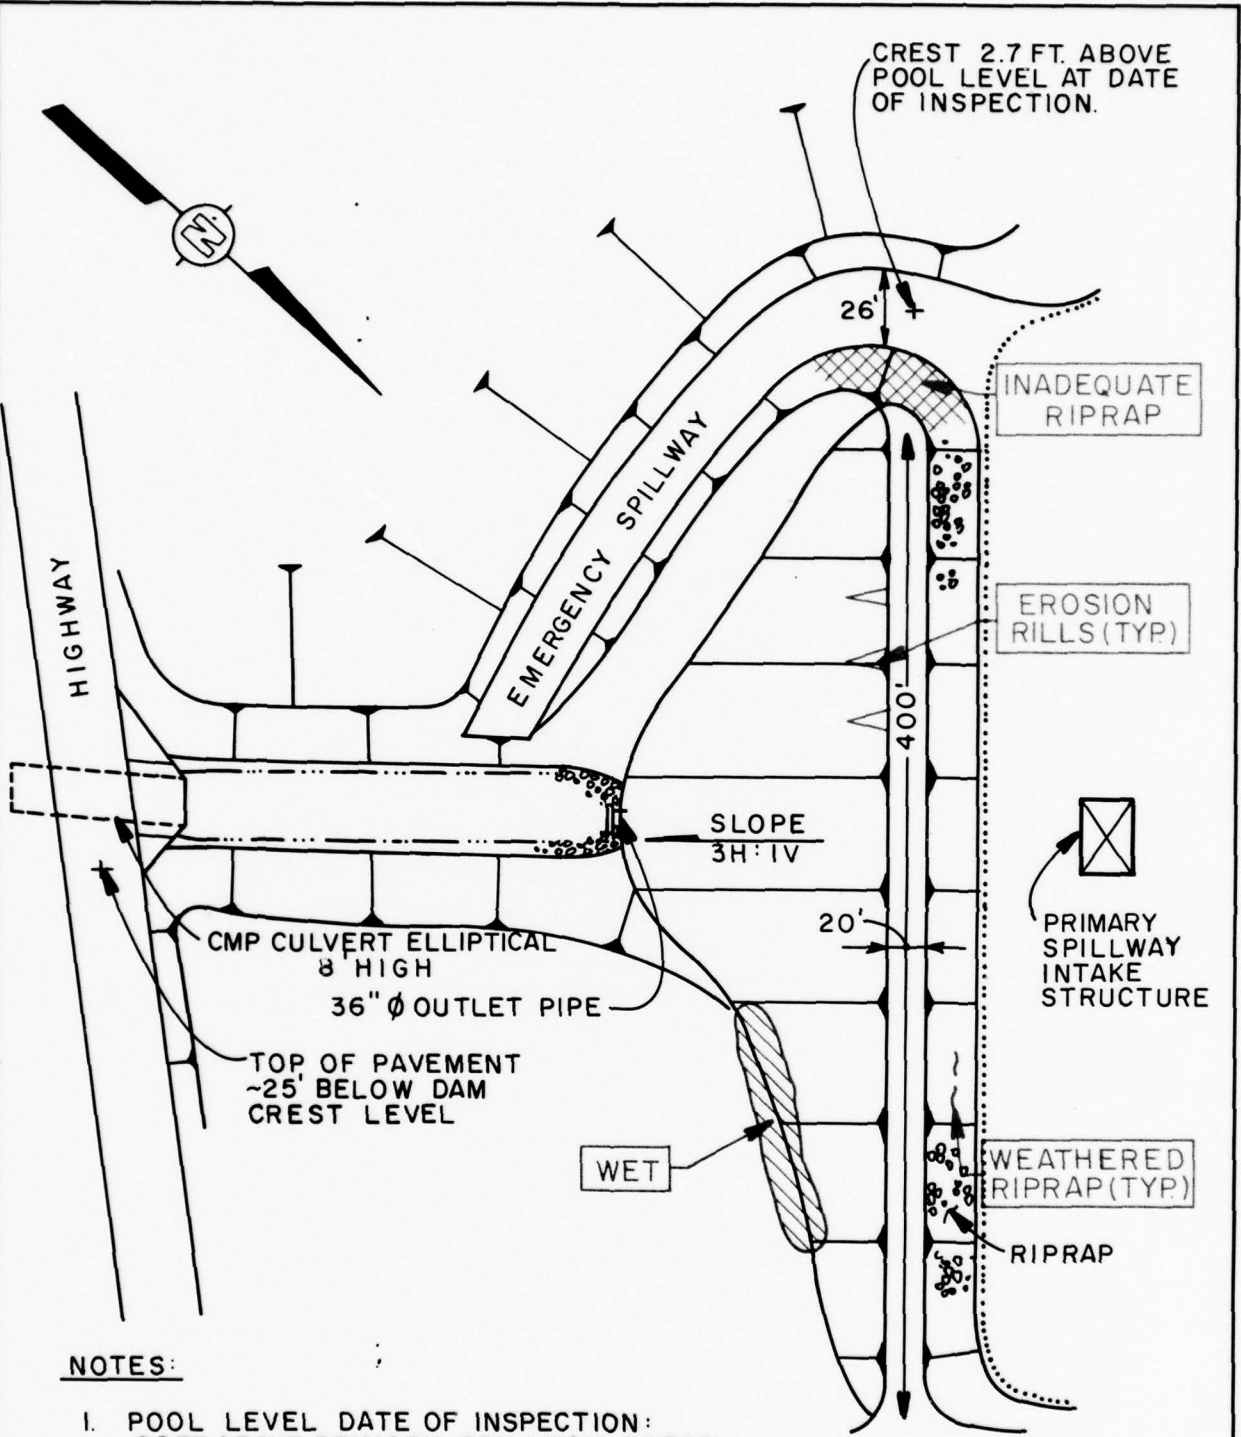
The top of the embankment was surveyed relative to the pool level on the date of inspection, which was estimated at Elevation 1662.6 and the lowest area on the crest of the embankment was found to be within 0.1 foot above the design elevation of 1670. The dam crest profile is illustrated on Plate 9.

1. POOL LEVEL DATE OF INSPECTION:  
~0.2 FT. ABOVE PRIMARY SPILLWAY CREST
2. EMERGENCY SPILLWAY FREEBOARD =  
7.5 FT.
