KYLE DAM

NDI I.D. NO: PA-417

PHASE I INSPECTION REPORT
NATIONAL DAM INSPECTION PROGRAM

JUNE 1979

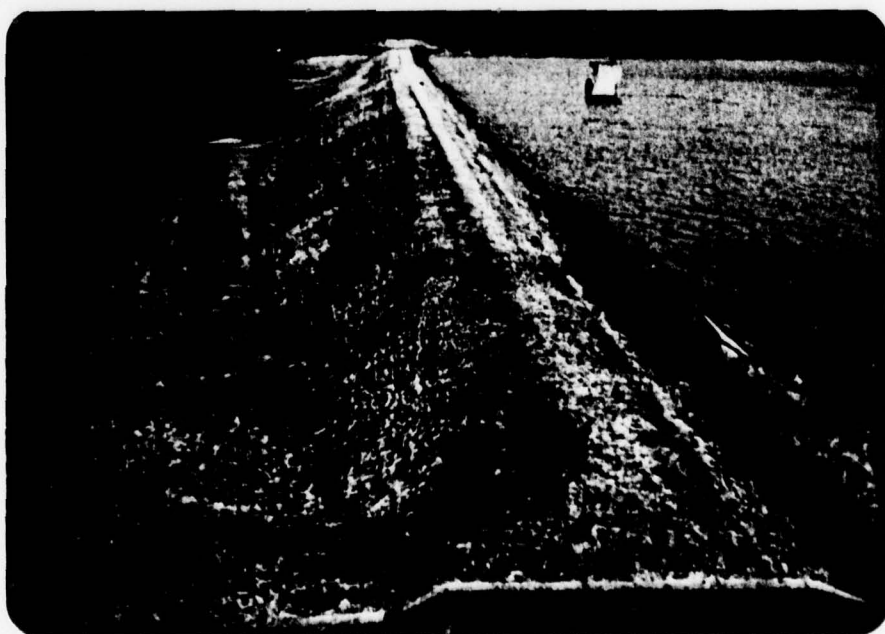
Downstream Face
