LITTLE YOUGHIOGHENY RIVER SITE NO. 5

NDI ID NO. MD 55

PHASE I INSPECTION REPORT

JUNE 1979

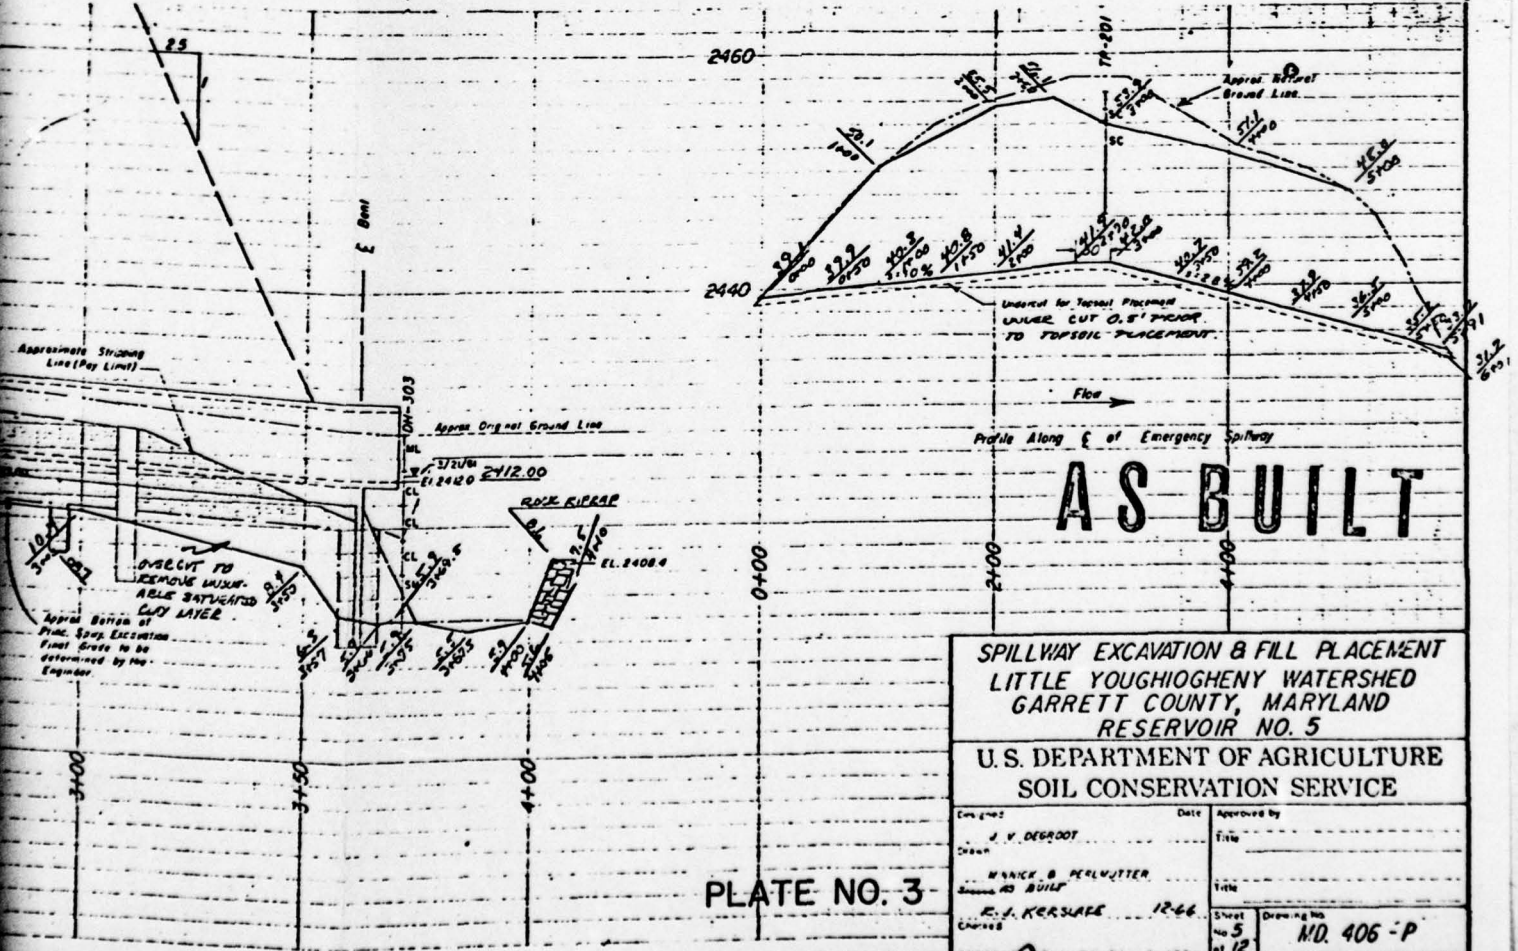
PLATE NO. 3

- 2) Seepage Drain System. According to as-built drawings, seepage water is collected by a sand and gravel filter trench and perforated pipe drain system. This drain system is located approximately 45 ft. upstream from the downstream embankment toe and is extended about 8 ft. below the original ground elevation. Collected seepage is drained out of the dam embankment by means of a sand and gravel blanket drain and two non-perforated outlet drain pipes located near the reinforced concrete pipe outlet. (Refer to Plate No. 3.)
