LITTLE YOUGHIOGHENY RIVER SITE NO. 7

NDI ID NO. MD 32

PHASE I INSPECTION REPORT

PHASE 1 REPORT
NATIONAL DAM INSPECTION PROGRAM

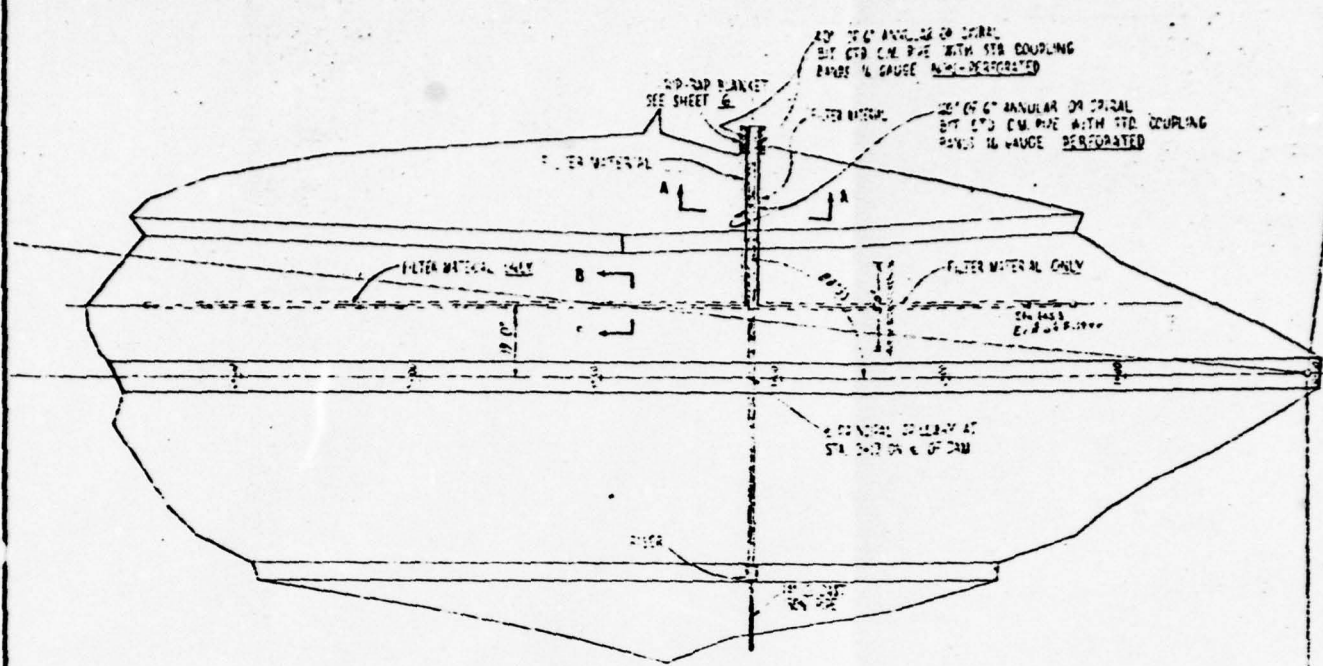
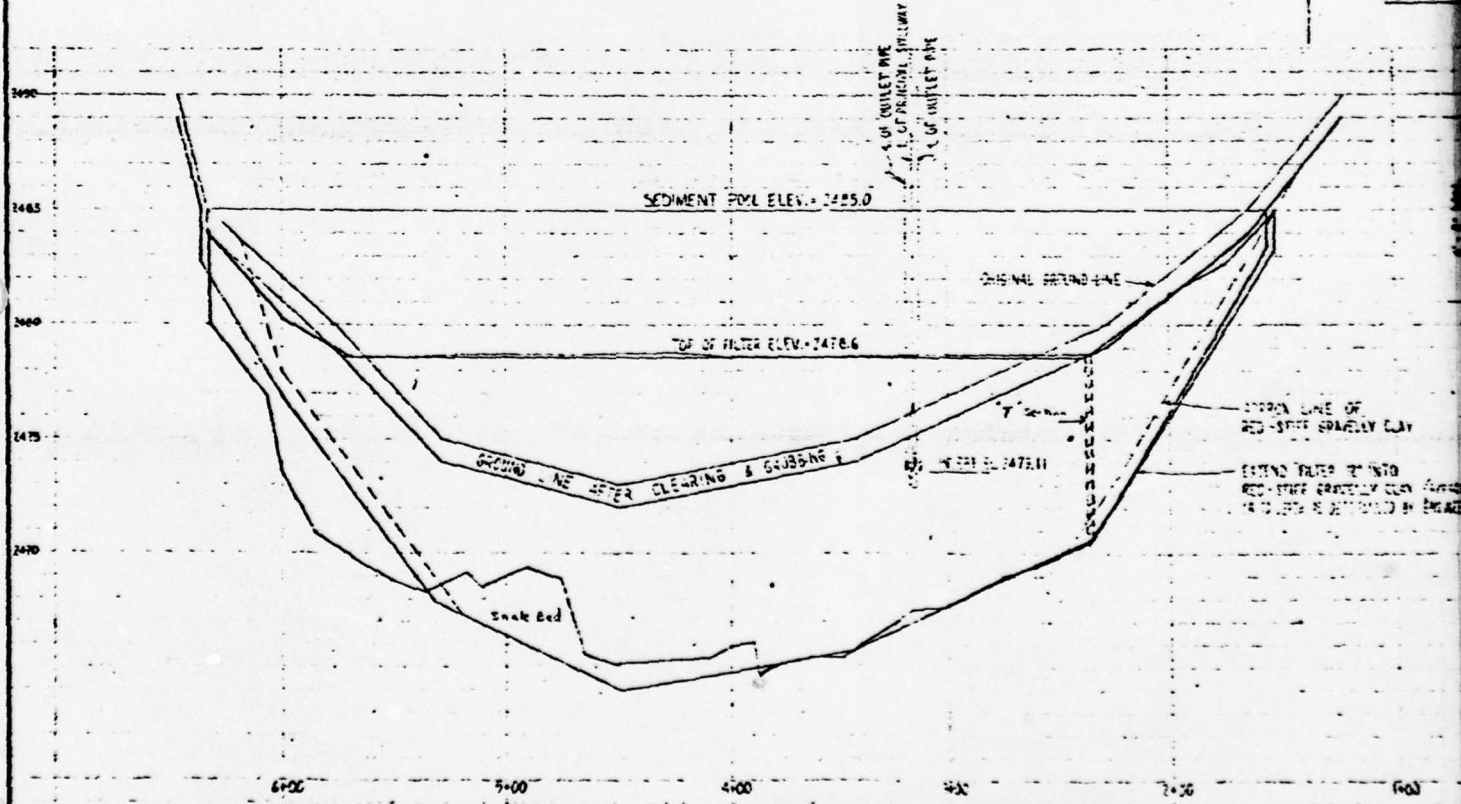
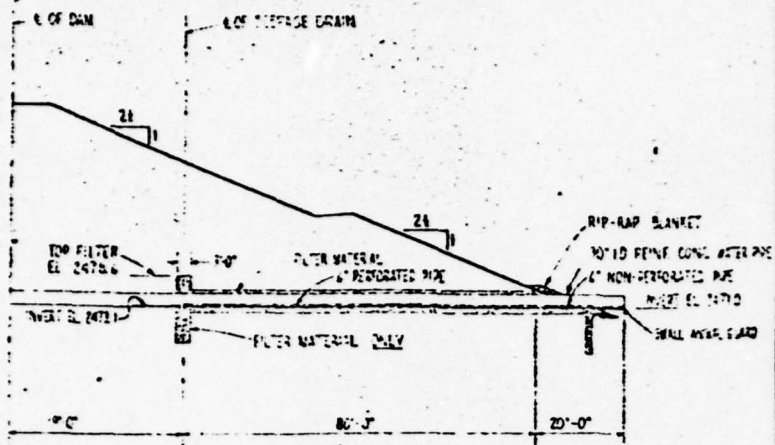
PLATE NO. 4

- 2) Seepage Drain System. Seepage control provisions consist of a filter trench collector system and a blanket drain and corrugated metal pipe outlet system. Filter trench extensions are located about 90 ft. upstream from the downstream embankment toe and are extended a maximum of 14 ft. below original ground. Collected seepage water is discharged into the outlet plunge pool. (Refer to Plate No. 4.)

blanket drain and two 6 in. dia. corrugated metal outlet drain pipes. The blanket drain and outlet pipes discharge the collected water into the plunge pool. Details of this seepage drain system are shown on Plate 4.
