**BOG BROOK DAM NO. 1  
AND DAM NO. 2**

**PHASE I INSPECTION REPORT**

**DAM NO. 1 - NY 00068  
DAM NO. 2 - NY 00069**

Prepared by: O'Brien and Gere Engineers, Inc.

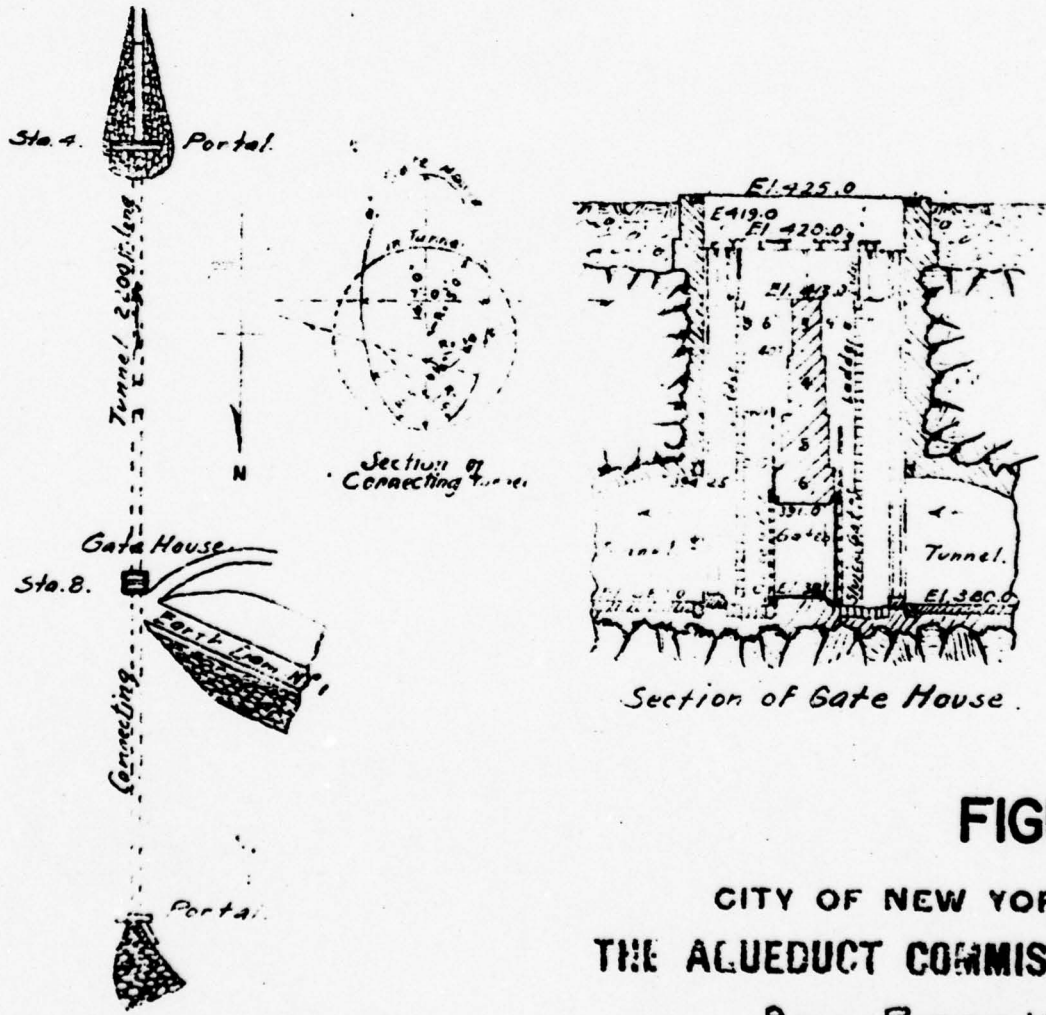
**FIGURE 7**

A second stone masonry outlet structure is situated on the south abutment of Dam No. 1. This structure houses two gate valves and a butterfly valve which control discharge into a 10 foot diameter, brick-lined connecting tunnel. (See Figure 7 for details). The tunnel is 2,200 feet long and is used to maintain the same operating pool level in Bog Brook and East Branch (Sodom) Reservoirs.

The inoperable valves in the connecting tunnel gatehouse and the outlet gatehouse should be repaired. The trees and brush growing on Dam No. 2 should be cut near the ground surface and an investigation made to determine the extent of the root systems before additional measures are undertaken. The toe drainage ditch for both structures should be cleared of debris and vegetation to insure proper collection of runoff and seepage.

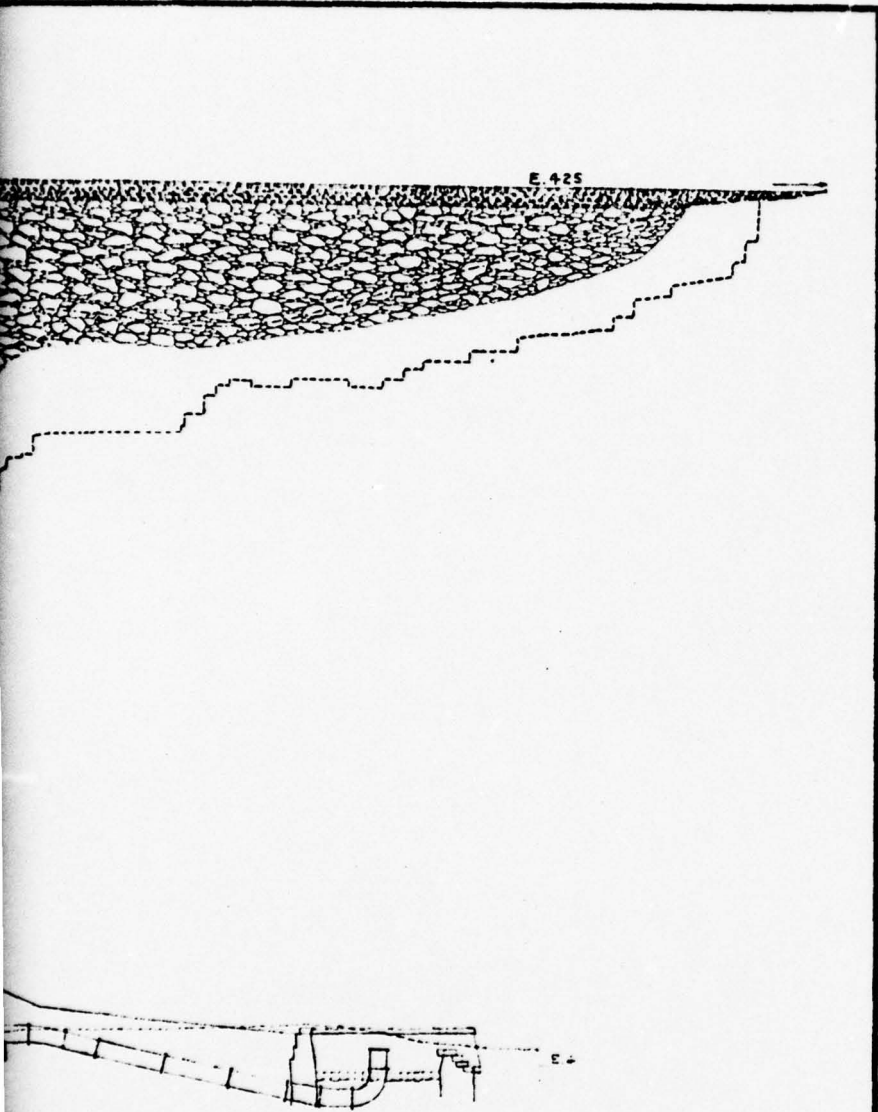
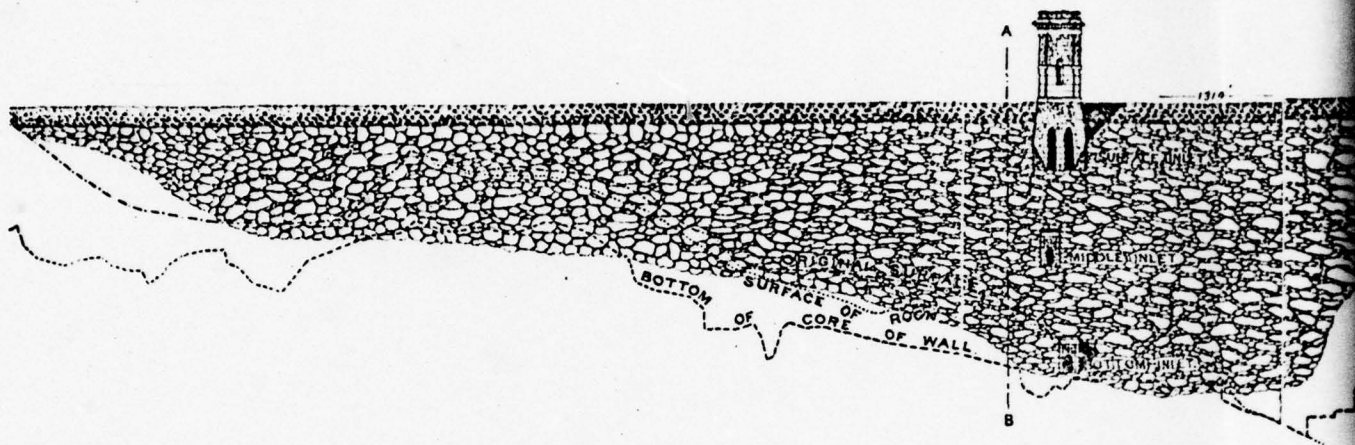
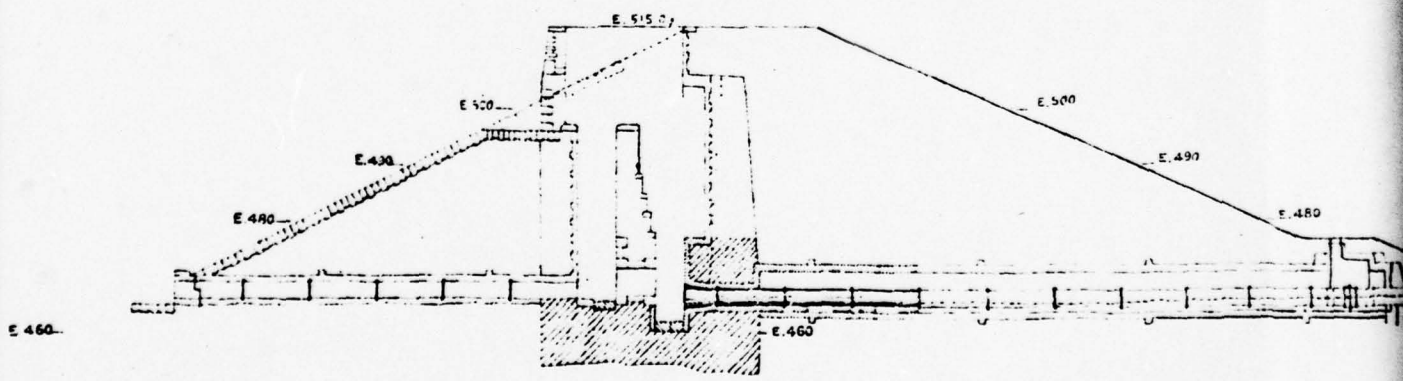
**FIGURE 8**

Two thirty-inch diameter cast iron pipes, housed in a horseshoe-shaped brick-lined culvert, convey the discharge through Dam No. 1. About 30 feet beyond the downstream toe of embankment, the conduits pass through a vault containing two horizontal stem gate valves. The pipes continue downstream about 200 feet where the discharge from each pipe exits through a fountain orifice into a common stilling basin. (See Figure 8 of Appendix).

The valve vault and tunnel housing for the outlet conduits appears to be in good condition. There was no evidence of flow in the tunnel at the time of inspection but some standing water (about 6 inches deep) was noted on the floor of the vault.
