TRW DEFENSE AND SPACE SYSTEMS GROUP REDONDO BEACH CA
9433 DESIGN POINTING ANOMALY. VOLUME I. TECHNICAL REPORT. (U)

0433 DESPIN POINTING ANOMALY

VOLUME I
TECHNICAL REPORT

REPORT NO. 28600-AR-010-01 ✓

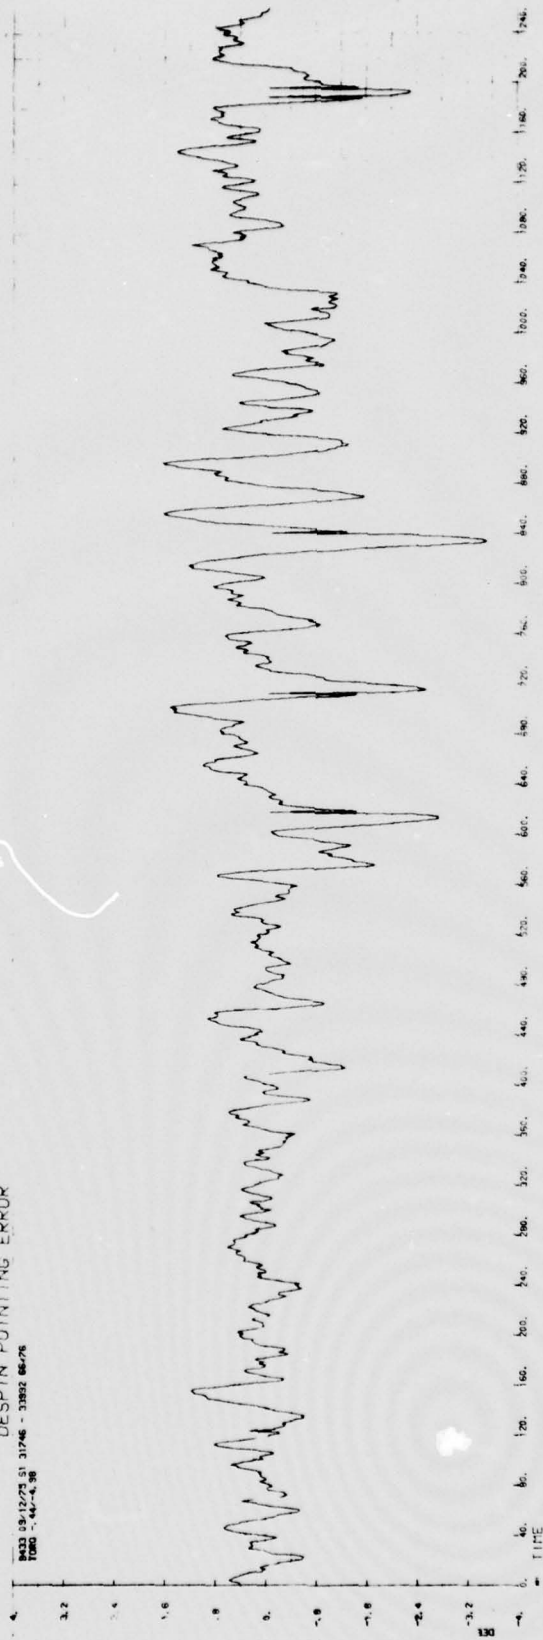
Figure 3.2-3. $\geq 1.0^\circ$ Pointing Error Transient

Several hours prior to reducing the spacecraft spin-rate, a 5.8° pointing transient had been observed (Figure 3.2-3). Since transients in excess of 6.0° would result in a loss of earth lock (normal mode), it was decided to reduce the spacecraft spin rate in an effort to possibly prevent this occurrence. A spin rate reduction to 50 RPM (from 60 RPM) was accomplished at 2000Z on 12 September.

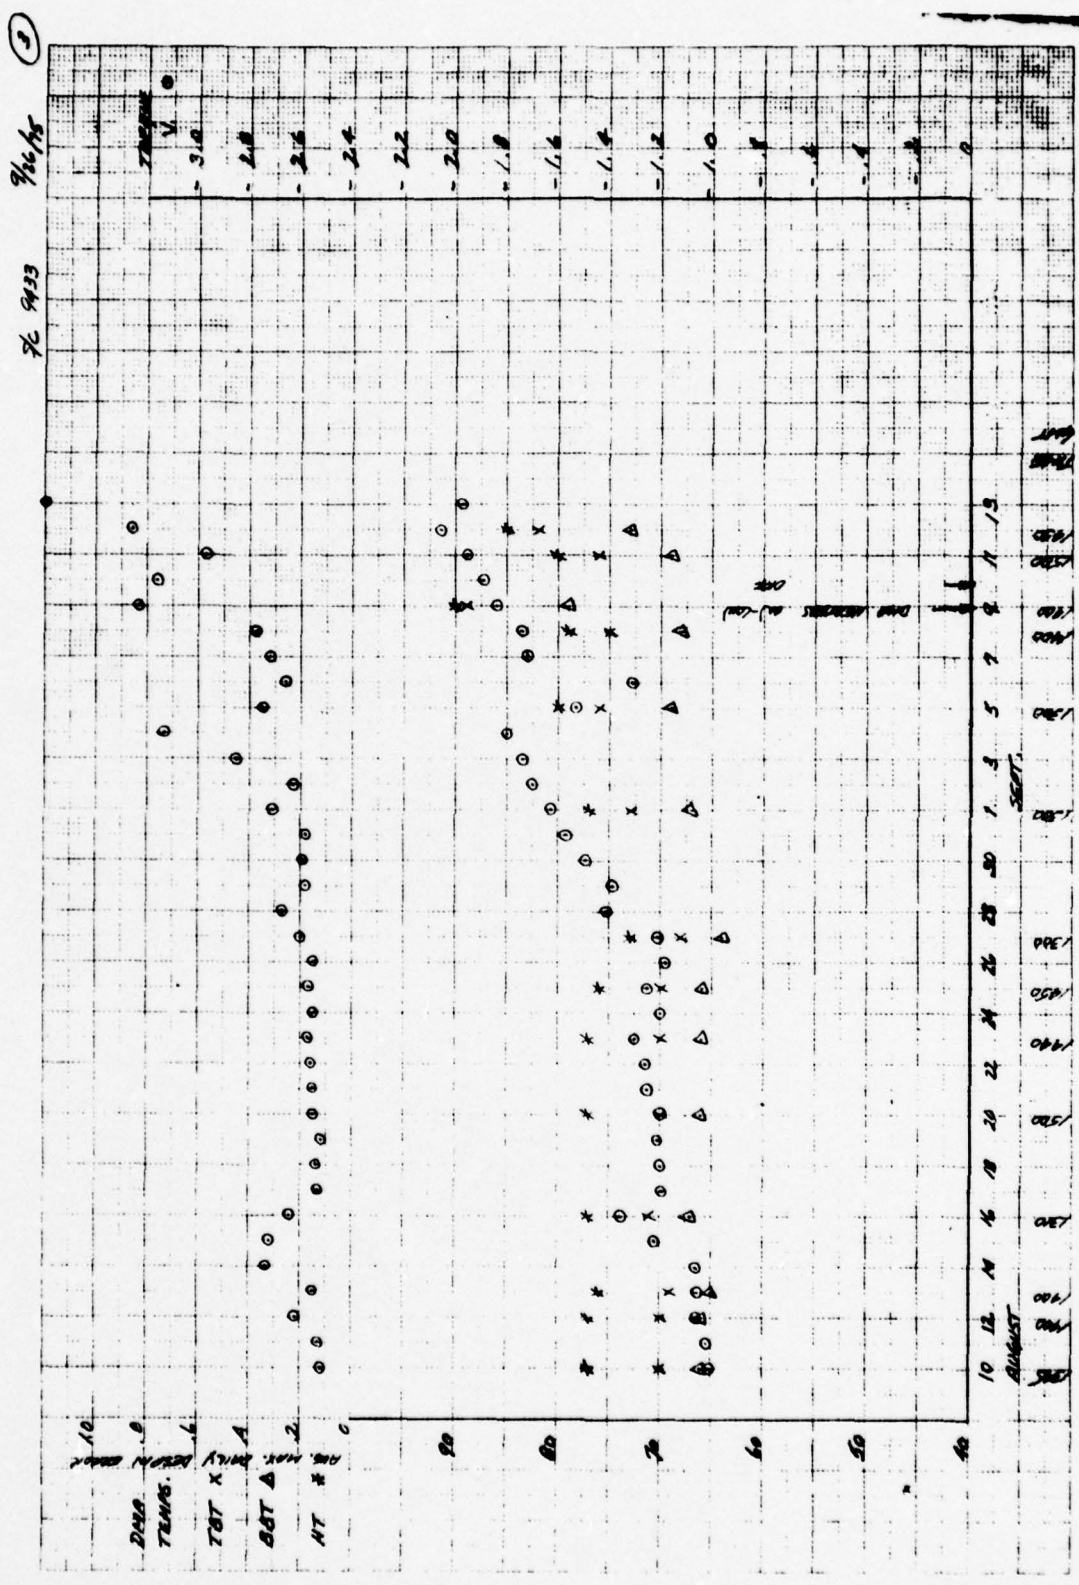
Figure 3.2-6. Daily Drive Torque, Despin Error, and DMA Temperature (10 August Through 13 September)

Because there appeared to be a correlation of performance with time-of-day, it was thought that thermal gradients might be a driving influence. Therefore, an attempt was made to alter the thermal environment on 9 September by using the low level DMA heaters. However, the result was a further degradation in despining pointing as the required drive torque continued to increase. Typical pointing variations of 0.5° with large excursions of 1.0° were observed during the time of heater operation.

Turn-off of the DMA heaters did not result in a return of the DMA to its earlier thermal environment, apparently due to the increased drive torque causing higher power dissipation in the DMA motor. Pointing performance from heater turn-off until 9 September (when the spacecraft spin rate was reduced) continued at 0.7° at a friction torque level of 90 in-oz (pre-May 9 levels of $\pm 0.09^\circ$ at friction levels of 30 in-oz were typical).

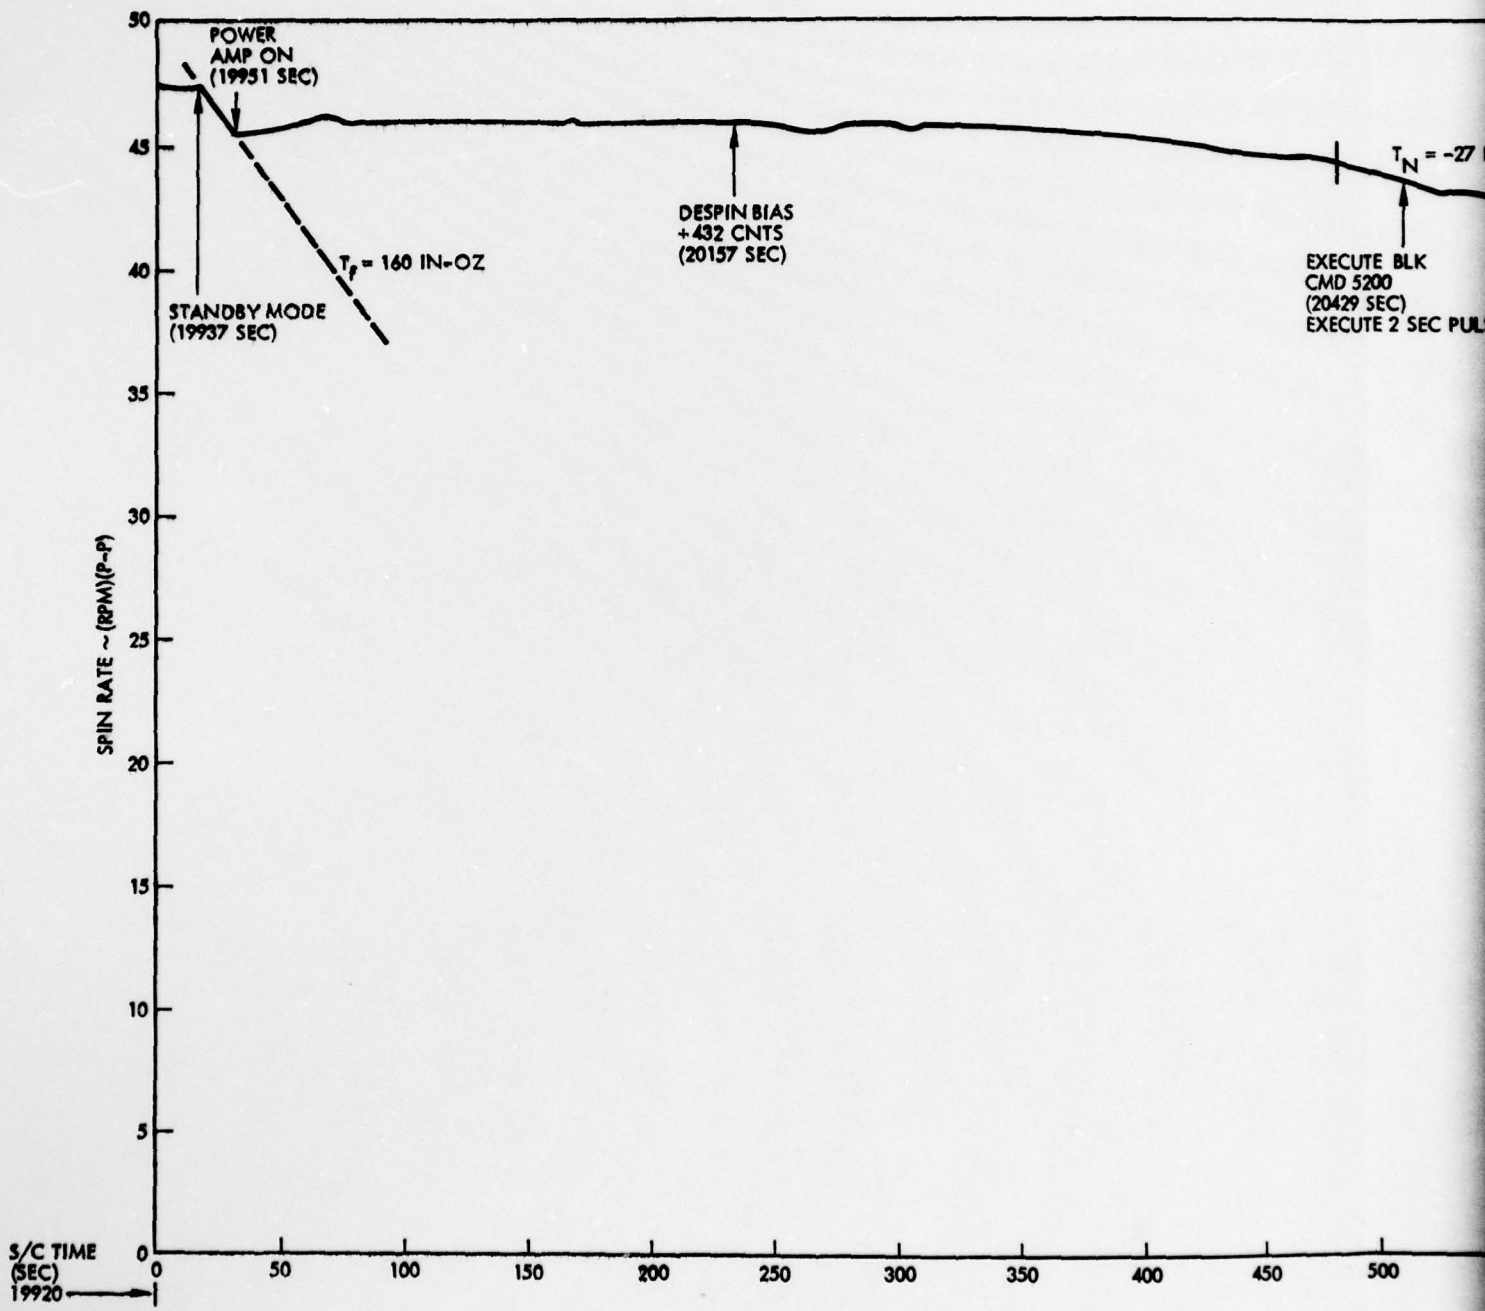
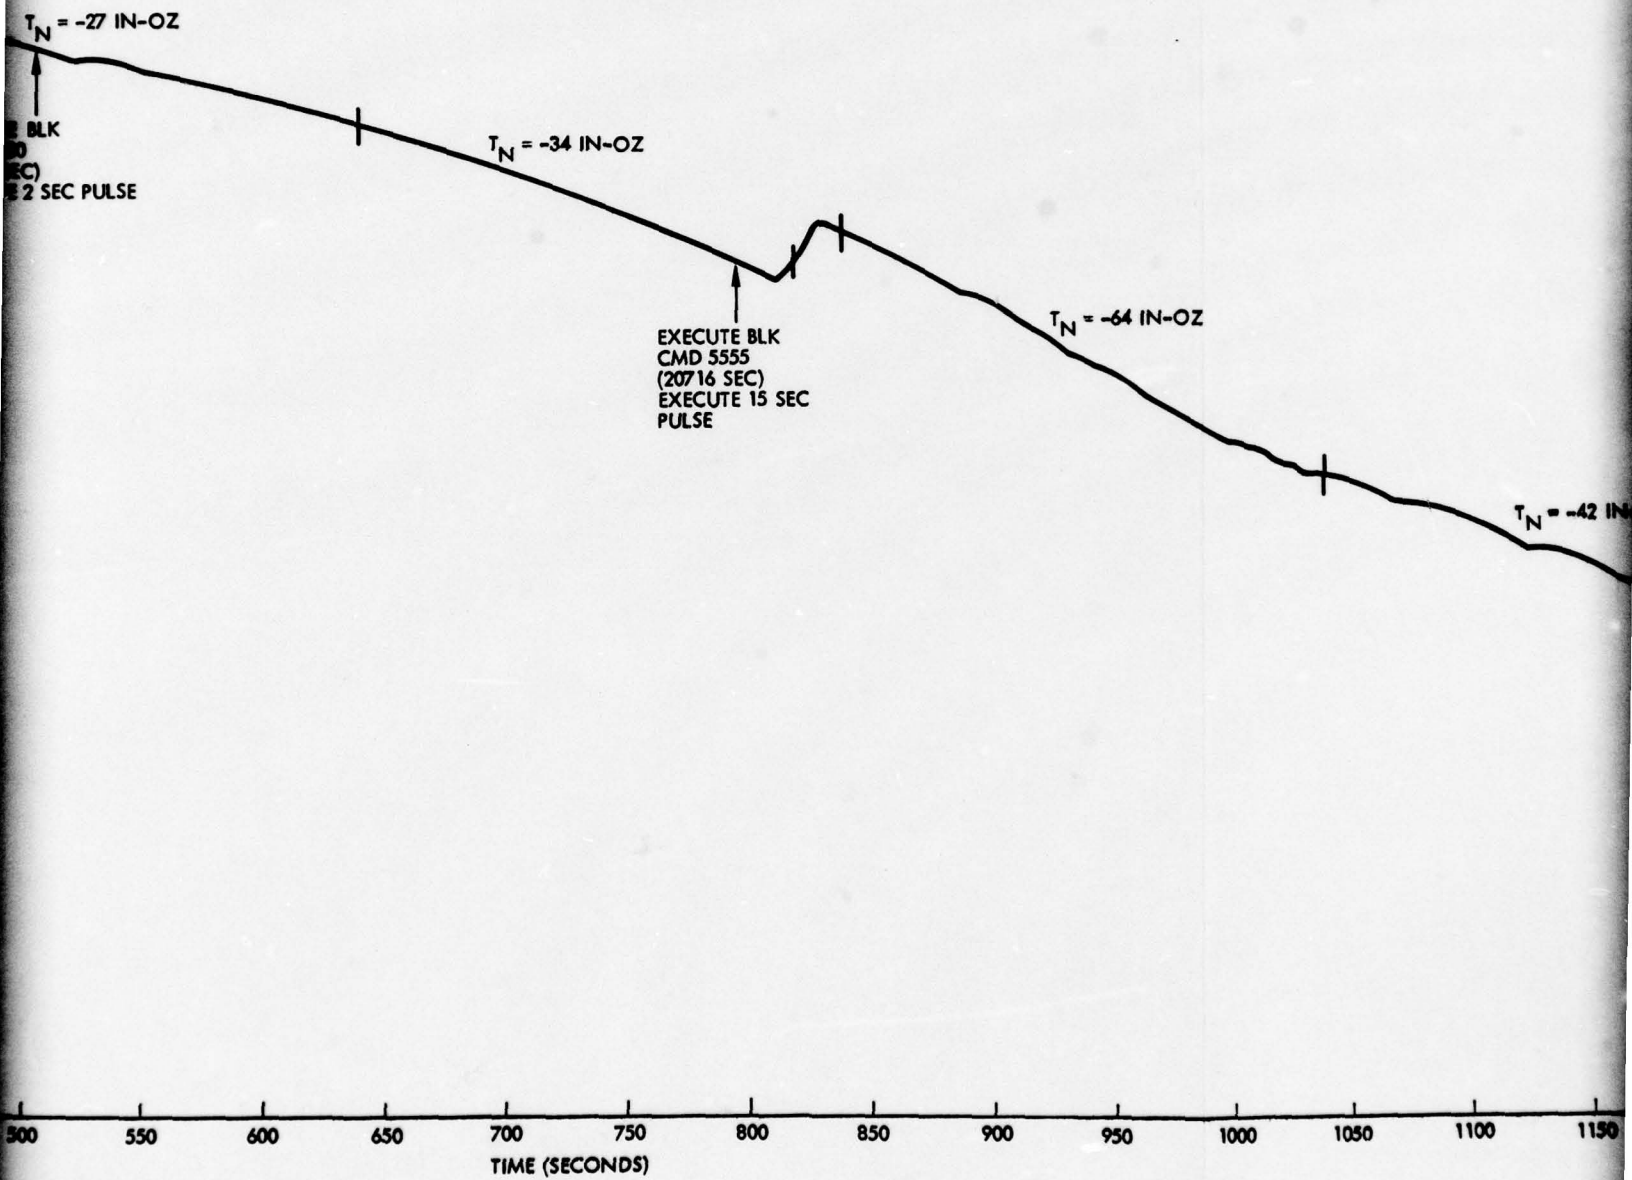
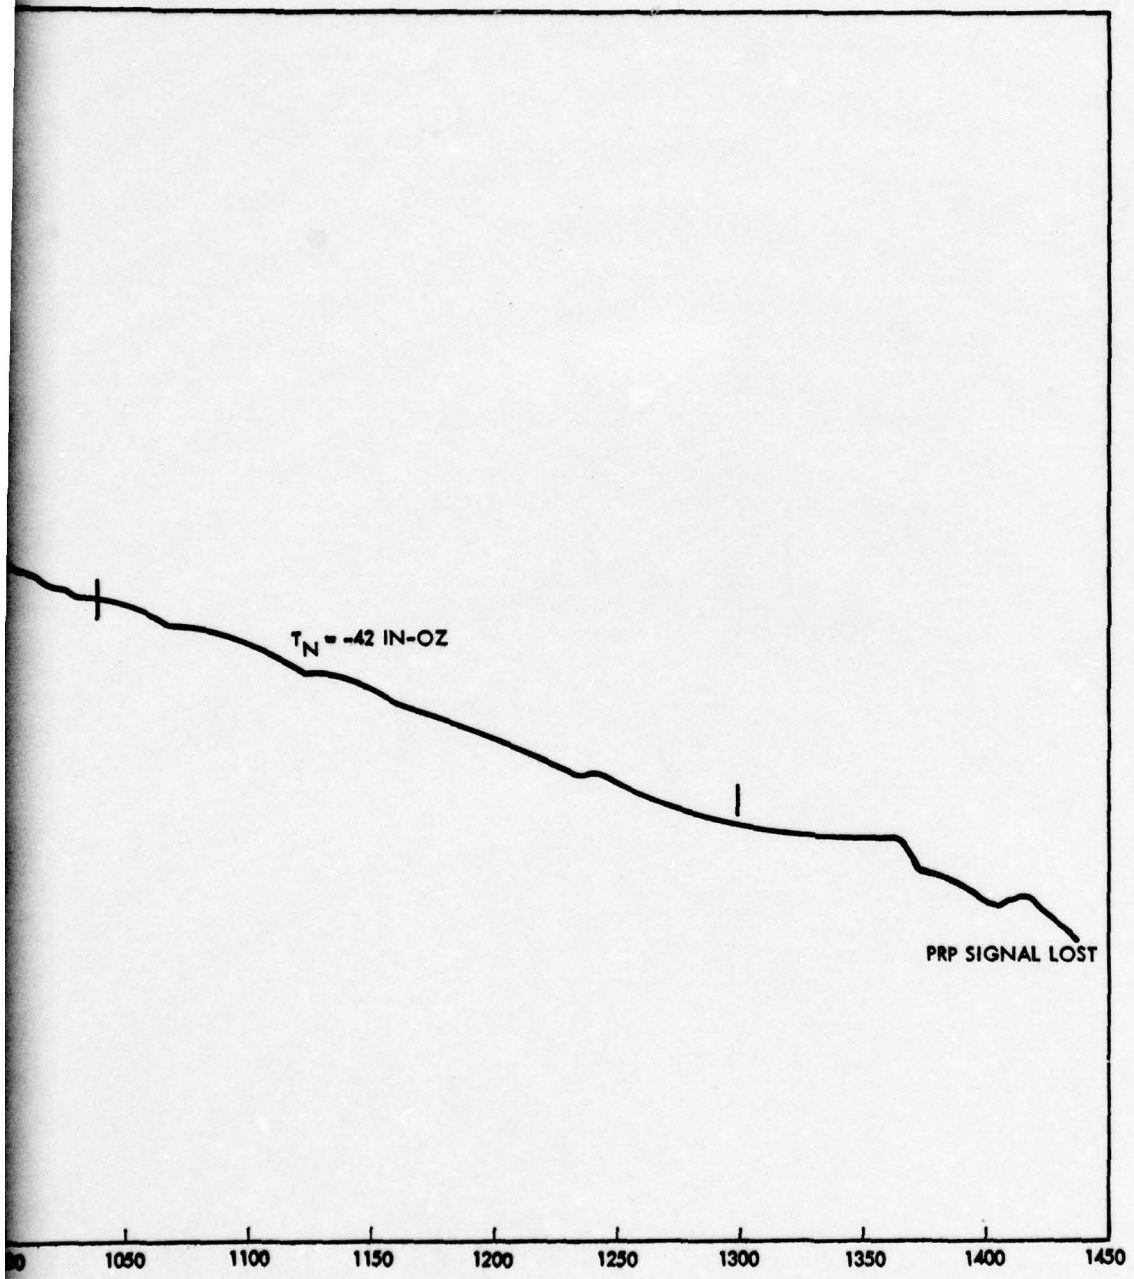
Figure 3.3-7. Spin-Up No. 3

- October 20 (Figure 3.3-7). The third complete platform spin-up occurred on October 20, 1975, as shown in Figure 3.3-7. The despin control system went into Standby at 19937 seconds. The pointing error prior to this time was wandering ± 3 deg and the torque voltage was reading -2.9 volts at 19850 seconds, indicating a high value of friction torque. Shortly thereafter, a torque (pulse or pulses) induced a large transient (6.2 deg), putting the system into Standby. Because full-time support was provided to S/C 9433 since October 7, 1975 (0600Z), the commands of Rate Mode, Power Amp On, and Rate Bias were issued shortly thereafter. It is clear from the data that in spite of these commands, the platform was still slowly spinning up. At about 500 seconds, a two-second spin jet pulse was fired. This was followed 300 seconds later with a fifteen-second spin-jet pulse. After each spin jet firing, the platform continued to spin-up and eventually the PRP signal was lost.

During this whole sequence, it can be seen that the friction torque takes on several values. Initially, when the system was in Standby, the short piece of data indicates a friction torque on the order of 160 in-oz. Following the issuance of Rate Mode, Power On, and Rate Bias commands, the net torques (T_n) indicated by the data over several segments of time were 27, 34, 61, 42 in-oz. Assuming that the saturated motor torque is 178 in-oz, these data imply friction torques (T_f) respectively of 205, 212, 239, and 220 in-oz.

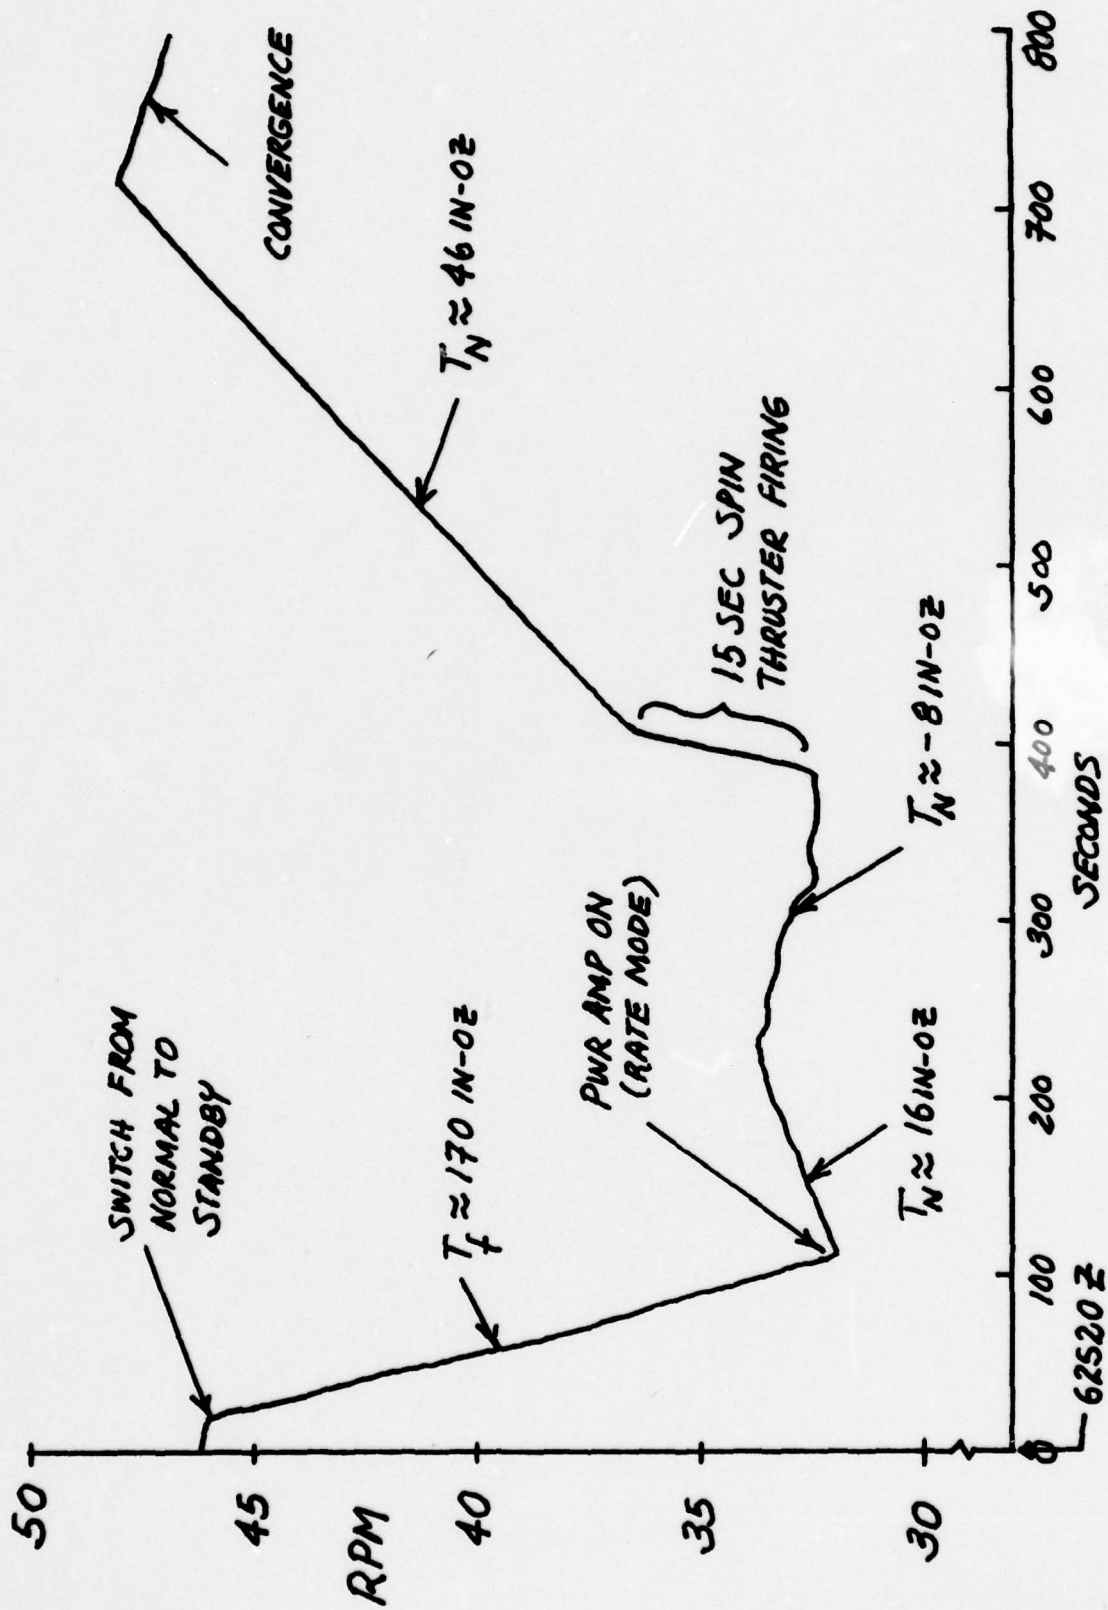
Figure 3.3-8. Platform Spin-Up and Recovery: 10/8/75

- 8 October (Figure 3.3-8). The initial decay of the platform spin rate indicates a friction torque of 170 in-oz. Recovery was possible but very slow. 270 seconds following the Power On command, the spin rate was holding around 32-33 rpm. A 15-second firing of the spin jet was used to augment the motor torque. The platform then proceeded to be despun with a net torque of 46 in-oz. This implies that the friction torque was on the order of 125 in-oz. This apparent reduction in friction due to the dynamics induced by thruster firings has been observed on several occasions.

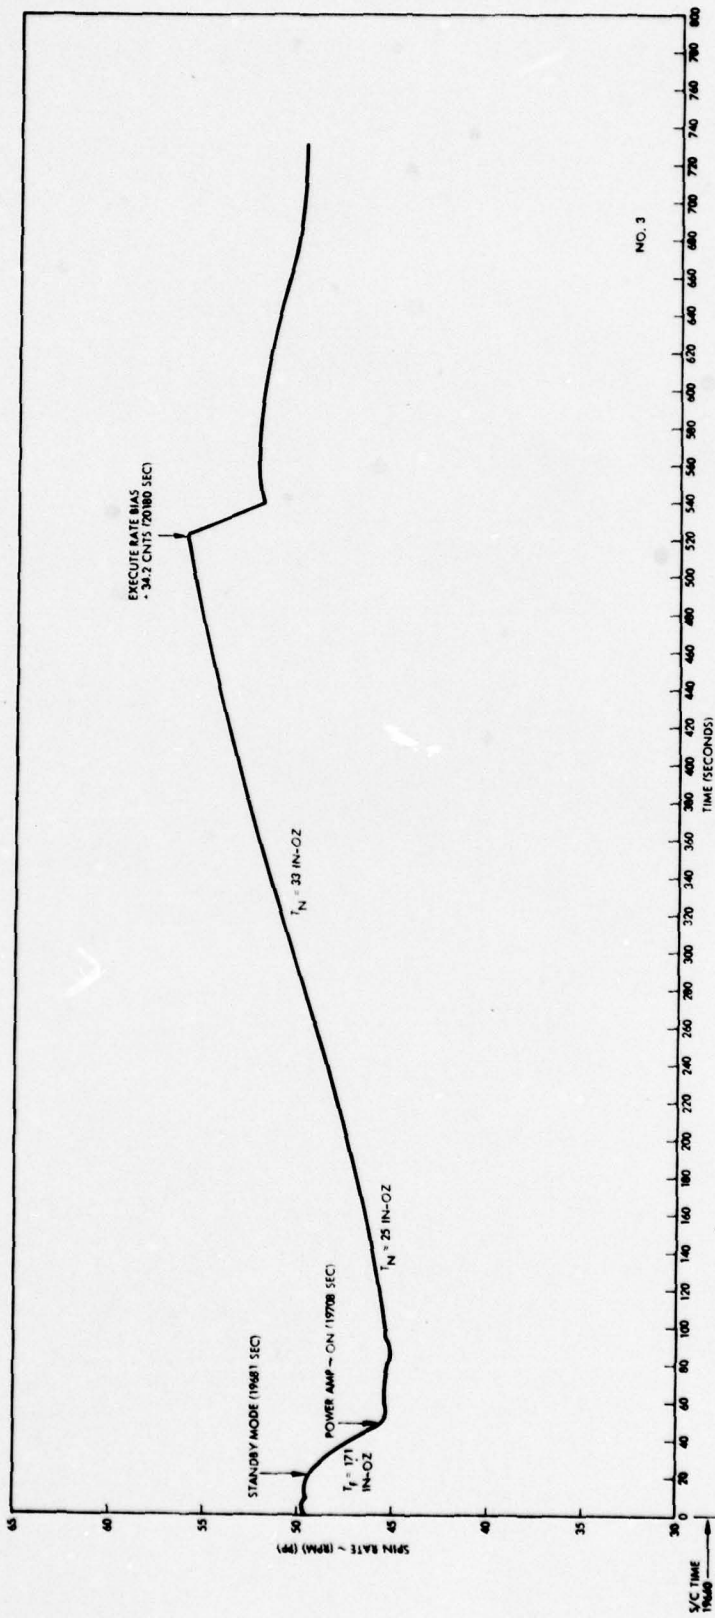
Figure 3.3-9. Partial Spin-Up

- 11 October (Figure 3.3-9). This Standby was preceded by large pointing error excursions of ± 5 to 6 degrees and the telemetry on the torque voltage saturated at -4.98 volts. However, about 540 seconds prior to Standby (19434 seconds), the pointing excursion was ± 0.7 deg and the torque voltage was -1.81 volts, again indicating a high running friction torque. The spin rate decay following Standby shows that a friction level of 171 in-oz was present. With the Power Amp On, it was expected that a

slow despinning of the platform was possible. After 30 seconds of a constant spin rate following Power Amp On, the platform proceeded to despin with a net torque of 25 in-oz (or friction of at least 140 in-oz) over the next seconds. For the next 230 seconds thereafter, a net torque of about 33 in-oz existed as the platform continued to despin. At about 520 seconds, the rate bias command of 342 counts (49.6 rpm) was issued and the system converged to the bias value.

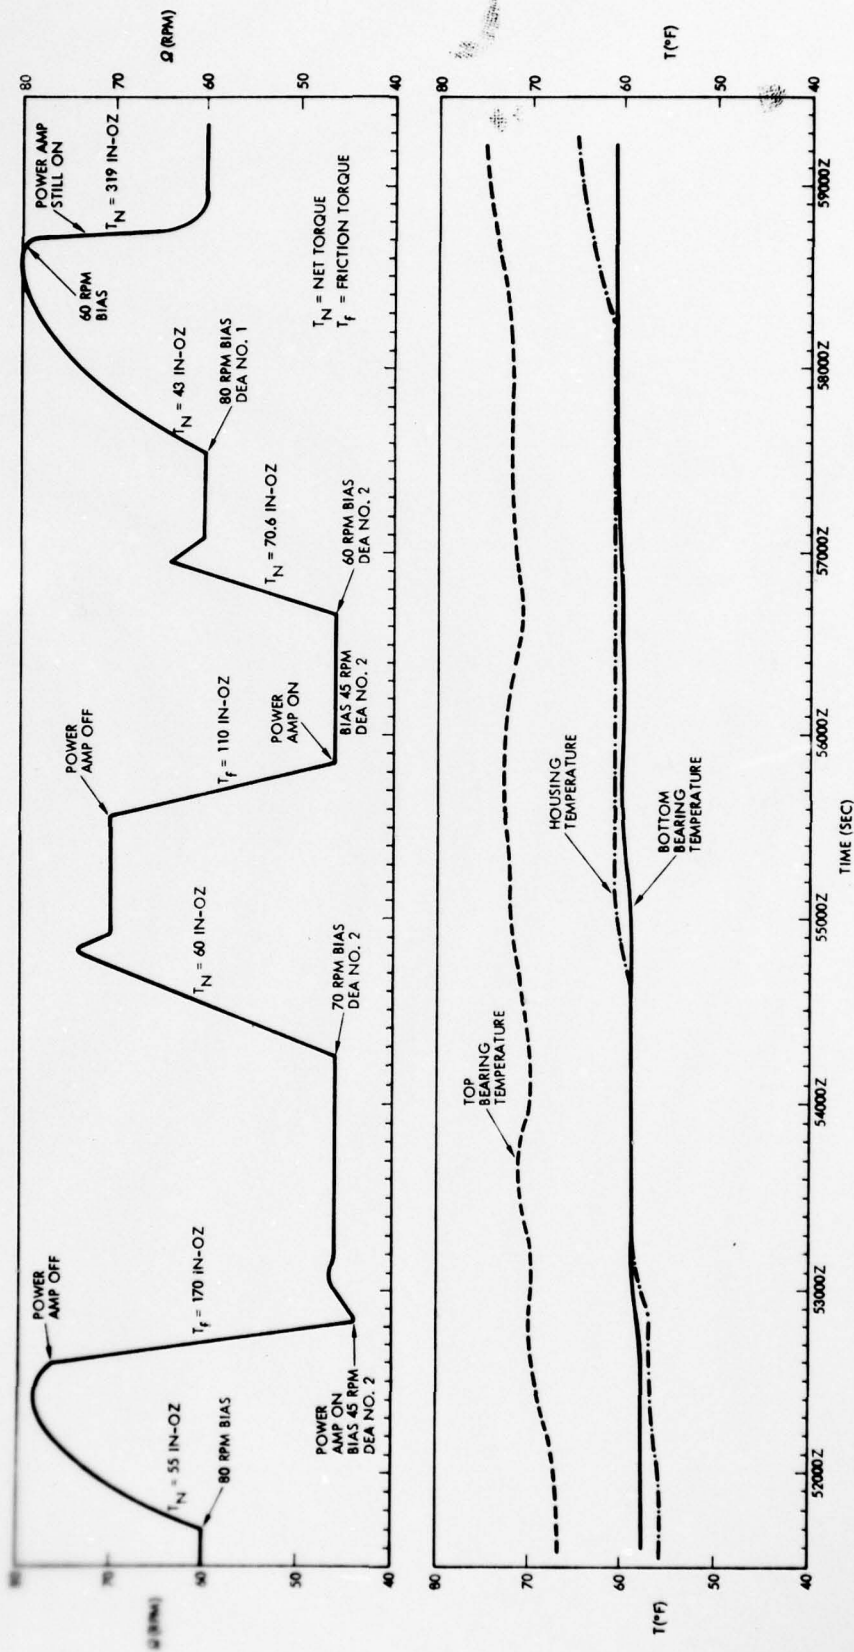
Figure 3.4-1. 9433 Friction Test Summary

Figure 3.4-1 shows the results of attempting the above sequence of operations. The initial run-up to 80 rpm was unsuccessful, even though maximum motor current (as indicated by the main bus current) was drawn

throughout the period of the attempted run-up. Inspection of the initial run-up/run-down cycle (system time from 51700Z to 52800Z) yields the following observations (Figure 3.4-2):

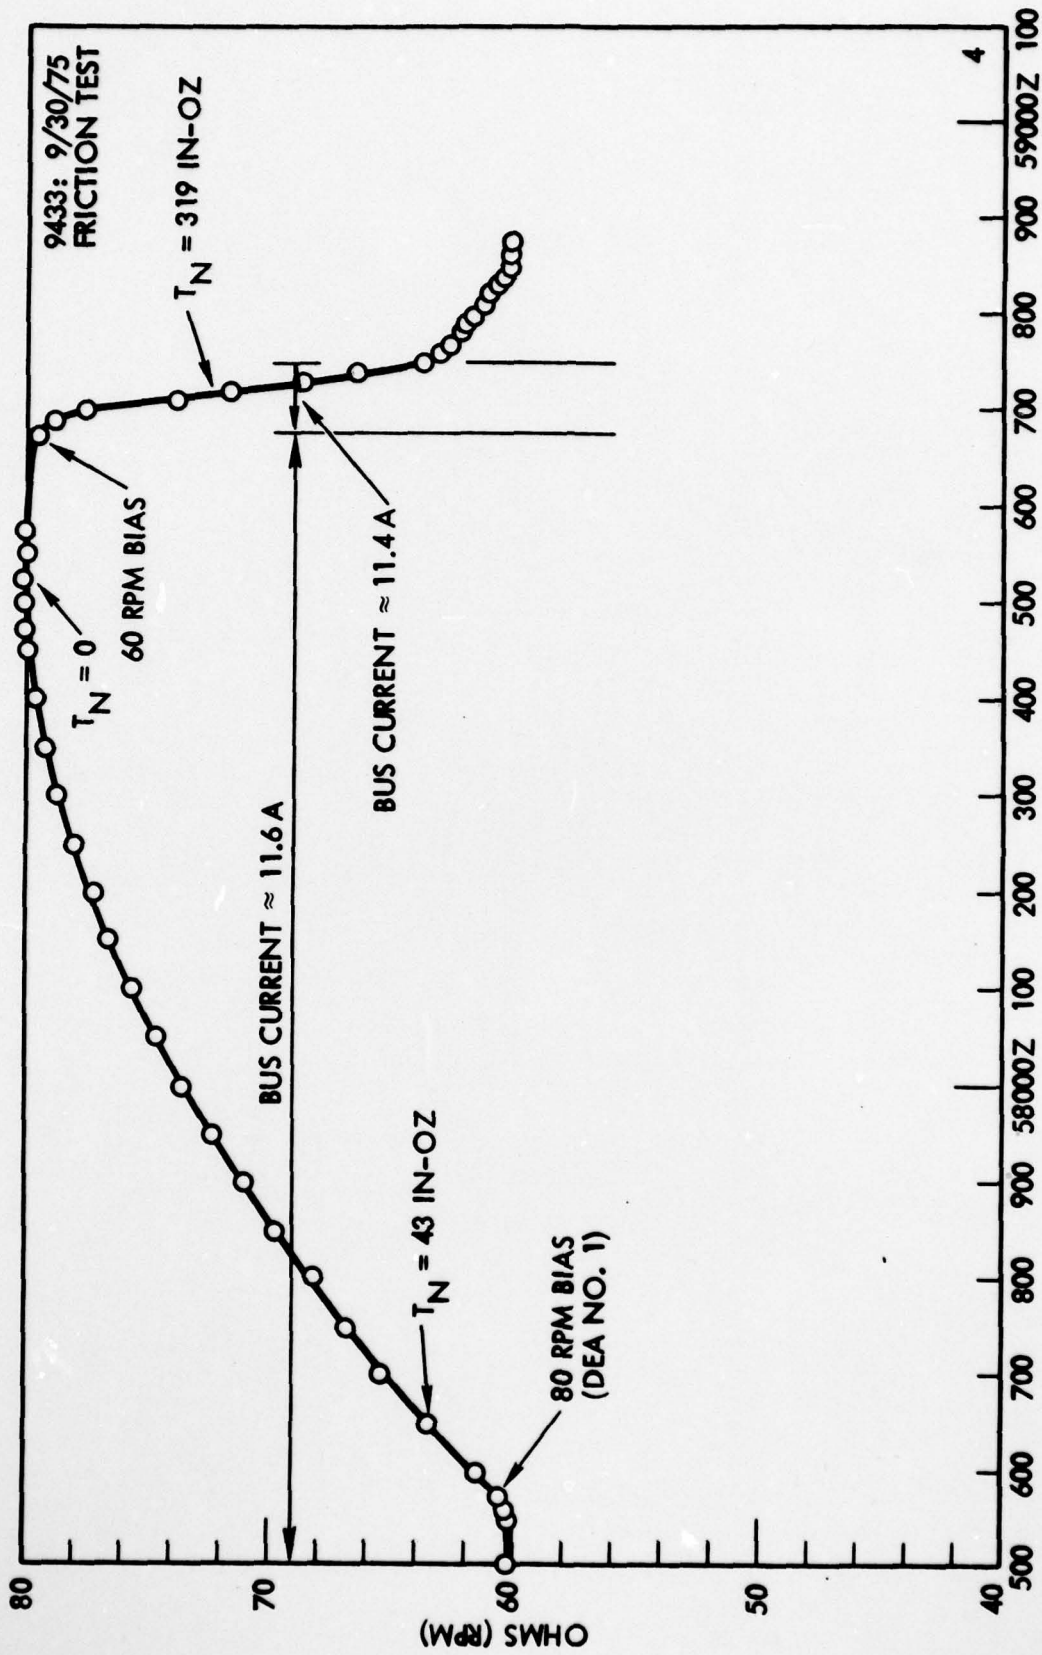
Figure 3.4-5. Friction Test Data (Case 3): 9/30/75

In order to evaluate differences in performance between the two available drive channels, the alternate DEA (No. 1) was employed to repeat the first attempt to run up from 60 rpm to 80 rpm (Figure 3.4-5). The results during run-up were similar to those observed with DEA #2; although the 80 rpm bias level was reached, the controller did not settle out (since no

overshoot, required for convergence, occurred). Unfortunately, friction-only run-down was not permitted; instead, the bias command was changed to 60 rpm and the run-down was driven by both the DMA motor and friction. However, assuming a motor torque of 170 in-oz, the friction level was 150 in-oz — clearly higher than the apparent friction torque at the beginning of this third cycle. It is concluded that the two DEA-DMA drive channels produced similar results, with the differences attributable to normal tolerance variations between the two drive channels.

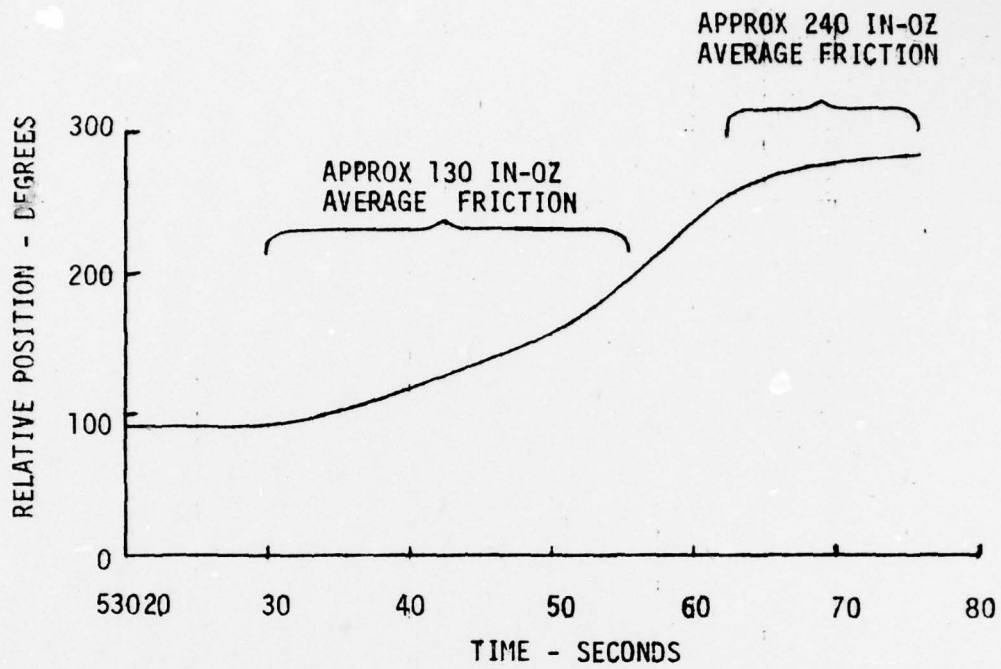
Figure 3.5-2. Relative Platform Position Versus Time, DMA Motor Only - September 13, 1975

After the platform spun-up on 13 September, an attempt to despin the platform was made by turning on the motor. The spacecraft spin rate was approximately 41 rpm at this time. Despin motion was initiated; however, relative motion ceased after slightly over one-half a revolution. The relative position, as deduced from earth chordwidth and spin rate data, is plotted vs time in Figure 3.5-2. DMA friction ranging from 130 to 240 in-oz are deduced from these data.

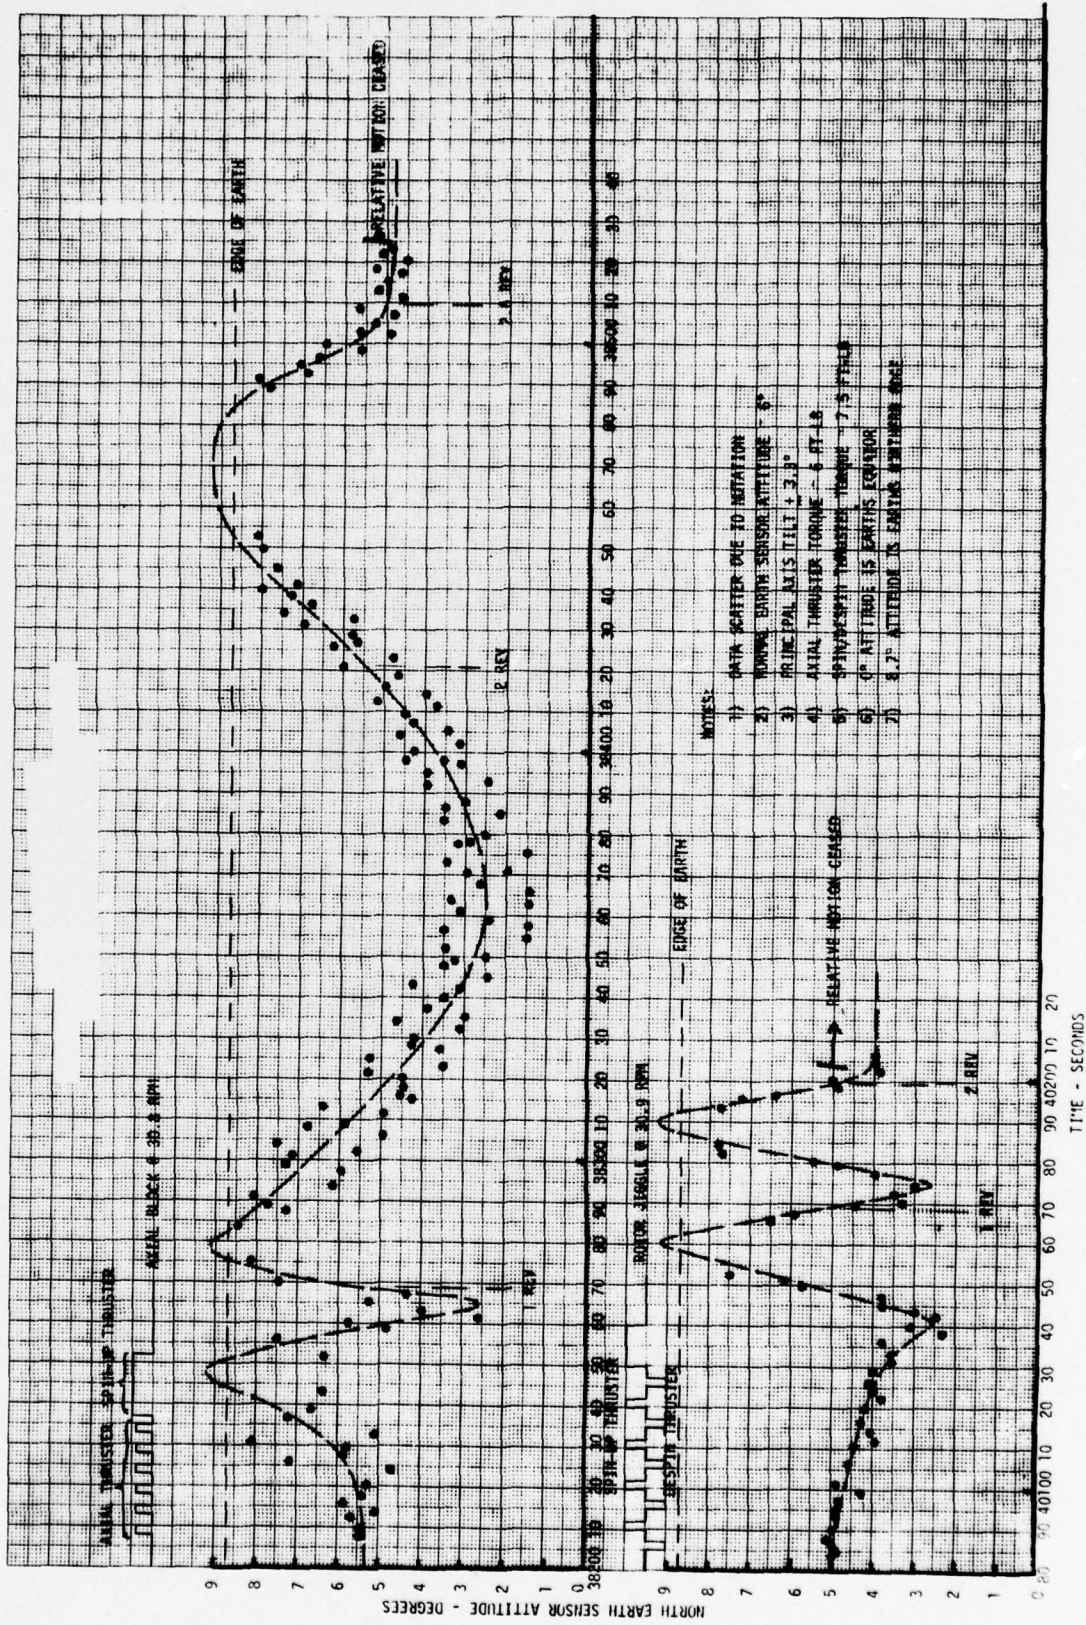
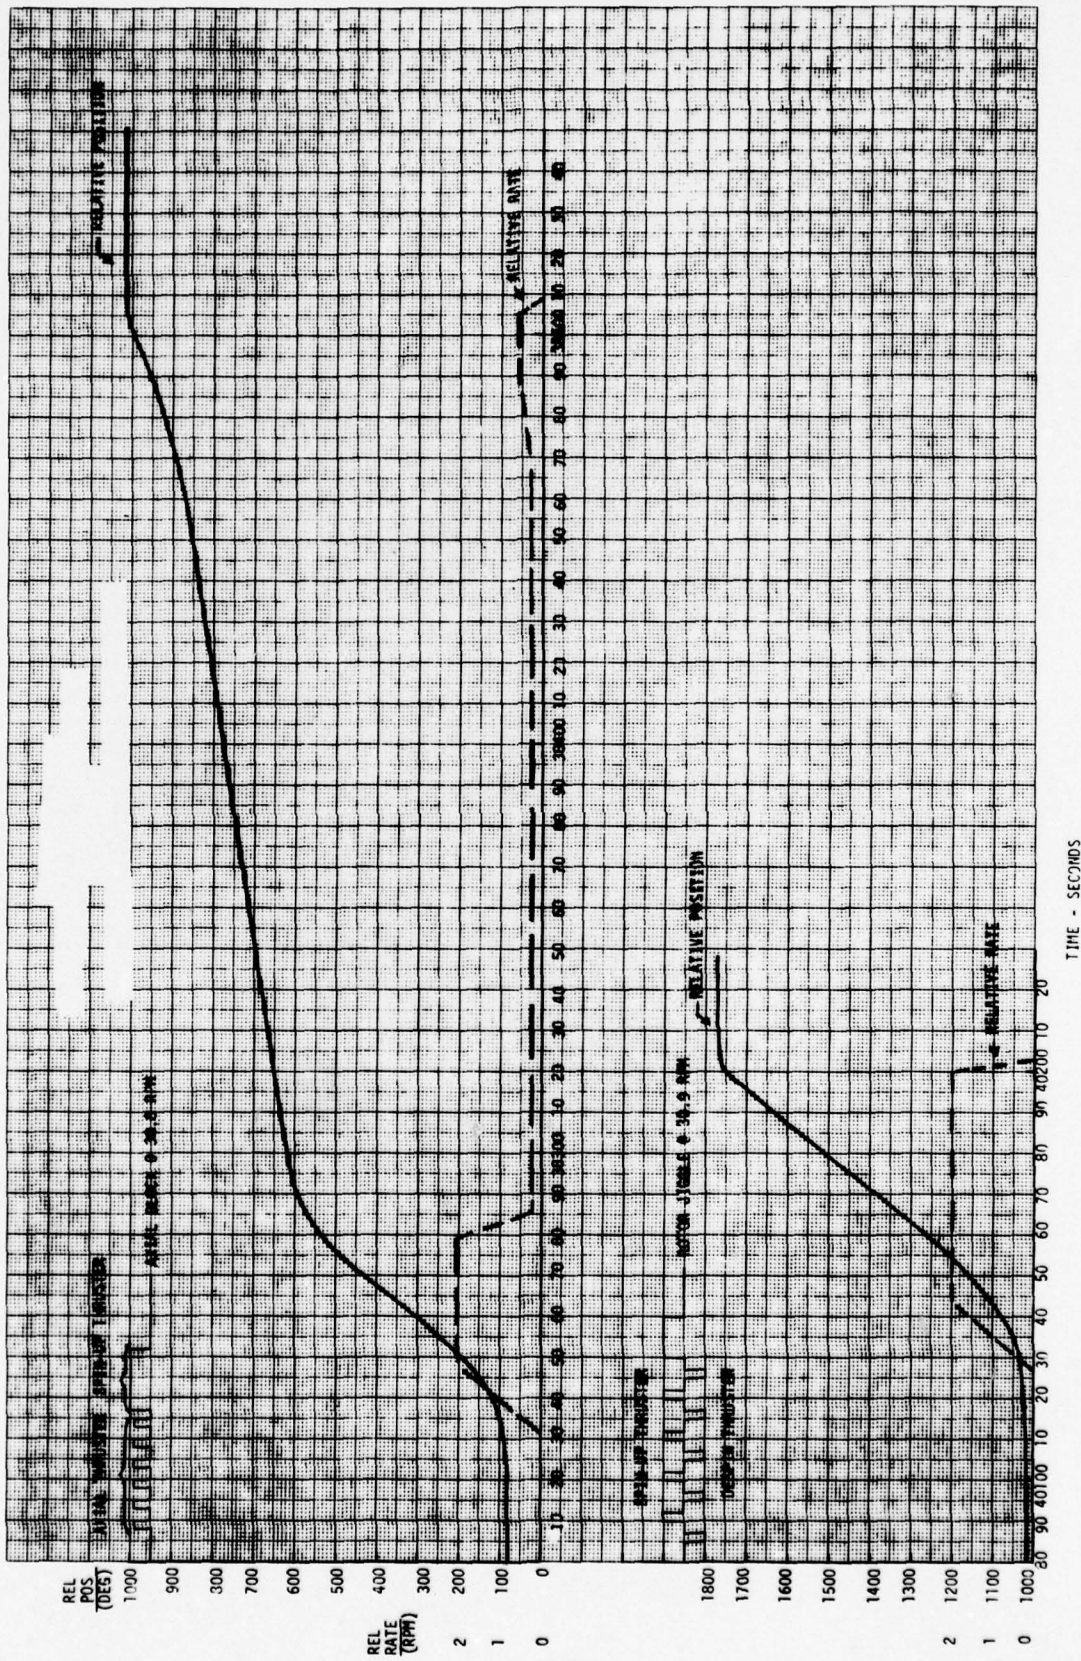
Figure 3.5-5. 777 F3 Recovery Attempts at 30 RPM 10-20-75 Platform Relative Position and Rates

The spacecraft attitude data and deduced relative spin rate and position for these two attempts are shown in Figures 3.5-4 and 3.5-5.

The data seems to indicate that the spin-up thruster firing was most influential in initiating the motion. The periods of constant relative rate implies that the friction torque was essentially equal to the motor torque, i.e., 170 in-oz. Higher values of torque spikes apparently occurred for short periods to produce sudden changes in relative rate. A slight increase of relative rate was noted just prior to the stoppage of relative motion on the first attempt.

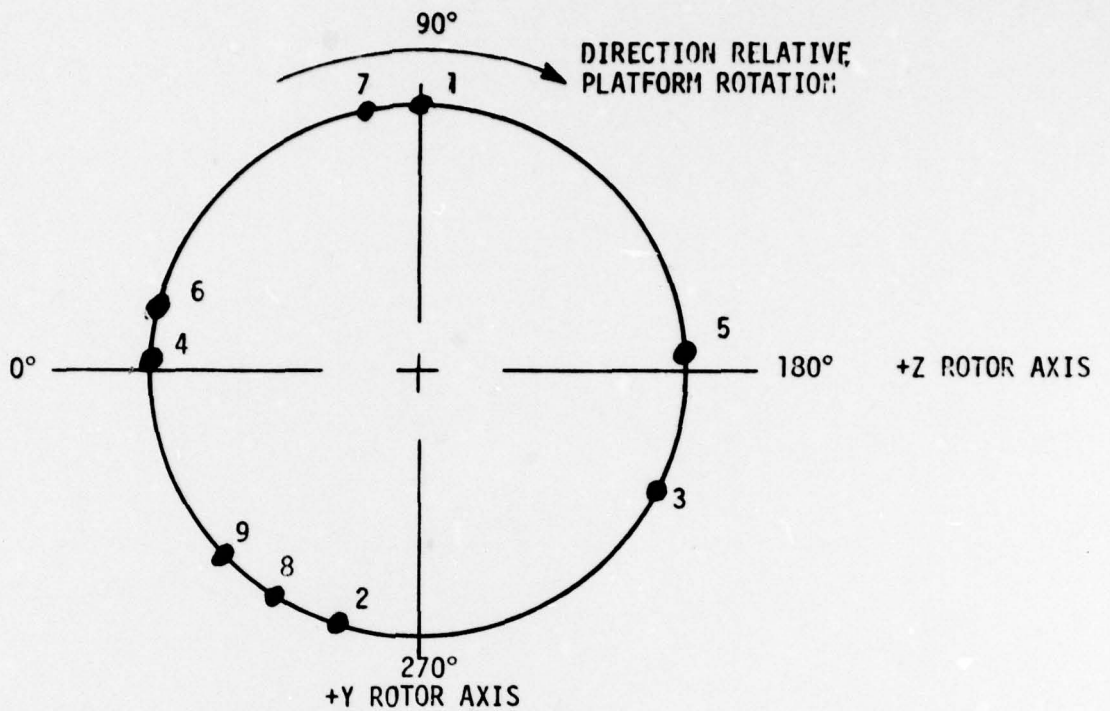
Figure 3.5-6. Approximate Position of Despun Platform and Rotor During Various Spun-Up Conditions - F3 Spacecraft

The relative positions between the platform and rotor after the various spin-up events and unsuccessful recovery events are shown in Figure 3.5-6. These positions do not indicate any preferential position.
