TRW DEFENSE AND SPACE SYSTEMS GROUP REDONDO BEACH CA
9433 DESIGN POINTING ANOMALY. VOLUME I. TECHNICAL REPORT. (U)

0433 DESPIN POINTING ANOMALY

VOLUME I
TECHNICAL REPORT

REPORT NO. 28600-AR-010-01 ✓

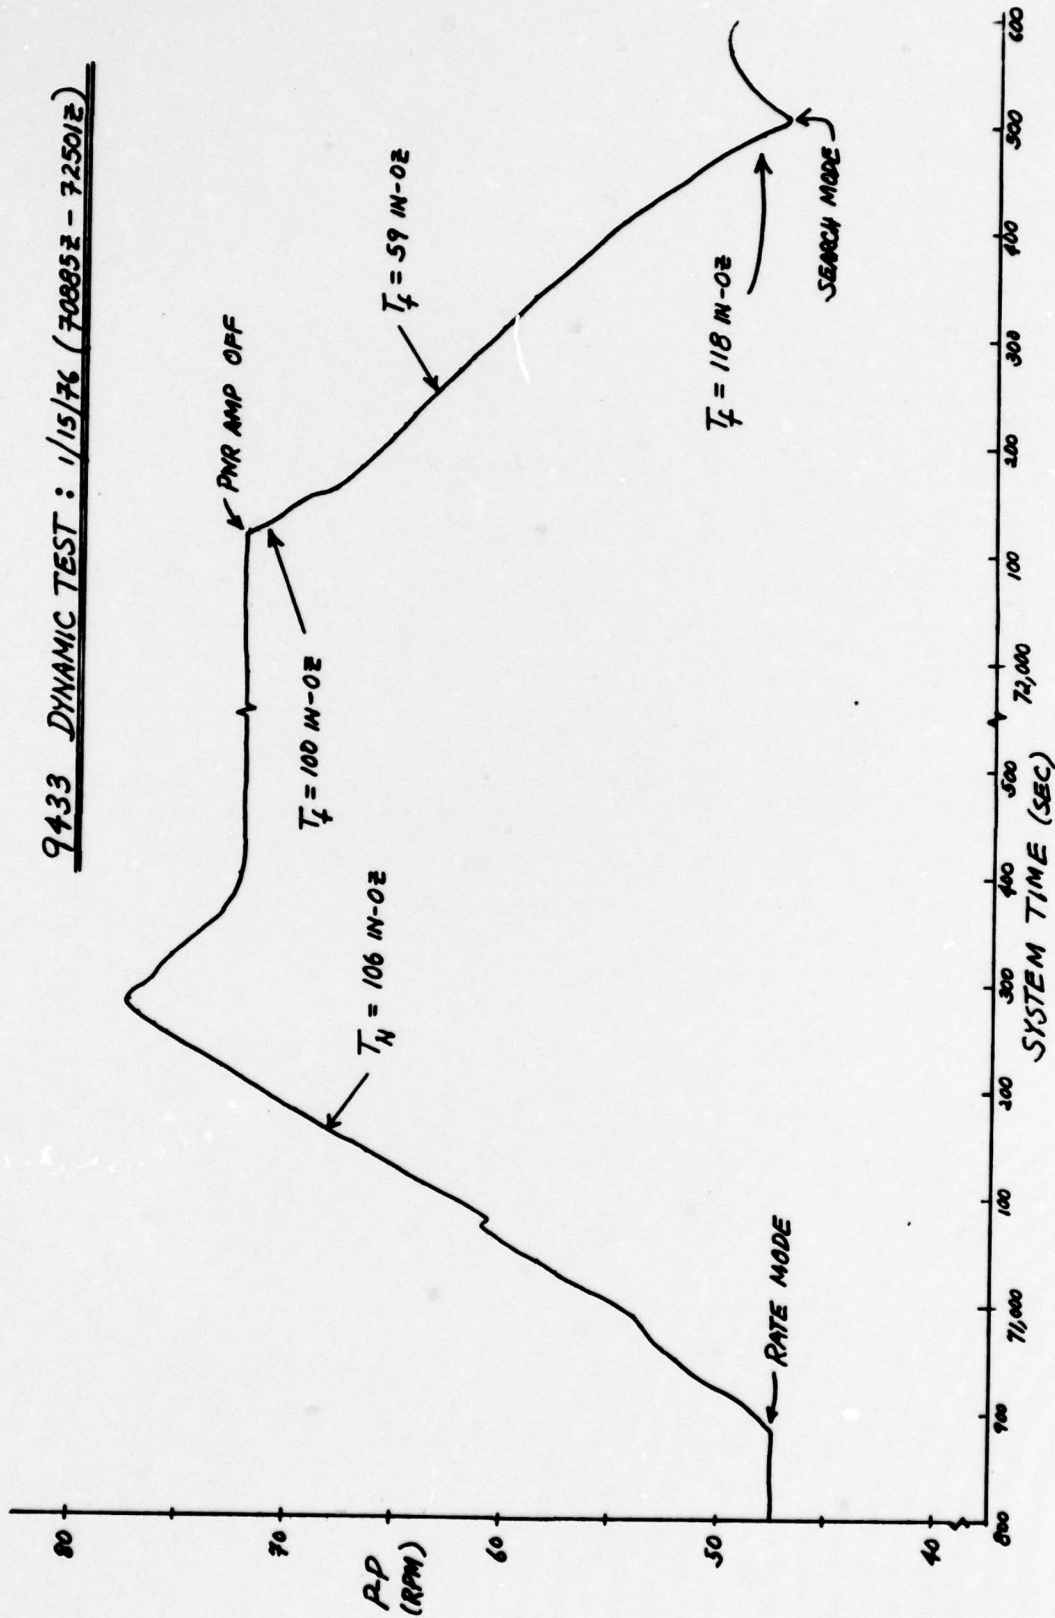
Figure 3.6-1. 9433 Dynamic Test: 1/15/76 (70885Z-72501Z)

Runup of the relative rate from 47.5 rpm to 72.1 rpm (step 4) was similar to the previous runup, as was the rundown (step 5) similar to the previous rundown. This data is plotted in Figure 3.6-1. Note that the torque applied between the rotor and platform can be computed from the change in rate:

where $I_R = 333 \text{ slug-ft}^2$, $I_P = 71 \text{ slug-ft}^2$, and $\Delta\Omega$ is the change in relative rate (P-P) in rpm during a 100 second interval. Again steady-state control while overspun was smooth and the bearing temperatures were seen to decrease. Rundown showed torque variations, with the largest torque occurring when the despun condition was approached. This data is generally comparable to the friction test data of 30 September 1975 shown in Figure 3.4-4.* By comparison, the friction level was generally lower in these more recent tests but showed greater variations (a characteristic noted at various times since 28 November 1975).

- Runup and rundown data are not repeatable. Based on limited data, a bistable situation may exist (i.e., Figure 3.6-1 compares well with Figure 3.6-3, while Figure 3.6-2 compares well with that portion of Figure 3.6-4 above the 60 rpm level).

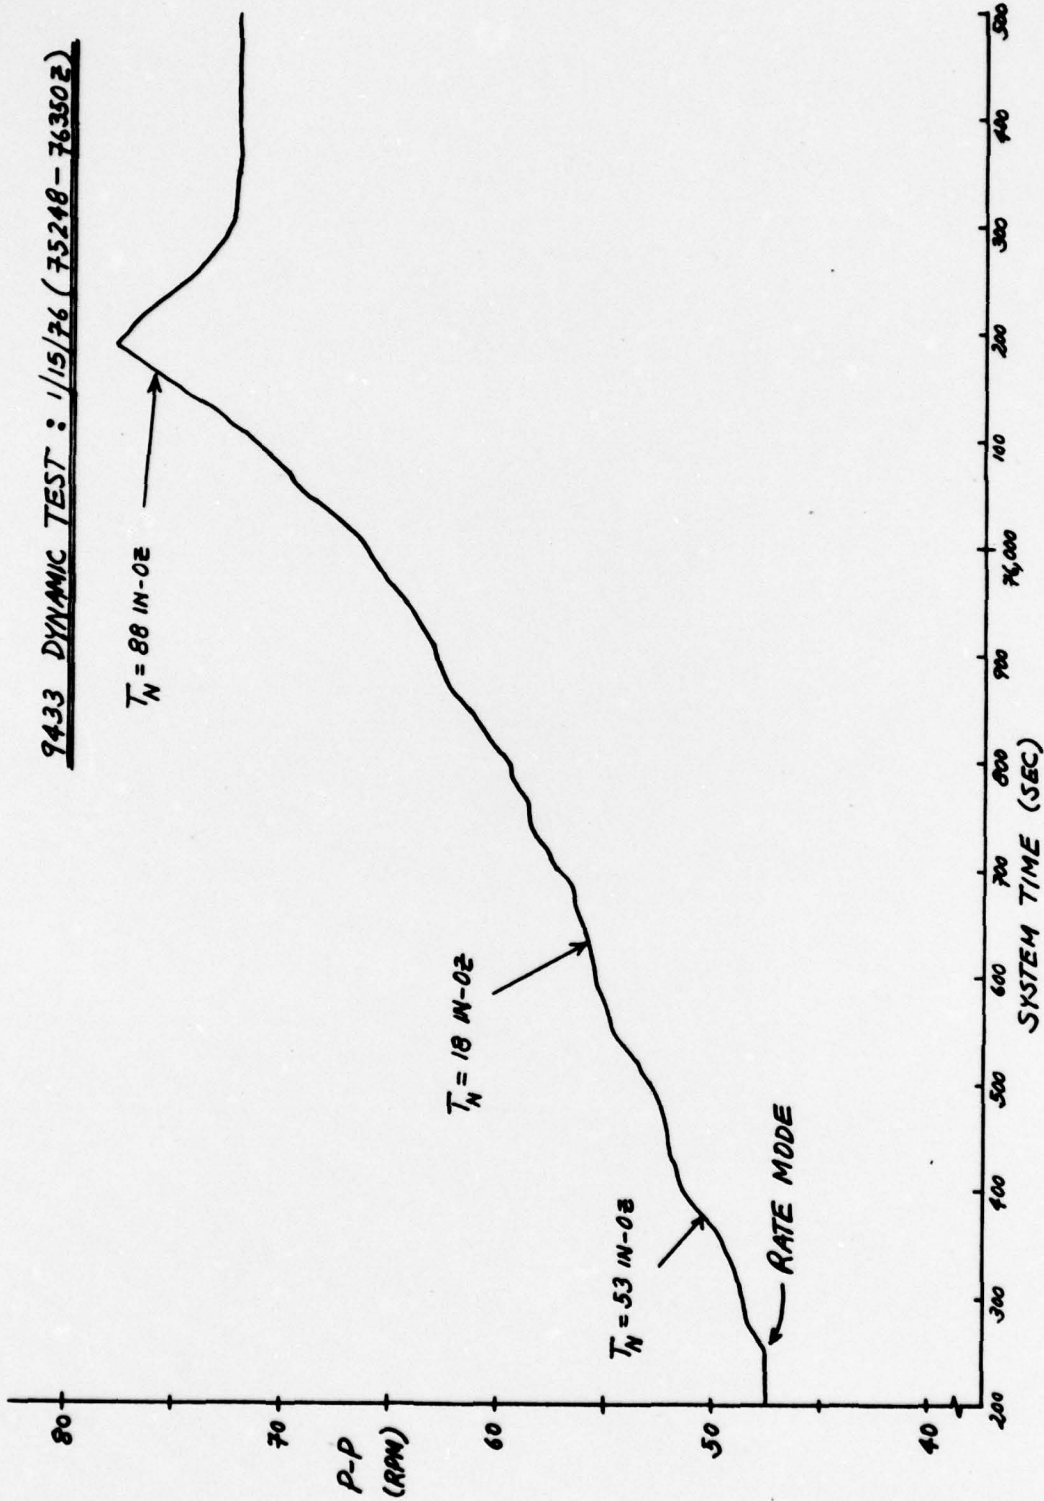
Figure 3.6-2. 9433 Dynamic Test: 1/15/76 (75248-76350Z)

Following this runup/rundown cycle, Normal Mode operation was attempted and sustained for approximately two minutes (step 6). A second runup to 72.1 rpm was then executed (step 7, Figure 3.6-2). Notice the striking difference between the runup periods of Figure 3.6-1 and 3.6-2 which (given no change in friction characteristics) should have been identical. The apparent decrease in friction as overspin increases is also of interest.

At this stage, it was apparent that friction level (or at least friction transients) are decreased by introducing a platform inertial rate (which, due to the platform mass unbalance, causes sideloads on the DMA). In order to examine this phenomenon further, the platform was spun down in stages (from an inertial rate of about 20 rpm, to 10 rpm, to 5 rpm, and then despun) as noted in steps 8, 9, and 10. A general decrease in the quality of rate control was noted as the platform inertial rate was decreased. However, no abrupt transition at a particular speed was observed; rather, the change in performance quality appeared to be gradual.

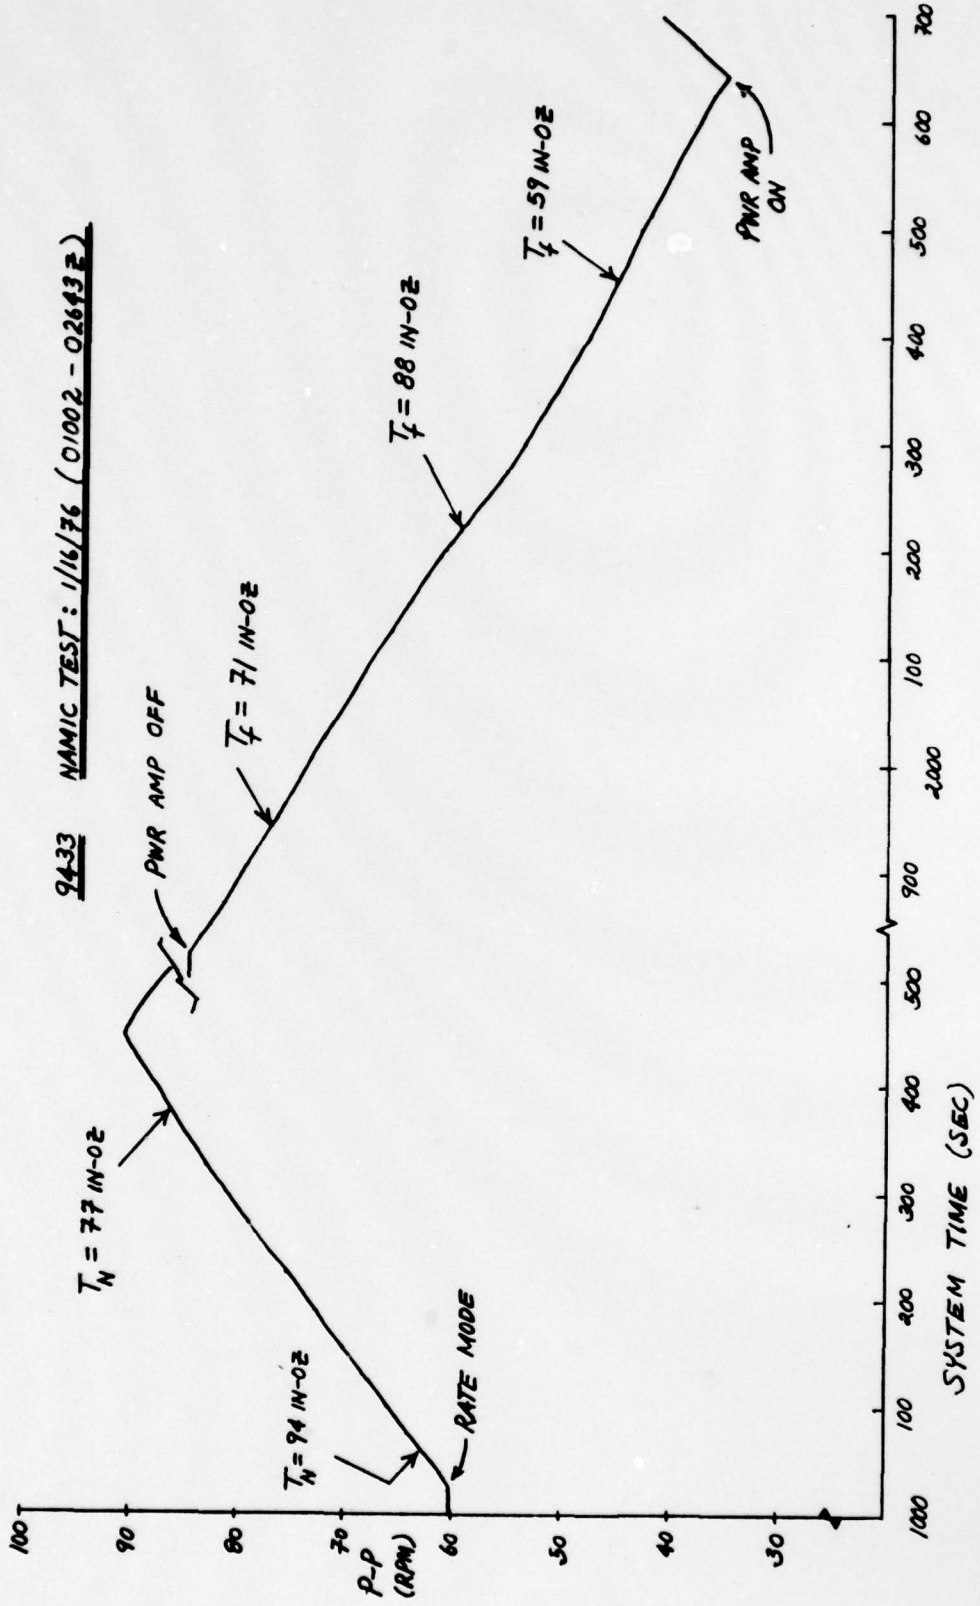
Figure 3.6-3. 9433 Dynamic Test: 1/16/76 (01002-02643Z)

30 September 1975. The platform was then overspun to 84.8 rpm and then allowed to despin to 35.4 rpm by turning off the DEA power amplifier (steps 12 and 13, Figure 3.6-3). Notice that the overspin rate was easily reached (compared to Figure 3.4-2 where the same equipment was in use), with net torques higher than before (and, therefore, lower friction torques). Rundown also showed lower friction torques than in Figure 3.4-2. Note also that the friction torque was highest (but not markedly so) near the despun condition (60 rpm).

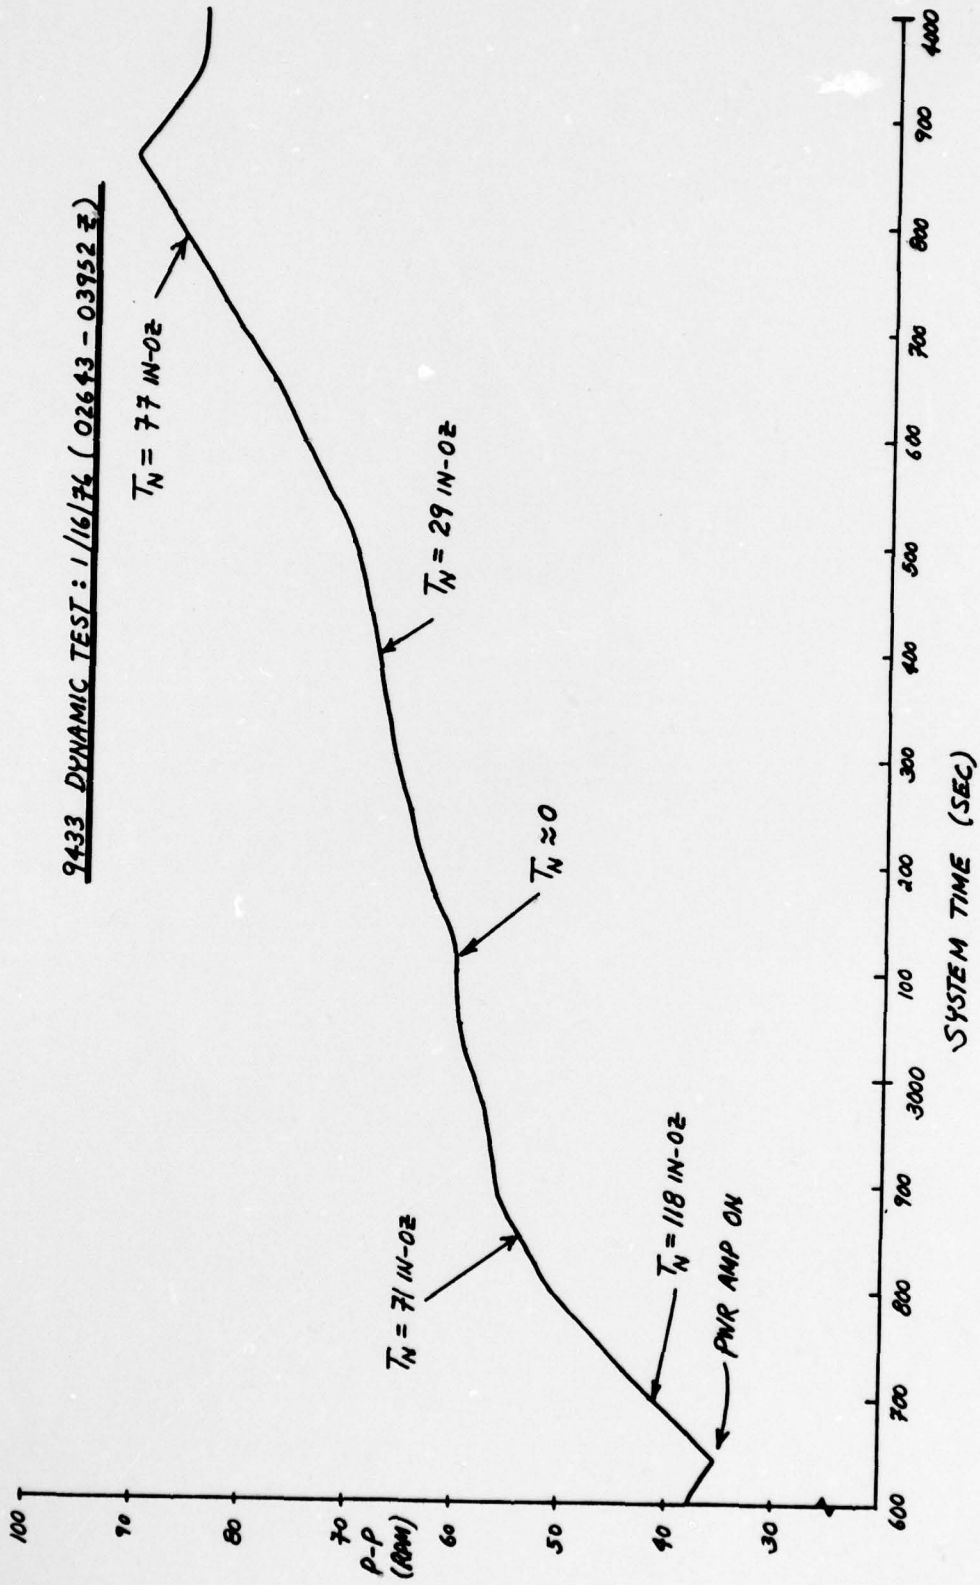
Figure 3.6-4. 9433 Dynamic Test: 1/16/76 (02643-03952Z)

As the final step, the platform was driven back up to a relative rate of 84.8 rpm by re-activating the DEA power amplifier. This operation is shown in Figure 3.6-4, which shows a performance characteristic which contrasts markedly with the data of Figure 3.6-3, while showing a similarity of the data of Figure 3.6-2. Note that maximum friction again occurs near the despun condition.

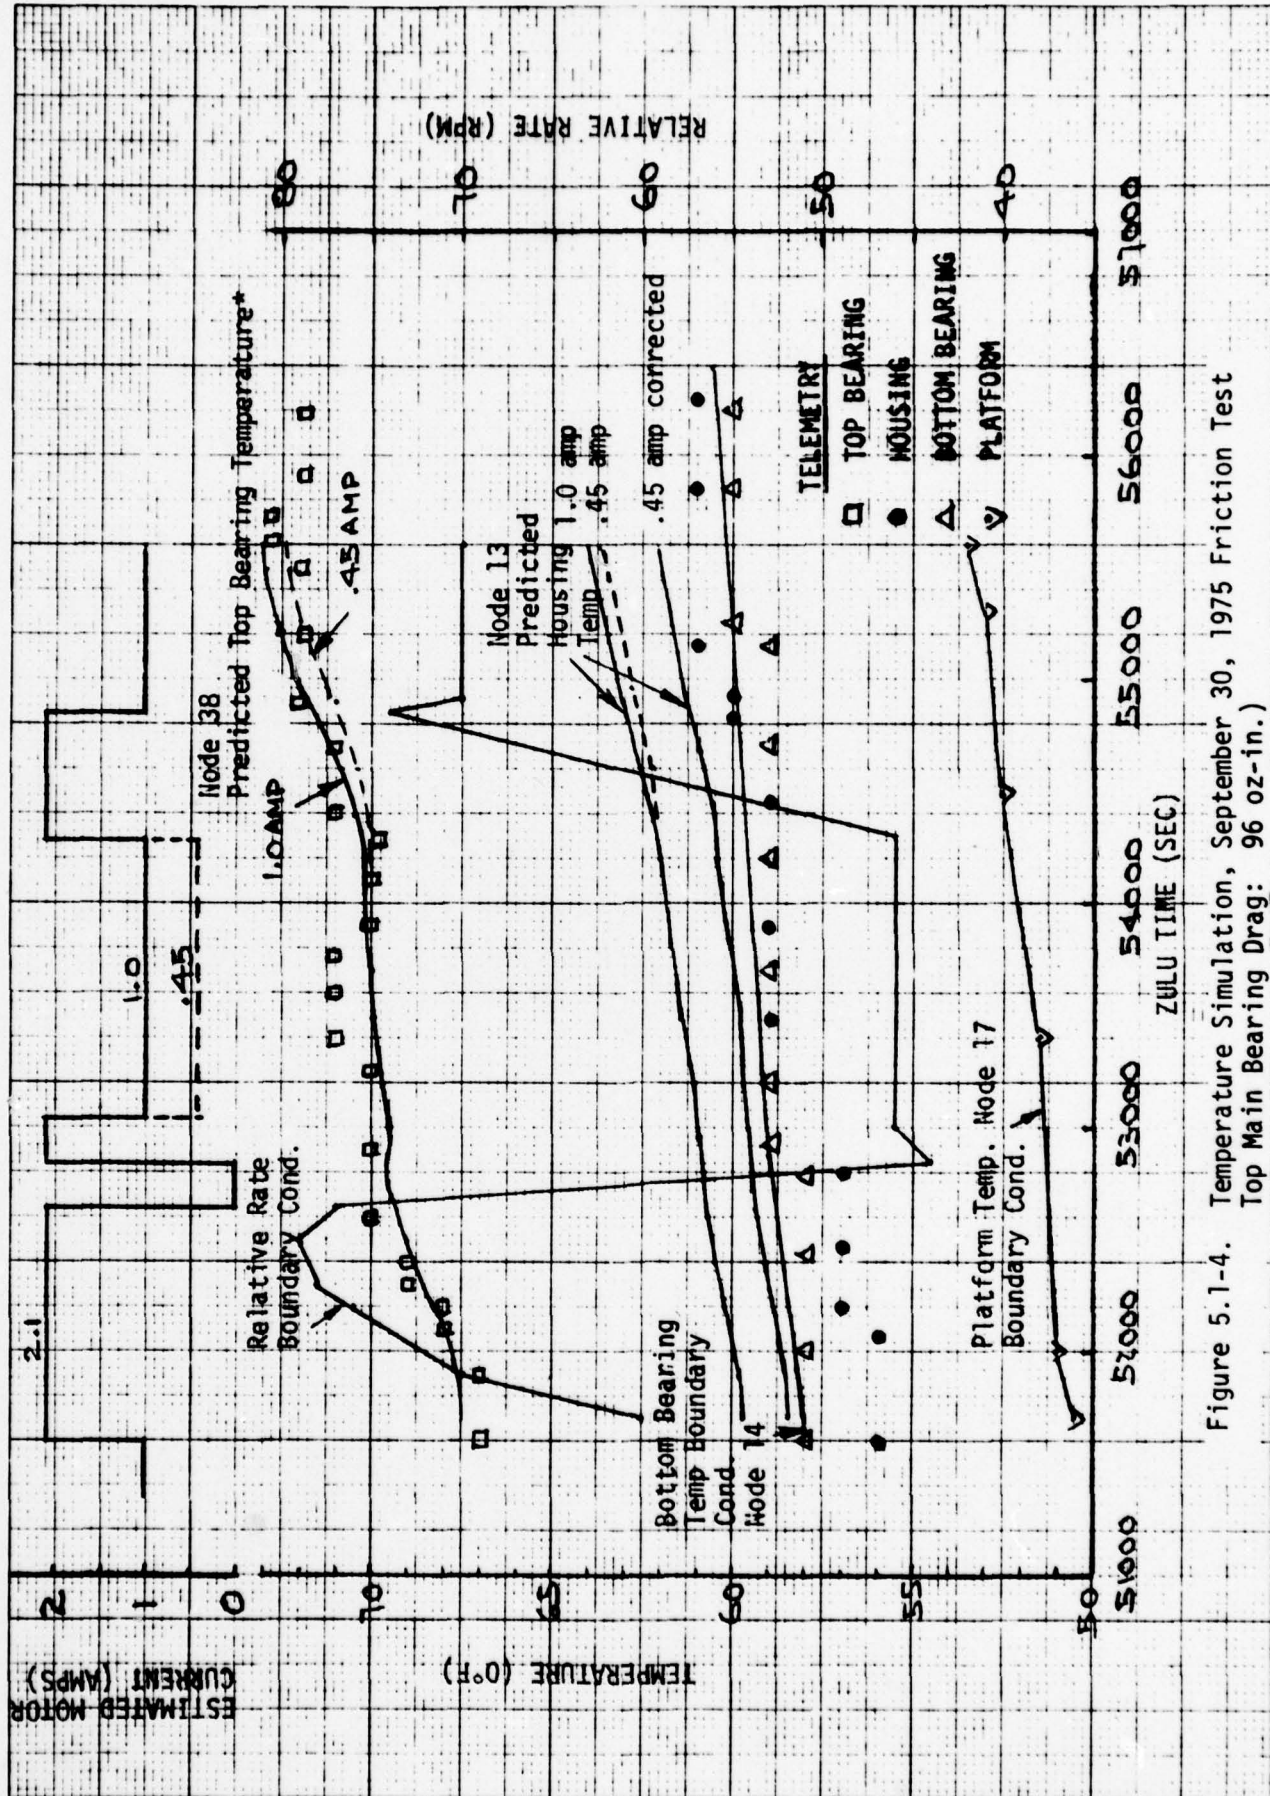
Figure 5.1-4. Temperature Simulation, September 30, 1975 Friction Test
Top Main Bearing Drag: 96 oz-in.)

These runs were generated in an attempt to correlate periods of high friction torque with extreme values of critical thermal gradients (i.e., at the bearings and at the power module snubber). In the friction test data (Figure 5.1-4), the peak torque period is 52400Z to 53000Z; the only significant correlation is with the top bearing gradient (Figure 5.1-5), which is too small in magnitude to be of concern. The same conclusion can be applied to the second case (Figures 5.1-6 and 5.1-7). The thermal gradient at the snubber gap continues to grow (and, therefore, reduce the gap) throughout each run, well beyond the period of extreme torque. This data tends to suggest that interference at the snubber is not responsible for either the increase in average torque or the occasional large torque transients.

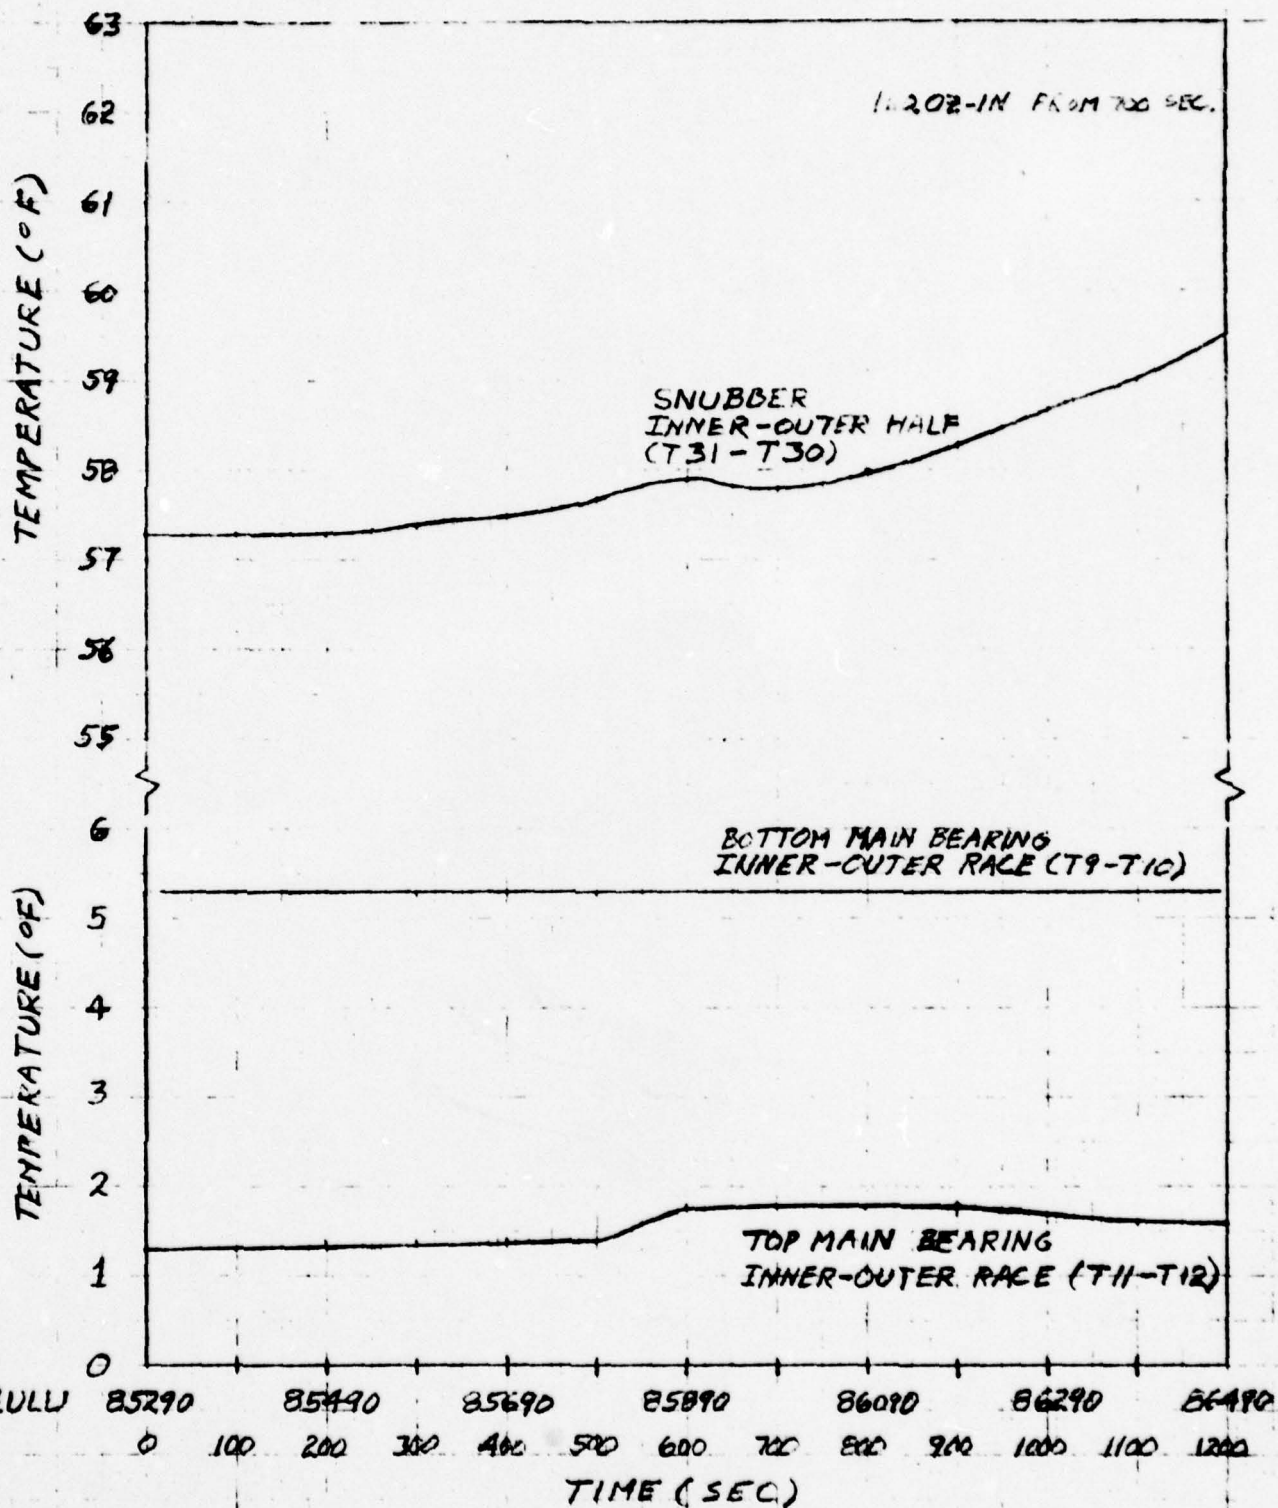
Figure 5.1-7. Thermal Gradients Temperature Simulation of 13 October 1975 Major Dropout

- The major friction transient occurring on 13 October was also simulated, and the comparative data was plotted in Figure 5.1-6. The key temperature gradients are recorded in Figure 5.1-7. The predicted temperatures are all within the tolerance range of telemetry data; note, however, that the simulation again predicted housing temperatures higher than observed in orbital data.

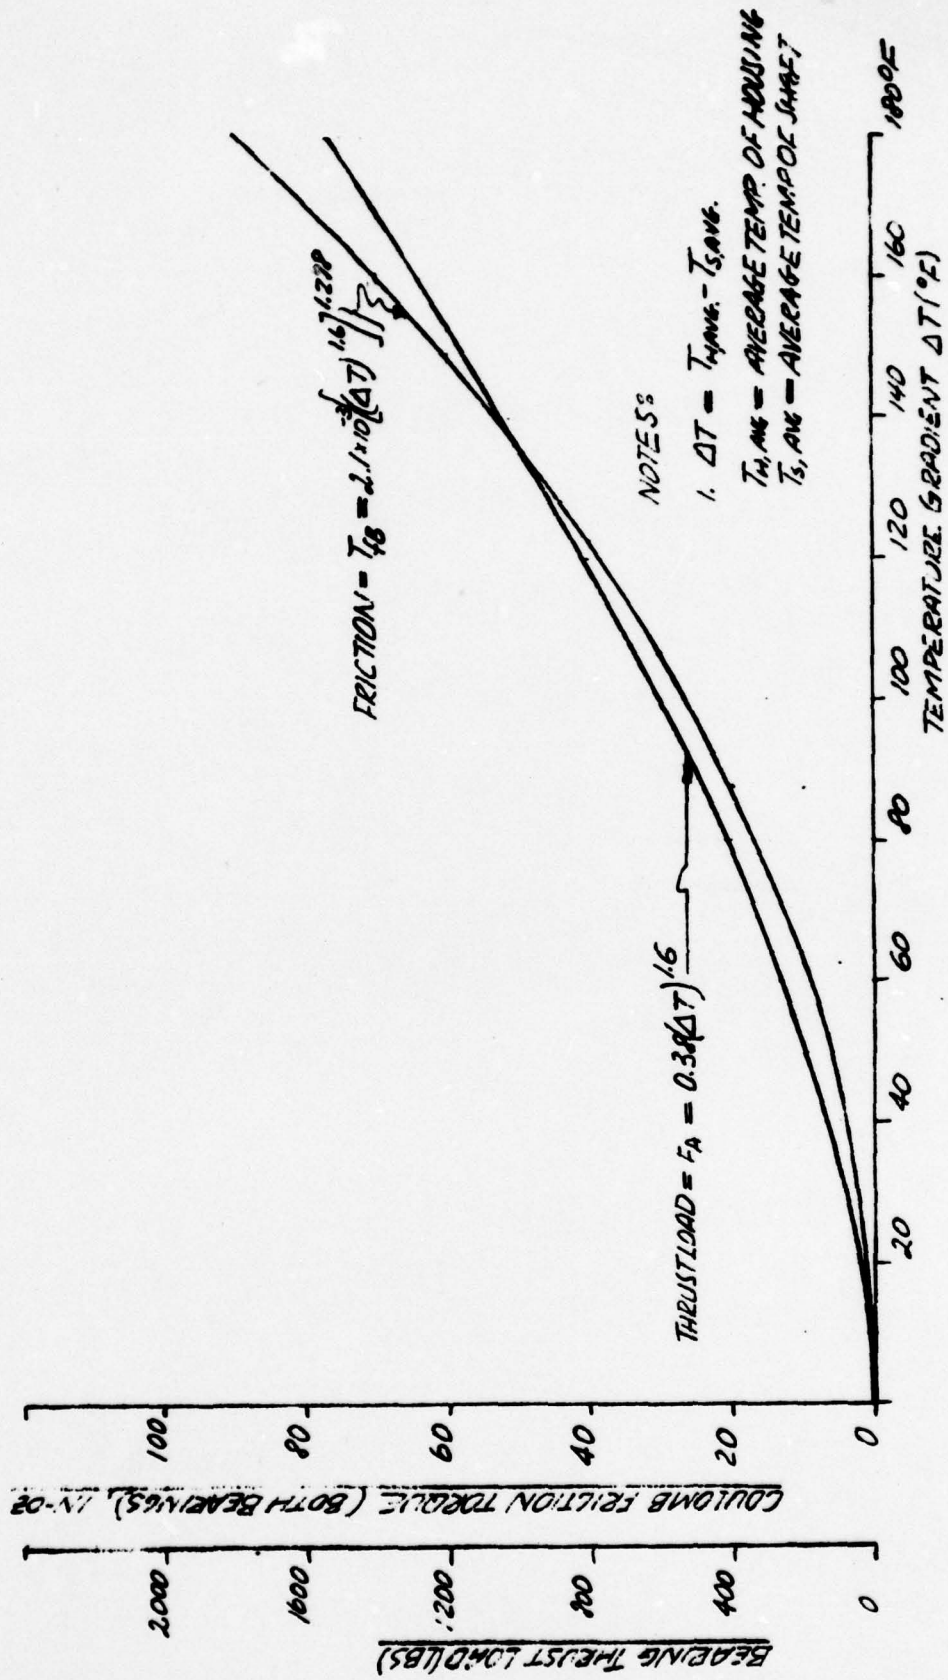
Figure 5.2-4. Bearing Δ Friction Torque and Thrust Load Versus Temperature Gradients (for Saturated Condition of Preload Mechanism)

The bearing friction torque values due to the gradient (ΔT) are shown on Figure 5.2-4. In order to recognize the magnitude of the thrust load, associated with the gradient ΔT , the relationship of these two quantities is also given on Figure 5.2-4. Figure 5.2-5 depicts the bearing friction torque as a function of the thrust load. Notice that the calculated correspondence with the experimental data is sufficiently good for acceptance with reasonable confidence the analytical relationships given on Figure 5.2-4.

- (b) the intensity of jamming is sufficient to retain the nominal (0.003 inch) relative position of the bearing with respect to the preload mechanism under load,
 - (c) the axial load is produced by a thermal gradient which is defined as the difference between the average housing and shaft temperatures,
- requires a thermal gradient (Figure 5.2-4) of 169°F to satisfy the anomaly's observed Δ torque increase of 60 in-oz.

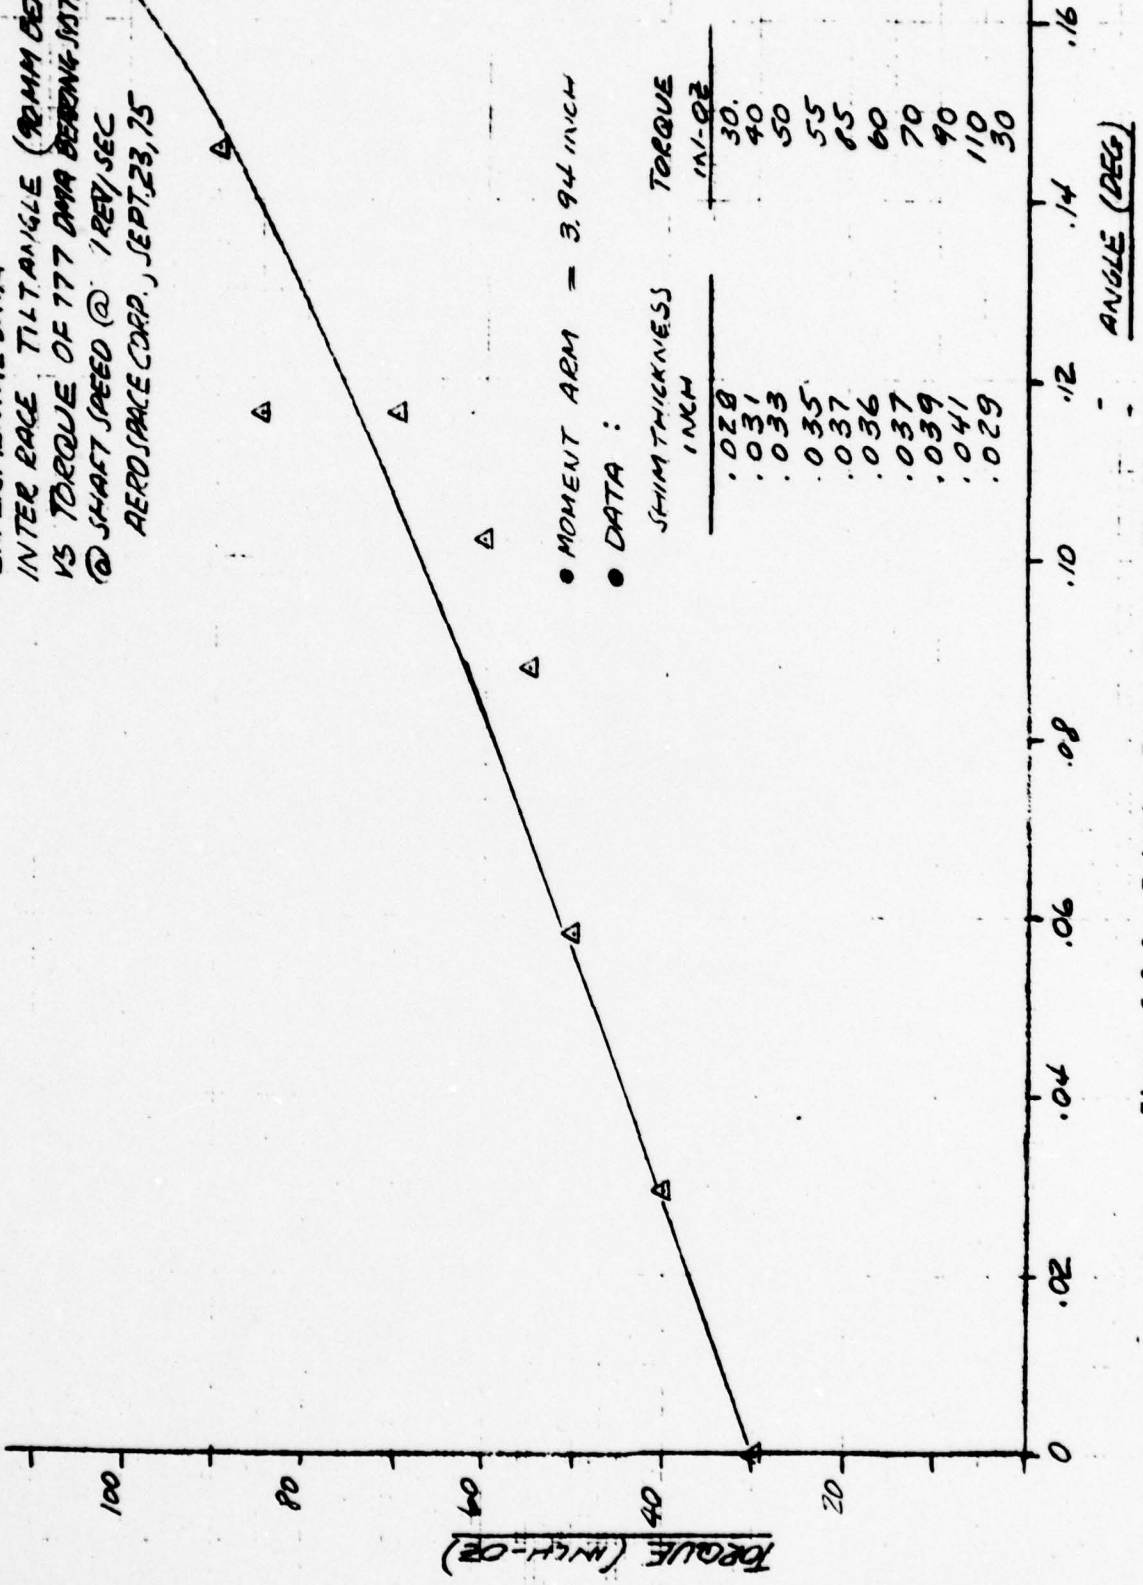
Figure 5.2-6. Friction Torque Versus Misalignment

- (2) Angular Misalignment of Bearing - Geometrically, by virtue of the pertinent radial and axial clearances (associated with the top bearing and the preload mechanism, respectively), it is possible to produce an angular misalignment that saturates the preload mechanism. The maximum angular quantity about an axis perpendicular to the rotational axis of the DMA associated with the misalignment, approaches 0.0485 degree of arc. This angle produces (refer to Figure 5.2-6) an increase of the bearing friction by 16 in-oz. Hence, to achieve the anomaly-associated torque increase in accordance to Figure 5.2-4, the required temperature gradient is 128°F.
- (3) Jammed Top Bearing's Inner Race - A hypothesis of the following conditions
 - (a) the radial clearance of the top bearing, between the inside diameter of its inner race and the outside diameter of the shaft is jammed by debris

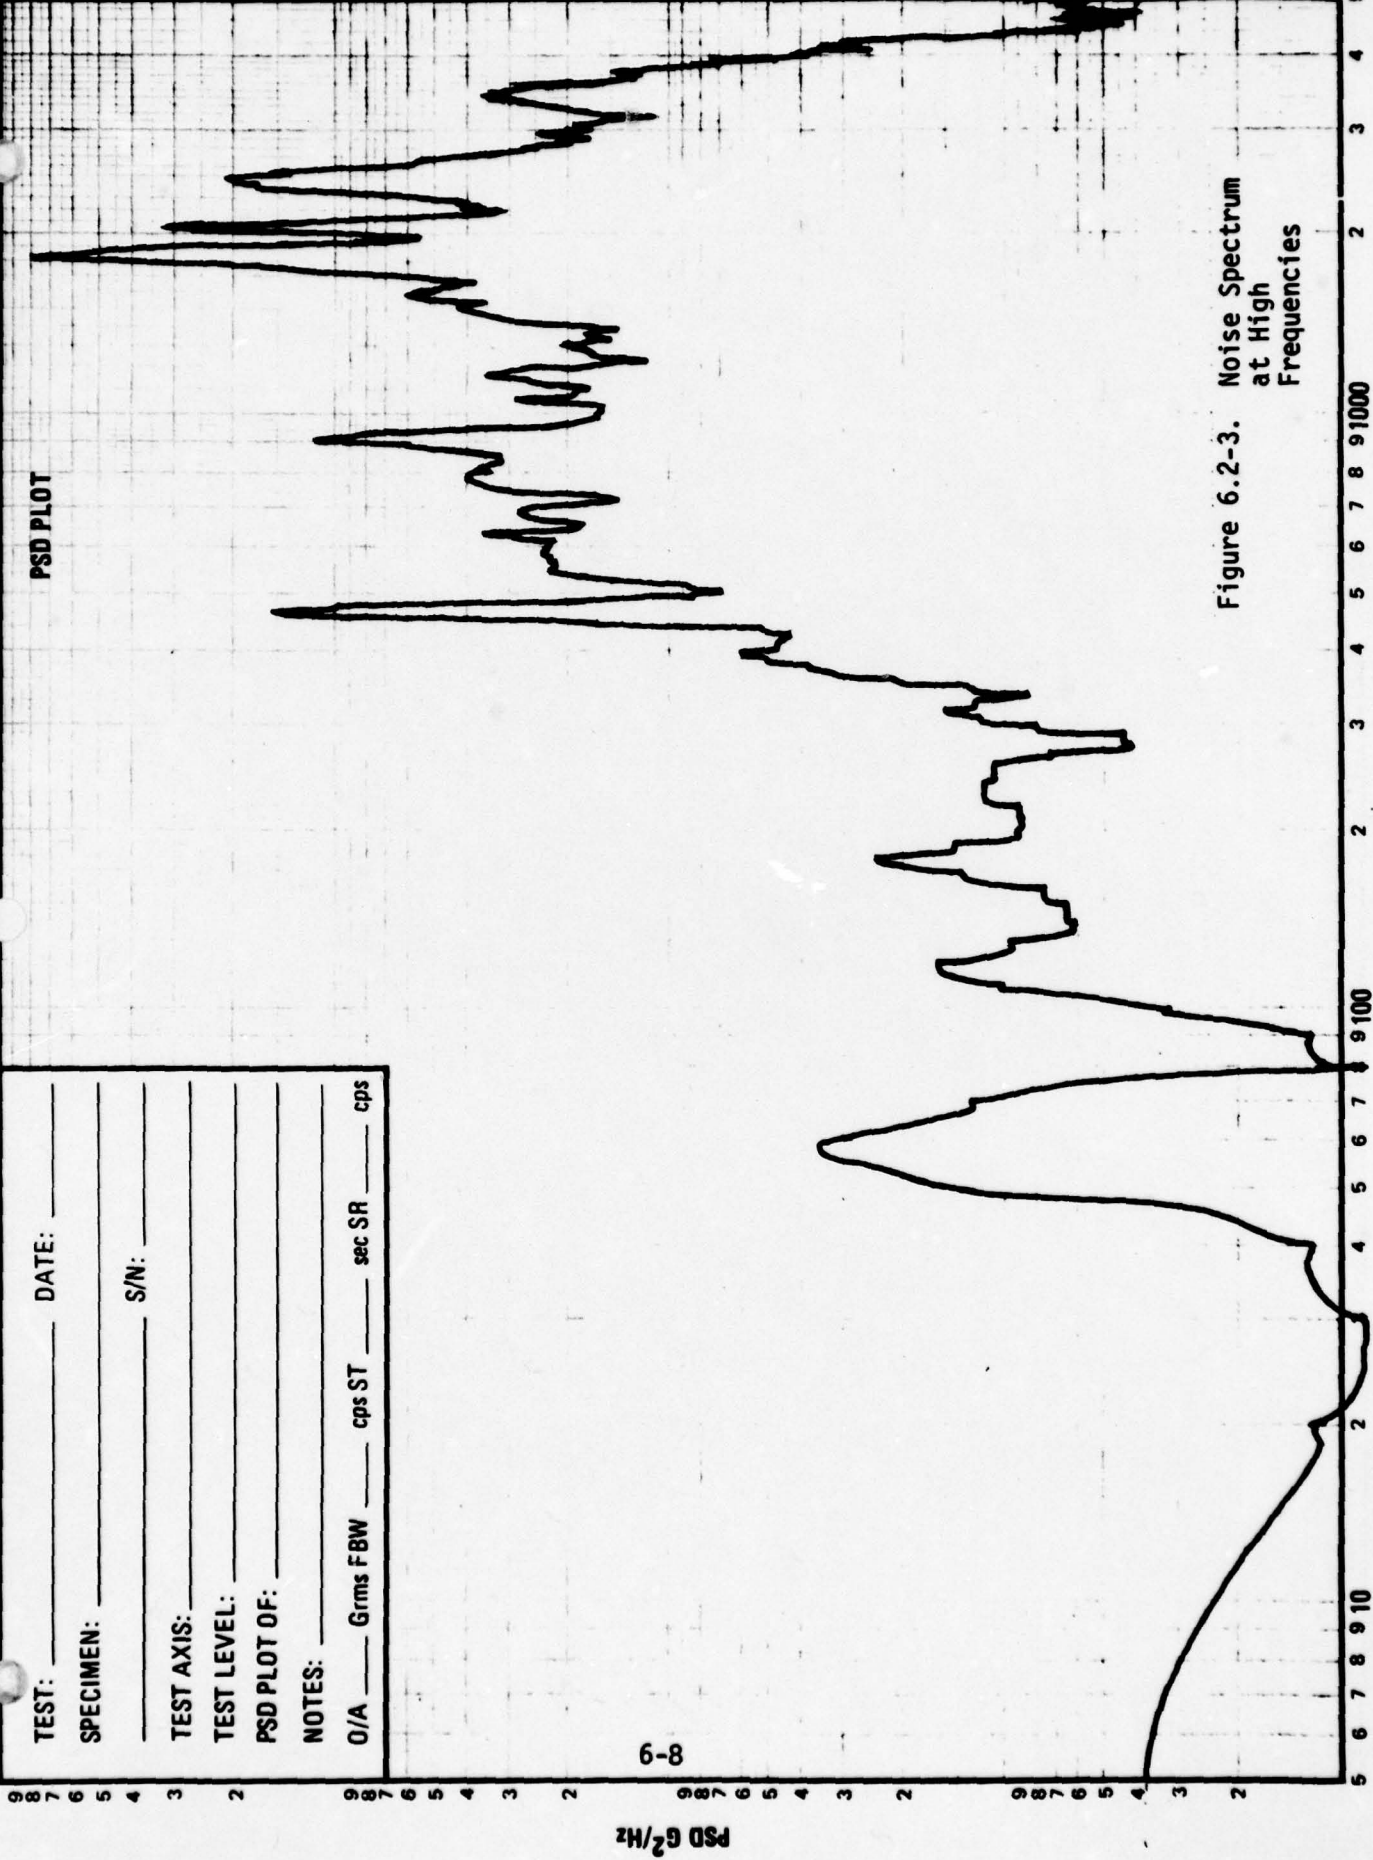
Figure 6.2-3. Noise Spectrum at High Frequencies

This data was also assessed in the high frequency regime, without using the repeating loop approach. The spectral data is shown in Figure 6.2-3. Note that much of the characteristic (e.g., roll off at high and low frequencies) can be attributed to the recording setup (microphone and recorder). The peak at 60 Hz is simply line ripple, as are probably those at 120 Hz and 180 Hz. However, there are other peaks at approximately 460 Hz and 920 Hz (repeated in a number of data samples)

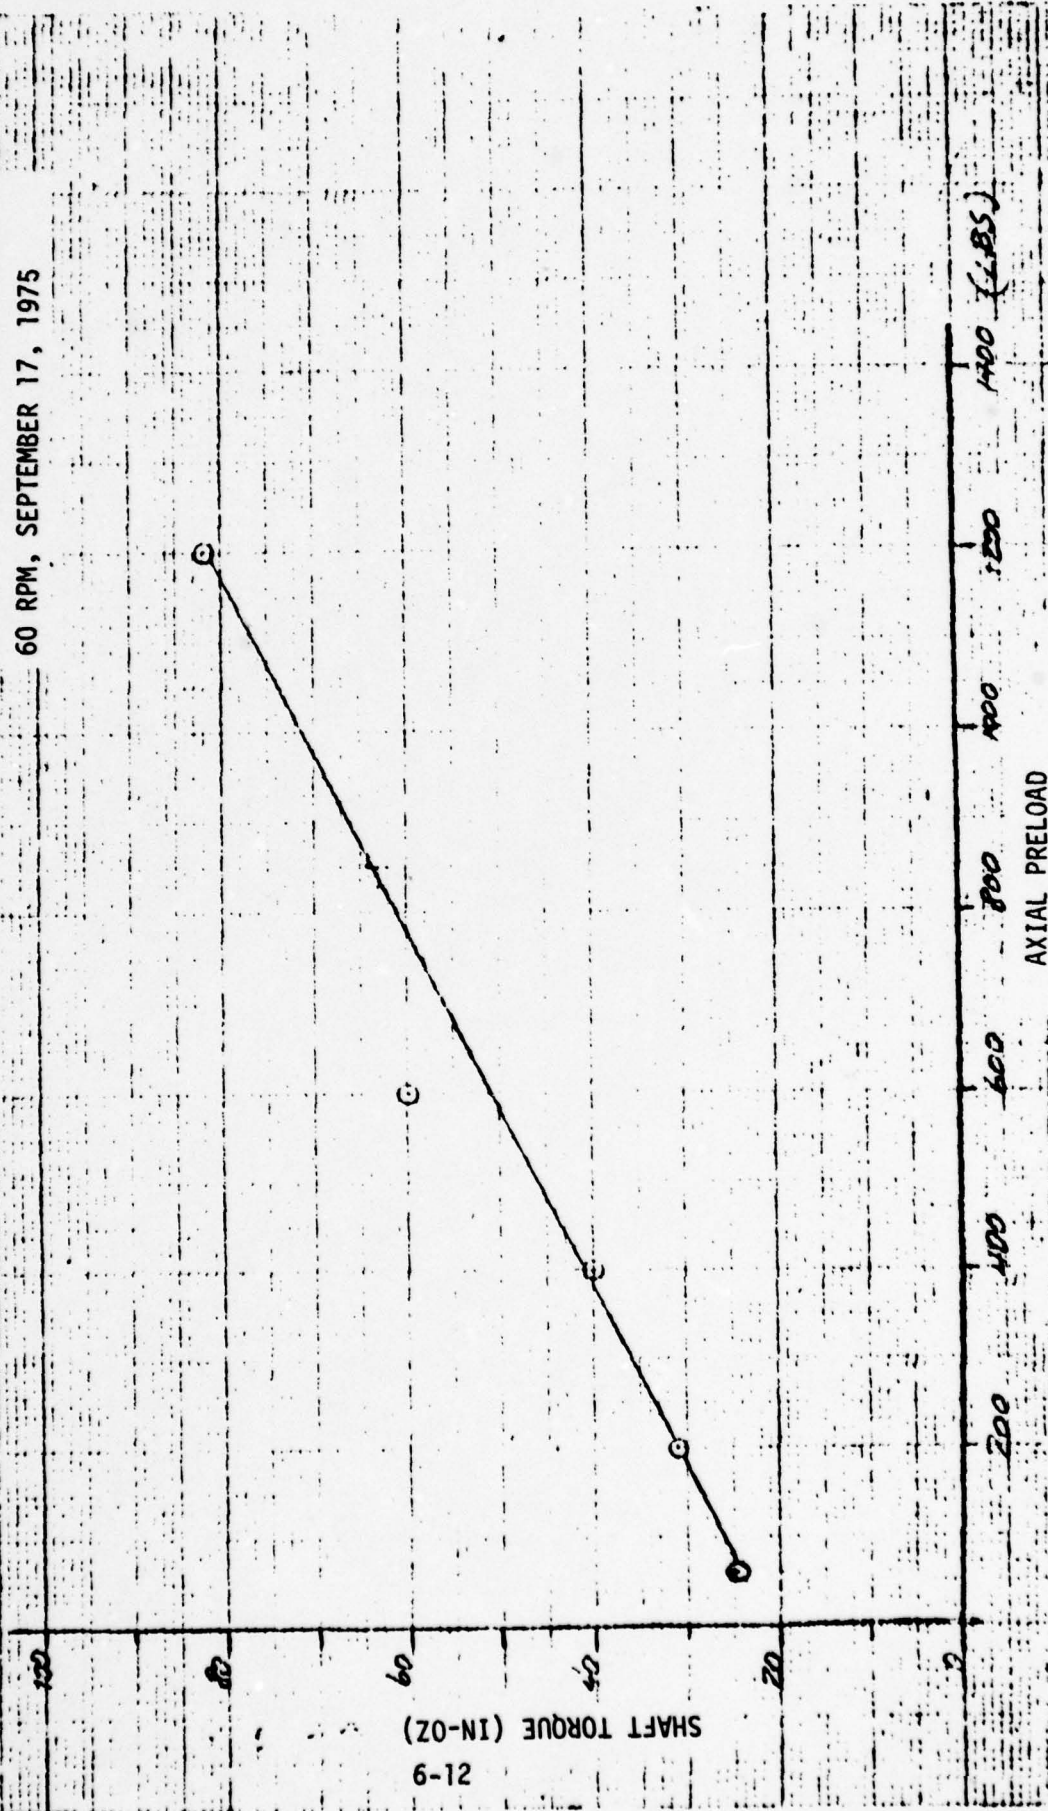
Figure 6.3-1. Main Bearing Friction Versus Preload

The DMA was mounted to an air bearing's null seeking dynamometer. A special axial loading spring assembly was mounted in-line with the DMA shaft to afford relatively accurate application of various value thrust loads. An extension of the shaft passing concentrically through the loading mechanism was driven by a rate control servo motor. The bearing friction torque, reacting against the null servo, was measured directly by the dynamometer system, and the value of the applied load was a function of the calibrated spring deflection. The test data was taken at 60 RPM and the results are given on Figure 6.3-1. The data suggests that lock-up of the preload mechanism will not produce steady torques of the magnitude seen in orbit.

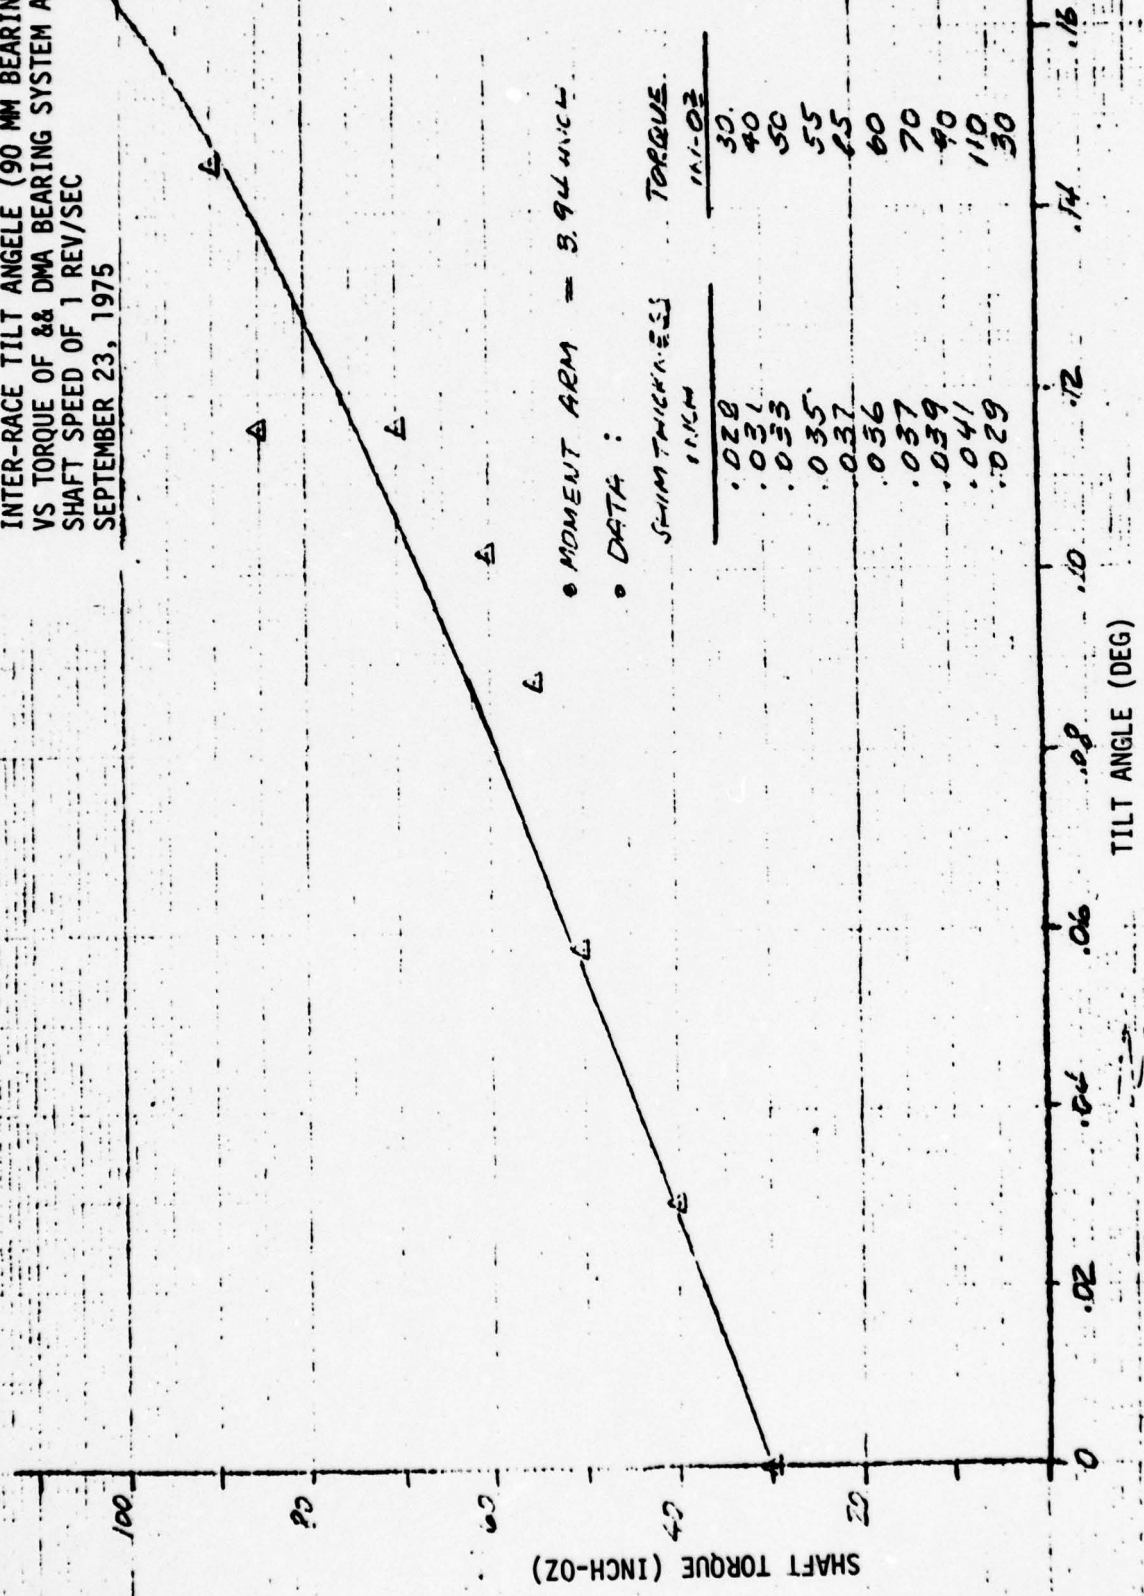
Figure 6.3-2. Main Bearing Friction Versus Misalignment

Using the same test facility, and a nominal bearing preload condition of 64 lbs, top bearing misalignment was induced by installing shims of various thicknesses between the bearing race and a plate fixed to the shaft. The resulting data obtained at 60 RPM shaft speed is given on Figure 6.3-2. This data shows inconsistencies with the observed orbital data, inasmuch as the maximum bearing misalignment geometrically possible is 0.04 degree, and at this value, the bearing friction increase from nominal is less than 15 in-oz.
