TRW DEFENSE AND SPACE SYSTEMS GROUP REDONDO BEACH CA
9433 DESIGN POINTING ANOMALY. VOLUME I. TECHNICAL REPORT. (U)

0433 DESPIN POINTING ANOMALY

VOLUME I
TECHNICAL REPORT

REPORT NO. 28600-AR-010-01 ✓

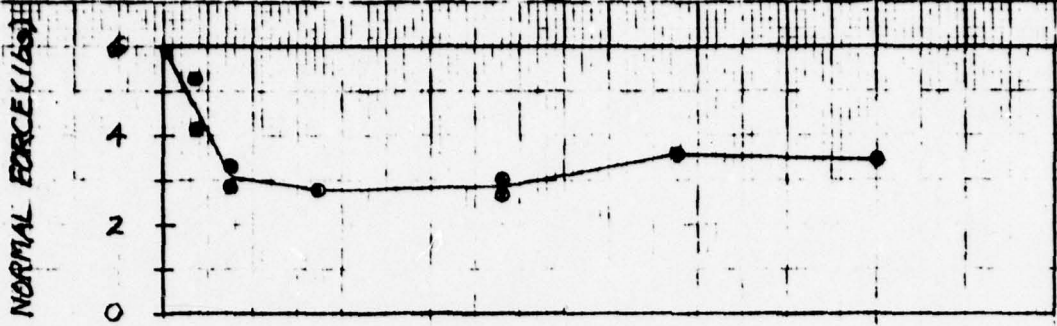
Figure 6.4-2. Snubber Wear Test Data

The test procedure was to run for a period of time and then to shut down and measure the total decrease (wear) or increase in dimensions along the contact radius. Figure 6.4-2 shows the radial wear resulting from a two hour test in which a constant snubber friction of approximately 50 in-oz has been maintained. The normal force was initially 5.9 lbs and was steadily reduced during the first 11 minutes to 3 pounds. During this period, the snubber was producing a black debris as the anodize coating was being worn

off. The reduction in normal force at constant torque indicated an increased shearing force. The shearing force stabilized after 11 minutes at a value of approximately 1.41 lbs. This was representative of a coefficient of friction of 0.47 between the snubber rotor and stator. Figure 6.4-2 indicates that the total radial wear increased steadily at a rate of approximately .002 inch per hour. The wear debris after 11 minutes consisted of galled powder, flakes, and rolled strands of aluminum.

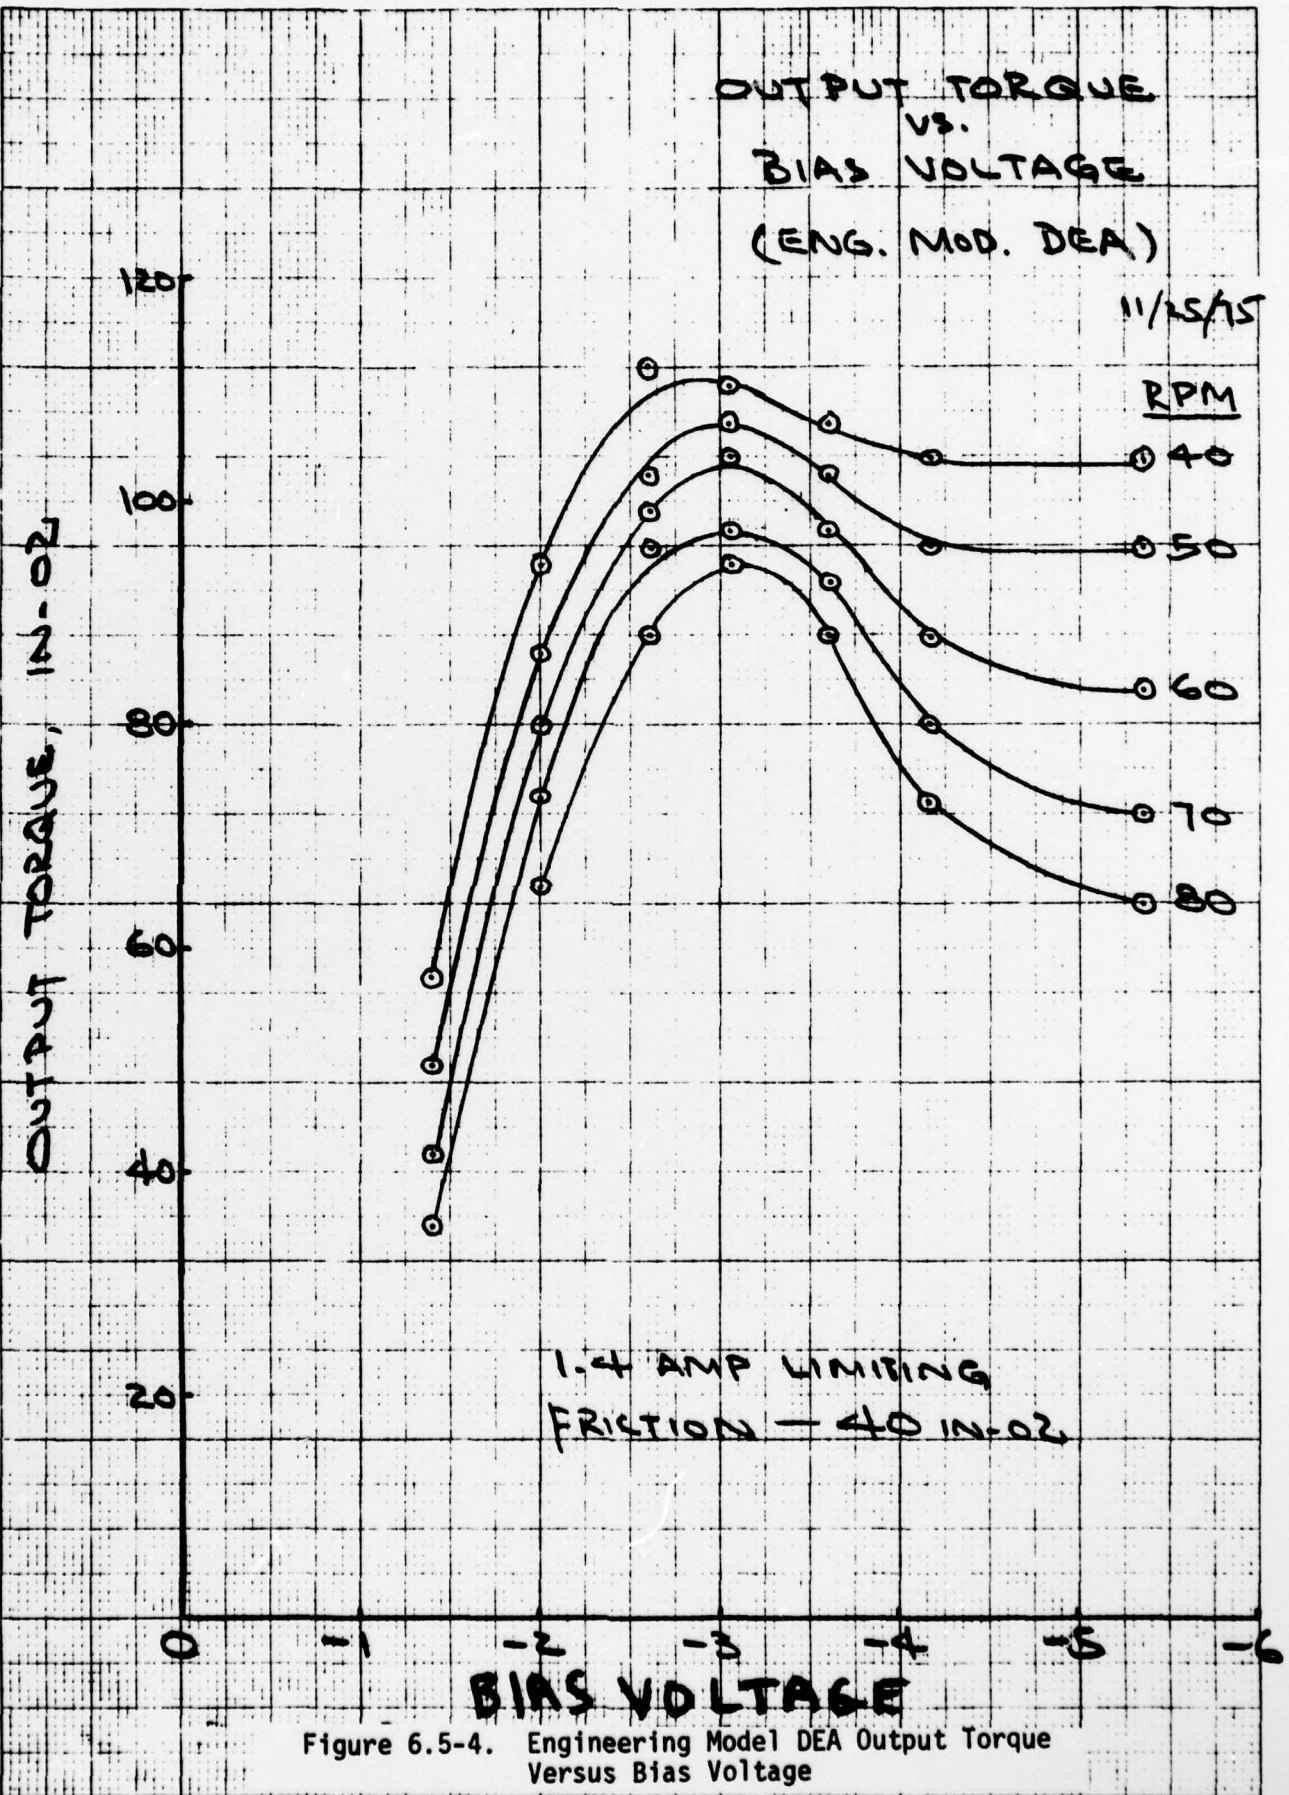
Figure 6.5-4. Engineering Model DEA Output Torque Versus Bias Voltage

A peculiar phenomena revealed by the test data is that the speed curves do not converge to a peak torque as the error voltage is increased linearly to a maximum value of 5 volts. Instead, they assume declining slopes (Figures 6.5-3 and 6.5-4) at error voltages over 3 volts. Moreover, the torque reduction appears to be speed-dependent - greater reduction with increasing speed. This characteristic can partially explain the net torque decrease near 80 rpm during the initial friction test on 30 September 1975 (Figure 3.4-2).

Test Data indicates that this torque decrease is due to a phase shift between the resolver signal and the drive current to the motor. Referring to Figure 1-4, this phase shift occurs due to the switching regulator being duty-cycled by the current detector to maintain a limited motor current in the saturated regime. This is equivalent to a reduction in the forward-loop gain of the feedback loop consisting of the summing amplifier, the pulse-width modulator, the switching regulator, and the power bridge. Such a decrease in the open-loop gain results in a decrease in the bandwidth of the closed-loop characteristic, with an attendant increase in phase shift between the resolver demodulator output and motor input.

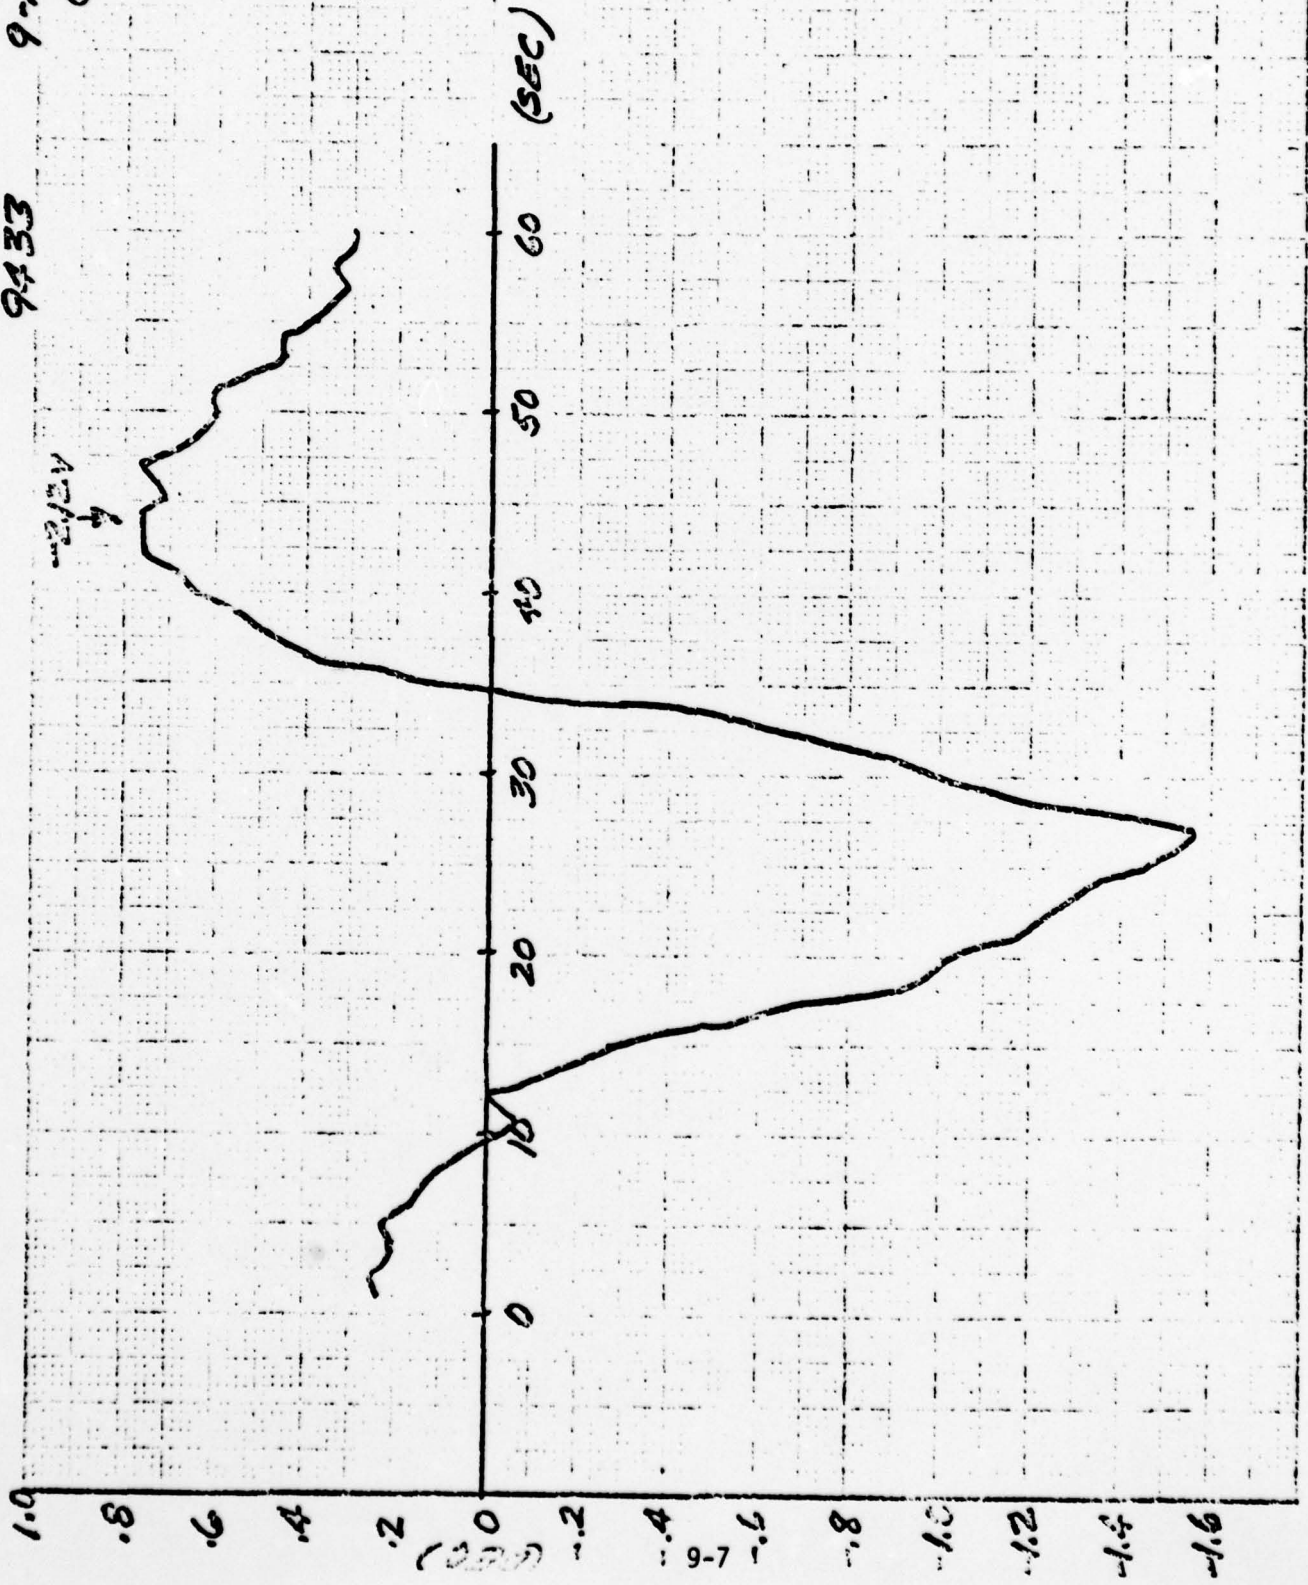
Figure 9-4. Pointing Error Plotted from Flight data, Sept. 10, 1975

An effort was made to match the simulated results with observed flight data. Figure 9-4 is a typical pulse plotted from flight data from September 10, 1975 when peak errors of approximately 1.5 deg were observed. For simulation, a constant friction level of 120 in-oz was assumed.* If the maximum available torque were 170 in-oz, then from Figure 9-3 it can be seen that a torque disturbance of a minimum of 25 in-oz was necessary to cause the pointing error. This is a significantly larger pulse than the 5 in-oz that was hypothesized to be the result of retainer whirl.

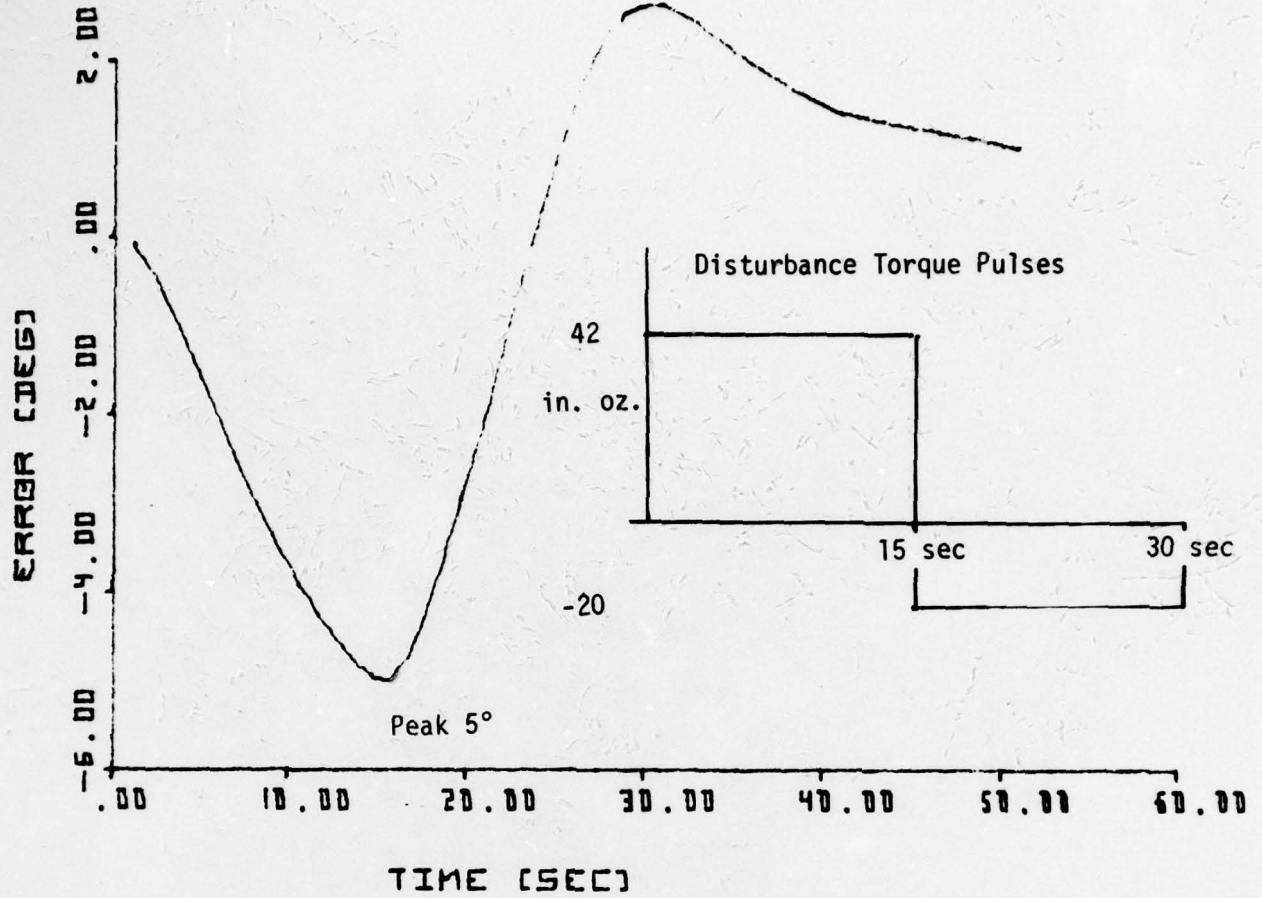
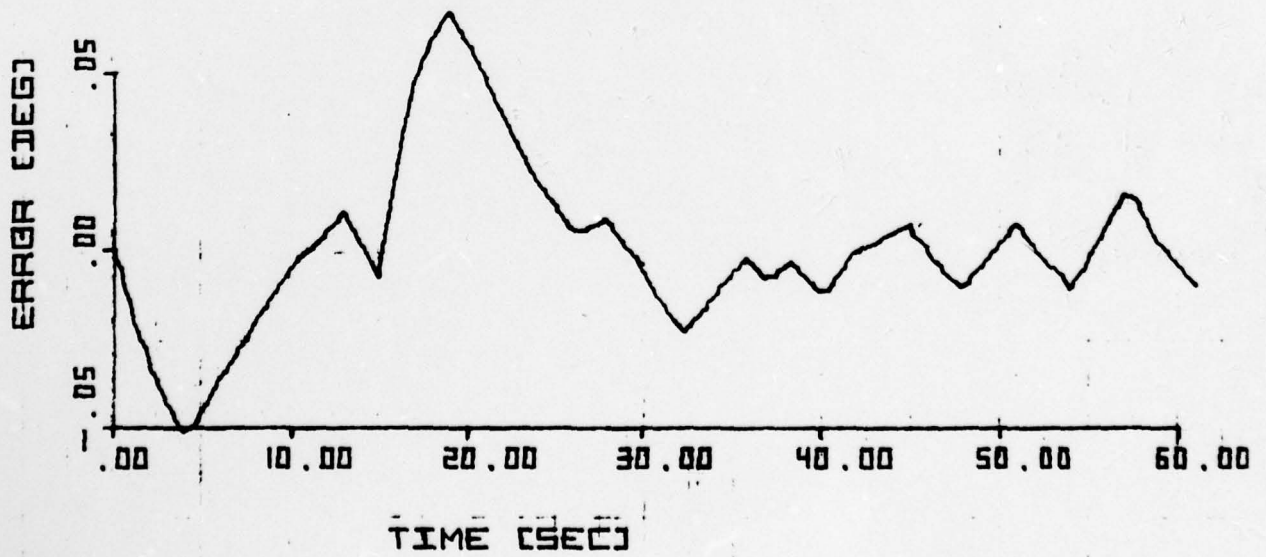
Figure 9-11. Comparison Between 777 Controller and Configuration C

A question came up as to how well an improved controller (Configuration C) which uses a rate loop in addition to the platform position loop in Normal Mode, would perform in the presence of the disturbance pulse that caused an observed pointing error of about 5 degrees. To simulate this case, a running friction torque of 120 in-oz was assumed (maximum torque capability = 170 in-oz), and a disturbance pulse of 42 in-oz for 15 seconds was simulated. The results for both controllers are shown in Figure 9-11. The configuration C results show a peak error of .065 deg; thus the rate loop virtually desensitizes the despinn control system to the effects of torque pulses.

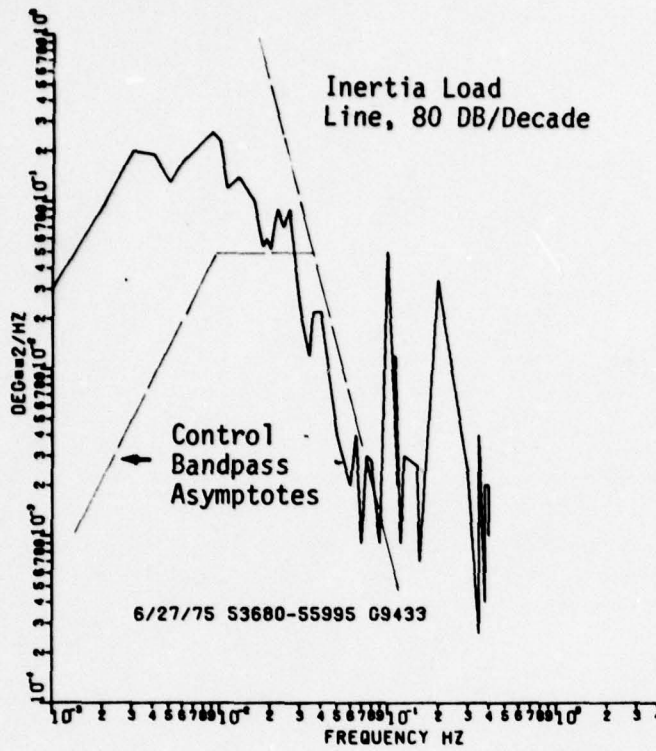
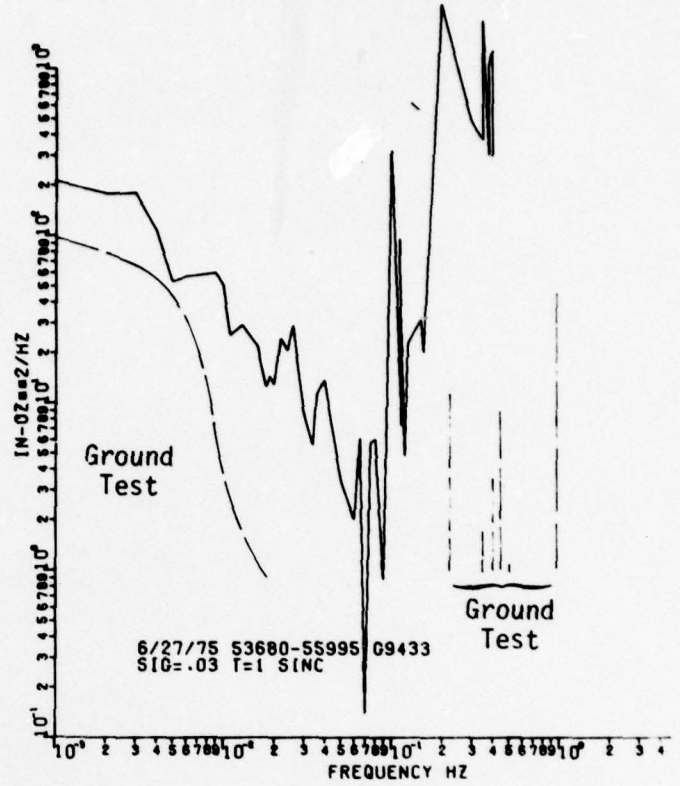
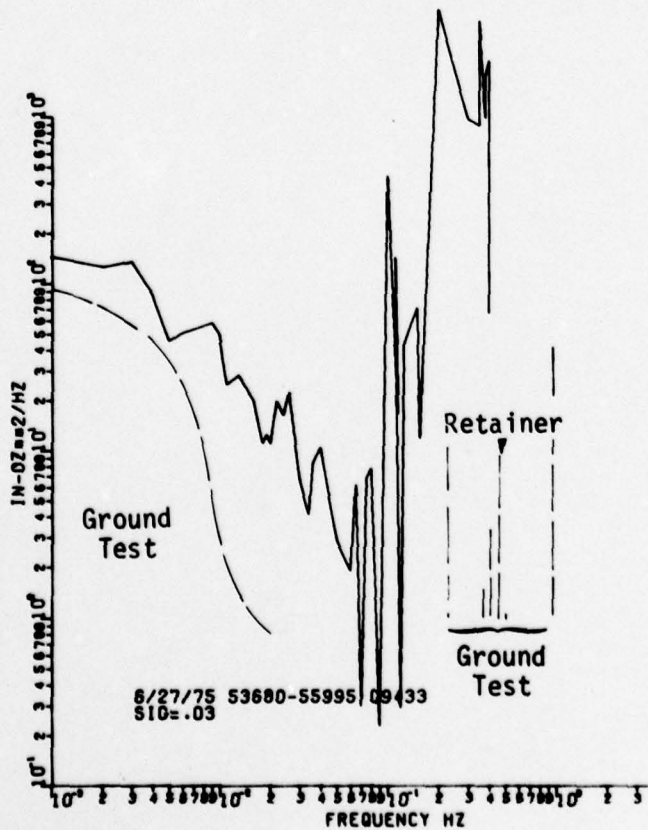
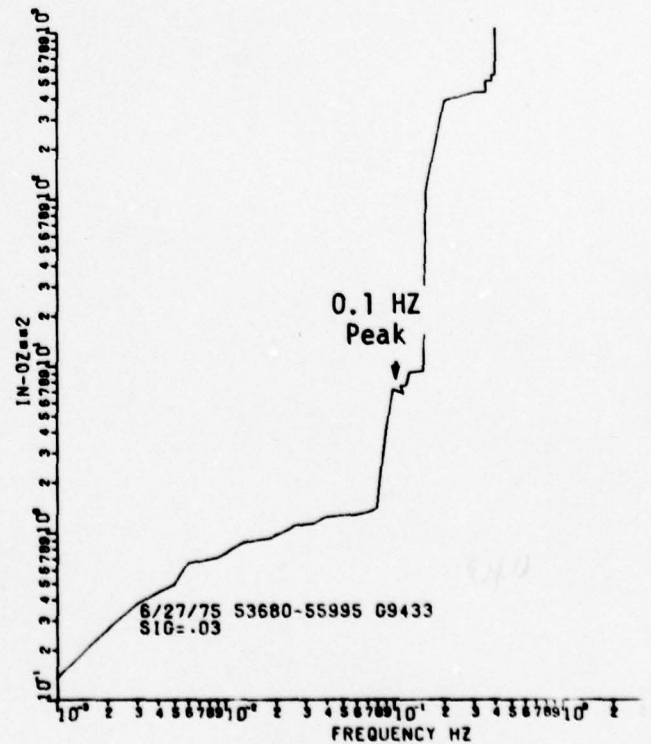
Figure 9.2-1. 9433 Pointing Error Data and Torque PSD 6/27/75 (Gain State 7)

The torque trends are summarized in Table 9.2-1 and are shown in Figures 9.2-1 B and C through 9.2-4 B and C. Both linear models show substantially the same result. For example, the linear model with the zero-order hold shows slightly higher torques at low frequencies and higher torques at high frequencies.

The calculated torque within the control band of 0.038 deg was compared to a single piece of ground test PSD data which is shown superimposed on the above figures. A similarity in curve shape is noted. The calculated torque curves appear higher in amplitude and the cutoff appears to be shifted to higher frequencies from 0.01 to 0.04 deg. The closest fit appears to occur with the early 6/27/75 data where, for example, at the low frequency end (at 0.001 Hz) a peak of 140 (in oz)^2 per Hz was obtained as compared to the ground test data of 94 (in oz)^2 per Hz. As time increases, the torque PSD values shift upward, but the shape is generally preserved in the low frequency band. At 9/12/75, before the first anomaly, torque

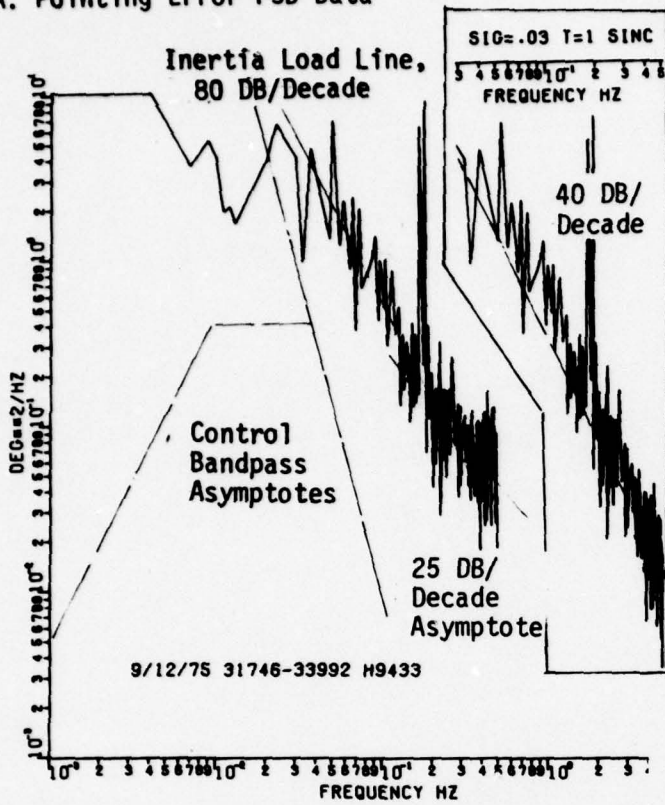
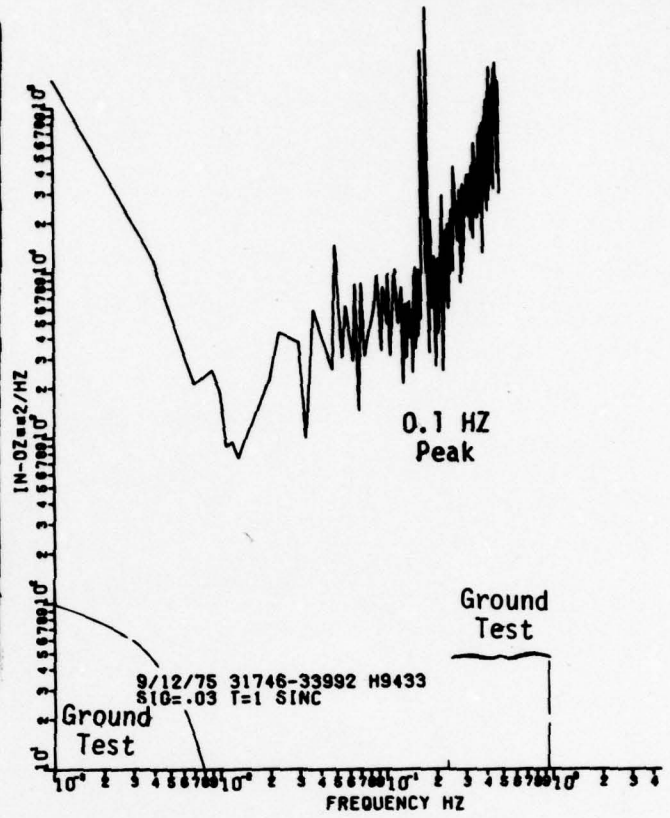
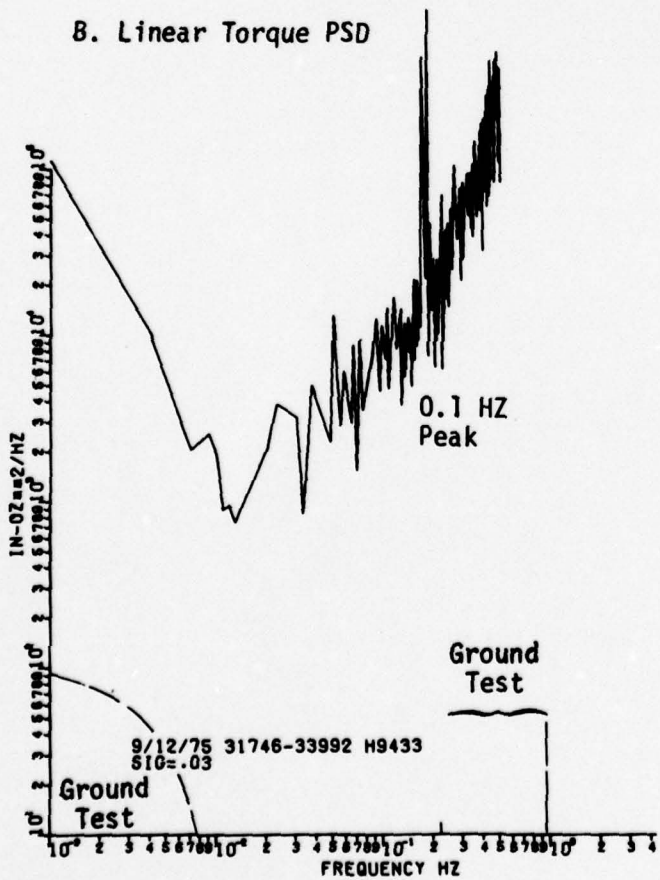
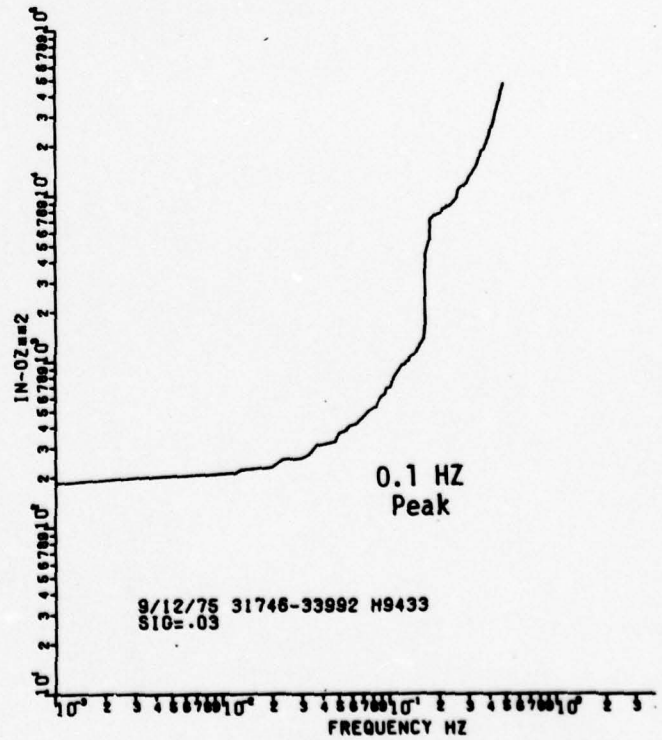
At low frequencies, however, the high pointing error trend could be caused by high frequency 1 Hz disturbances folded about 0.5 Hz or one half the sampling frequency. Since the platform rotates at 1 Hz, there is a strong likelihood of bearing disturbances occurring at this frequency. Since pointing error data is also sampled near this frequency, large pointing error amplitudes occurring near 1.0 Hz could be folded back and added to the low frequency pointing error. However, the torque disturbances causing these large amplitude high frequency pointing error excursions would have to be significant because of the 80 DB per decade attenuation contributed by the load inertia at high frequencies. These assumptions appear valid for the data in the 6/27/75 to 9/01/75 time period range. The preanomaly data taken on 9/12/75 does show strong effects of folding over the high frequency range

The 09/12/75 pointing error data shows approximately a 40 DB per decade attenuation for frequencies greater than the control bandpass frequency of 0.038 Hz or approximately half the rate of shown in the earlier cases. Furthermore, an amplitude shift upwards of 20 DB is noted for the low frequency end and 40 DB shift at the high frequency end (near 0.5 Hz). The decrease in slope to one half the normal constant torque inertia load line 80 DB/decade can be explained by an increase in the torque in the high frequency range. The departure from the 80 DB/decade trend noted in the earlier cases is also significant since this indicates the additive effects of folding at higher frequencies on the pointing error PSD. The folding effect probably strongly influences the pointing error PSD across the spectral band.

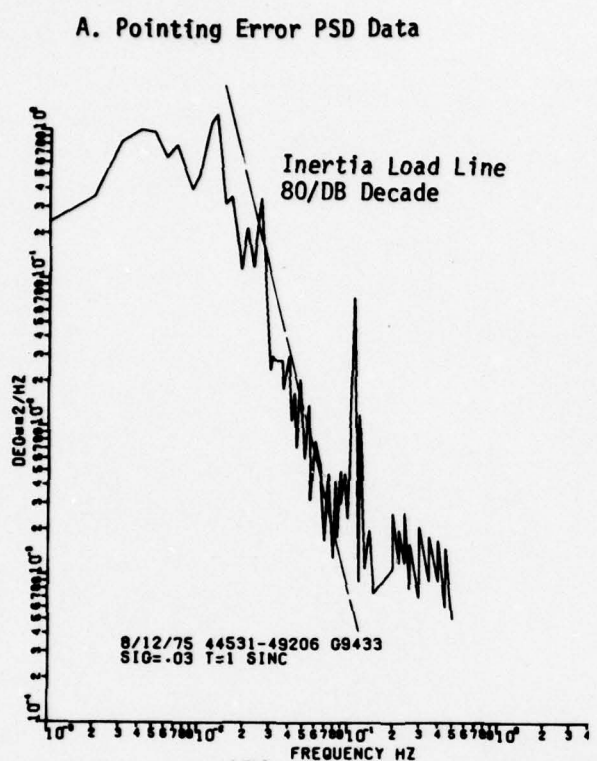
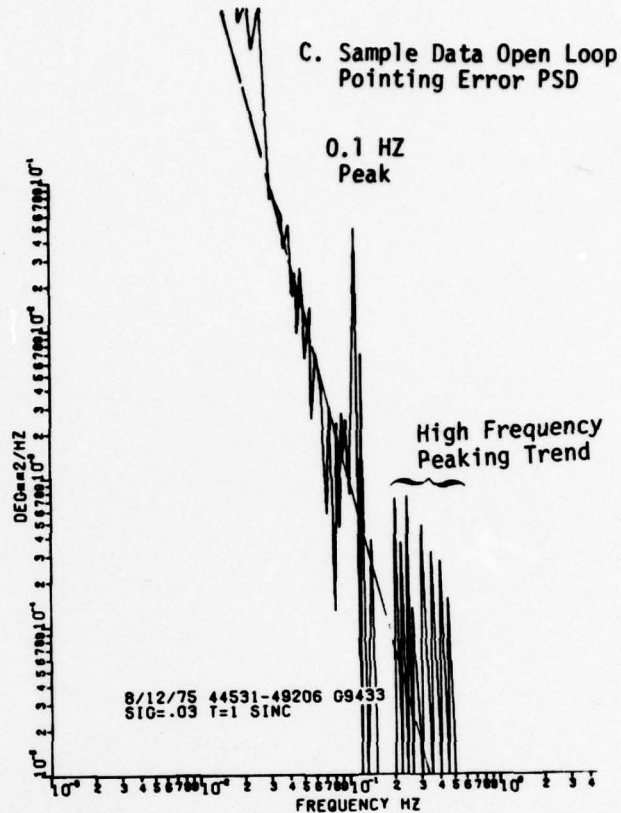
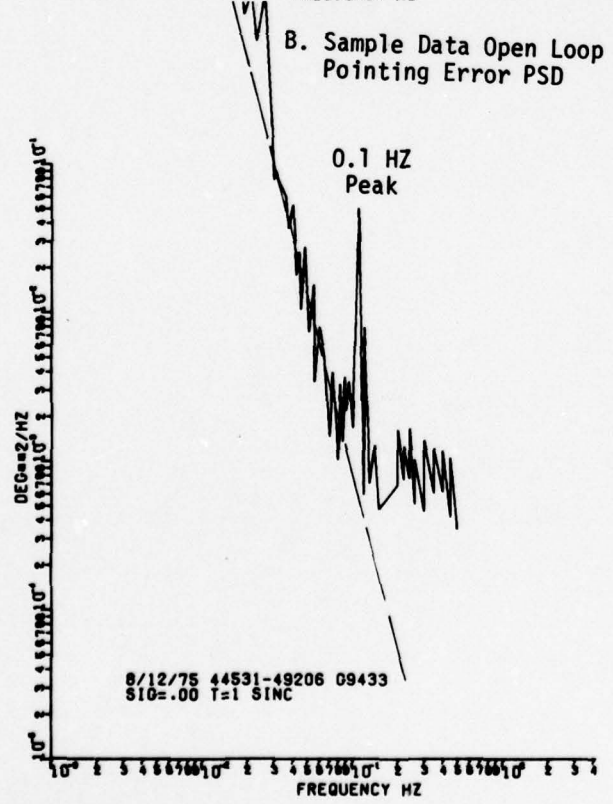
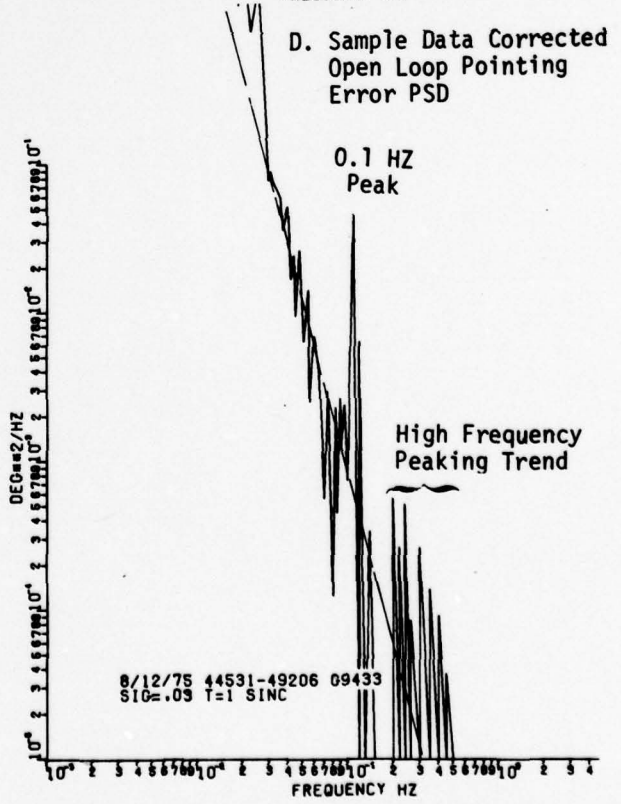
Figure 9.2-5. Pointing Error Data and Sample Data Open Loop Pointing Error PSD (Gain State 7)

the torque PSD cannot be calculated explicitly; however the open loop pointing error output PSD or the open loop effect of the disturbance torque input PSD acting on the platform inertia load dynamics can be calculated. These calculations were performed with variations of the sensor noise removed from the pointing error PSD data. (see Figure 9.2-5 for details).
