HINCKLEY DAM

PHASE I INSPECTION REPORT NATIONAL DAM SAFETY PROGRAM

NY 00181

Date: July 6, 1978

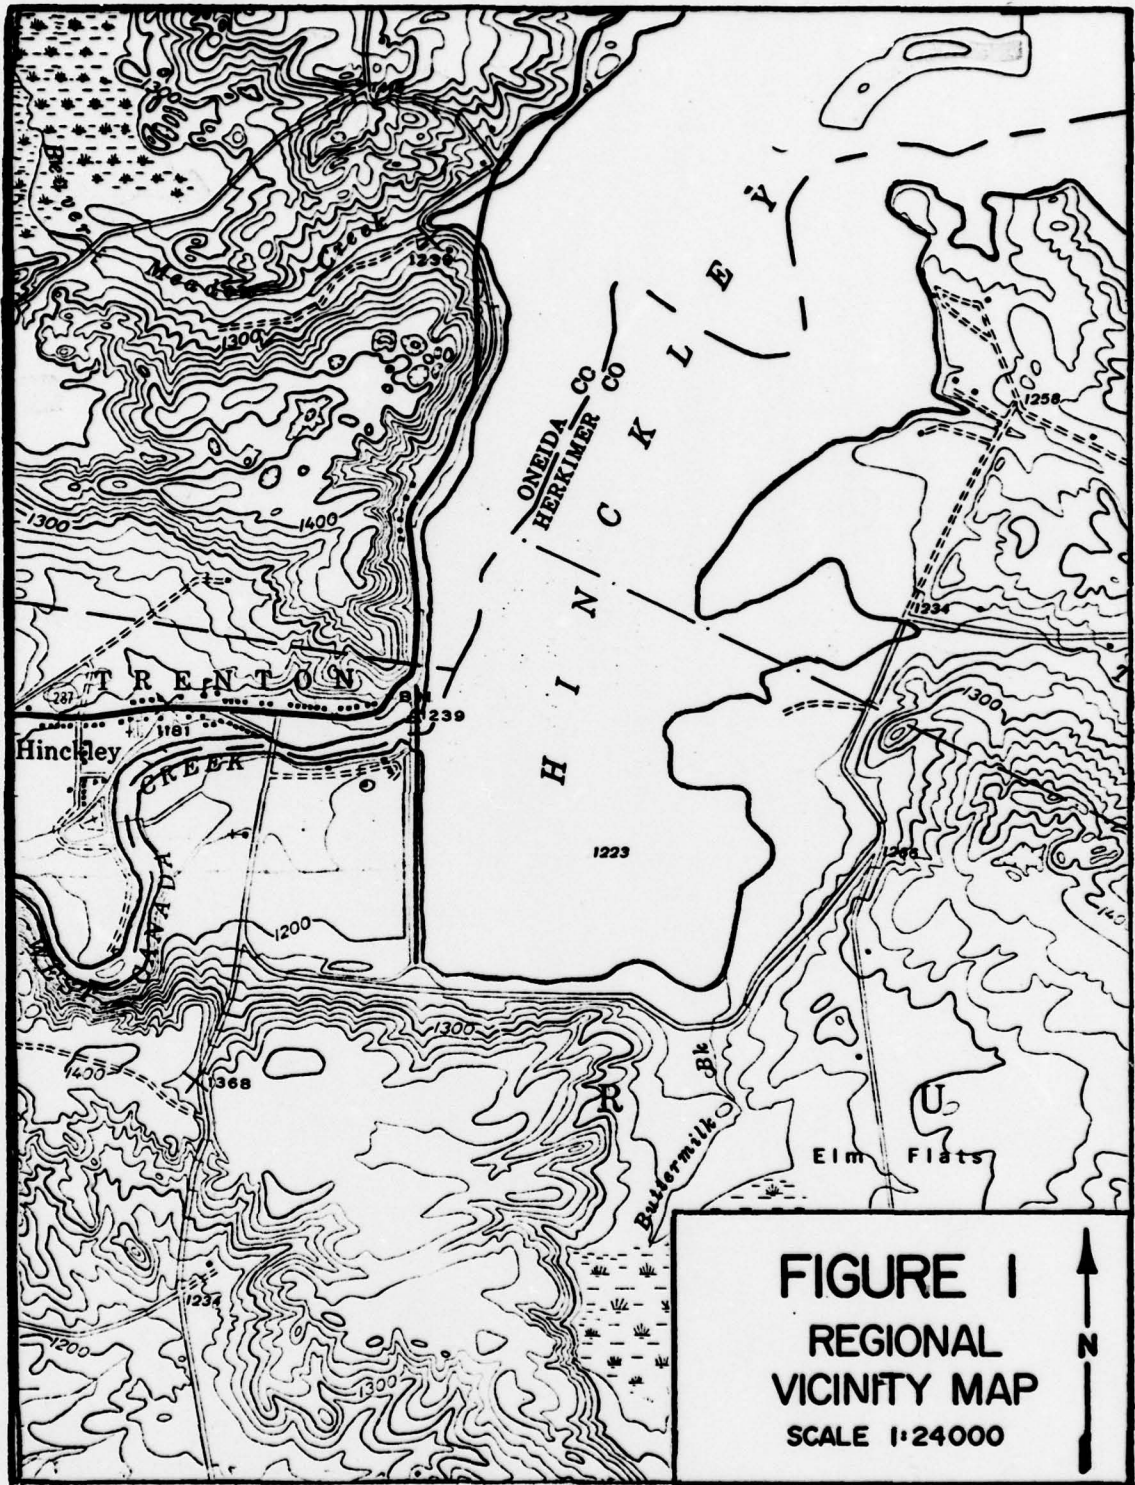
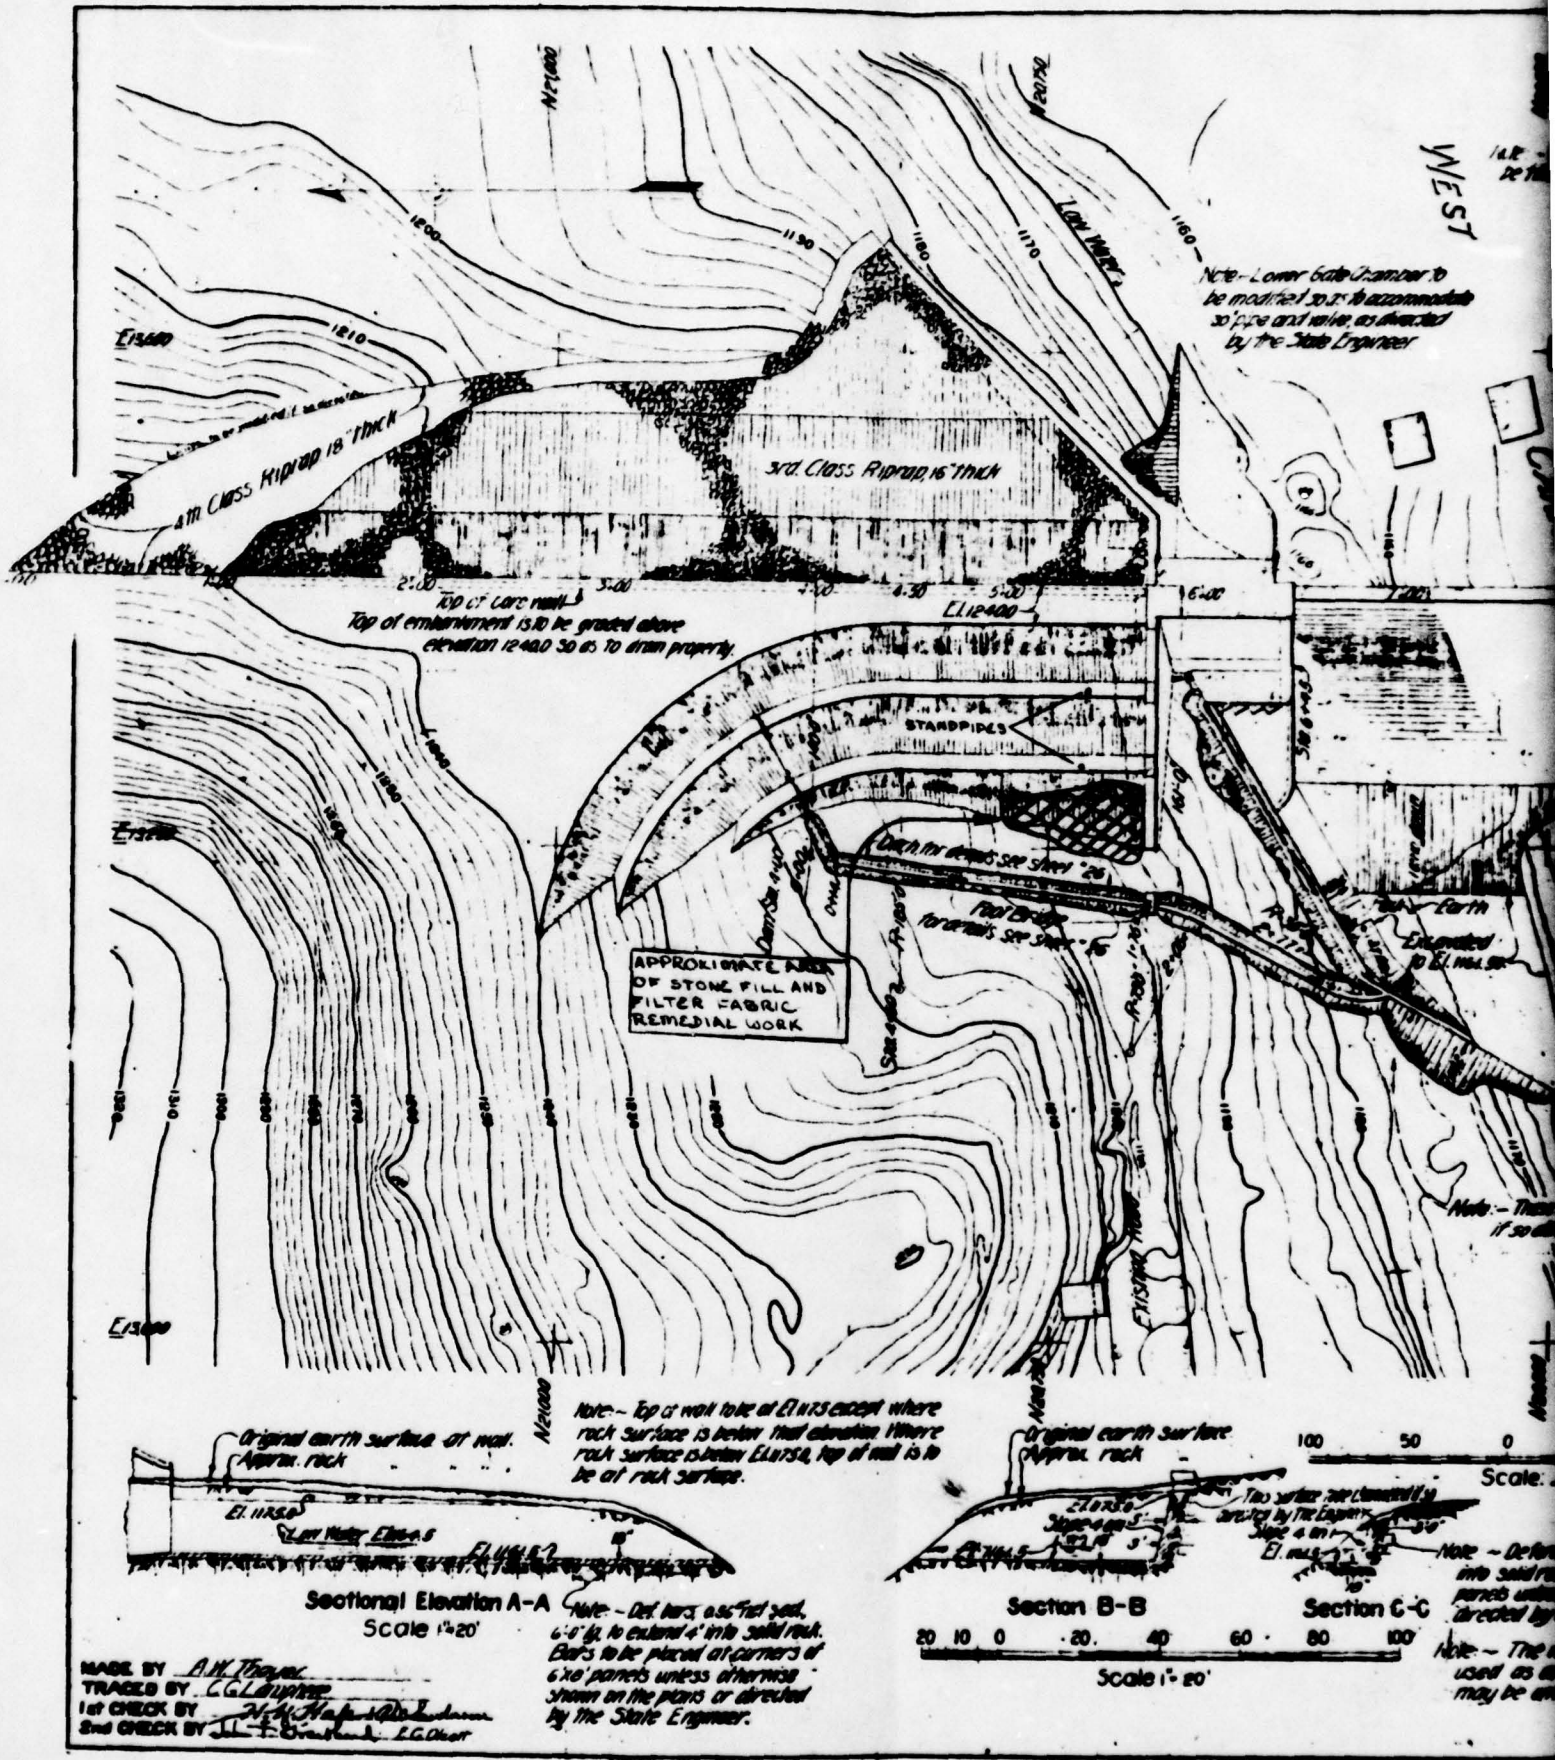
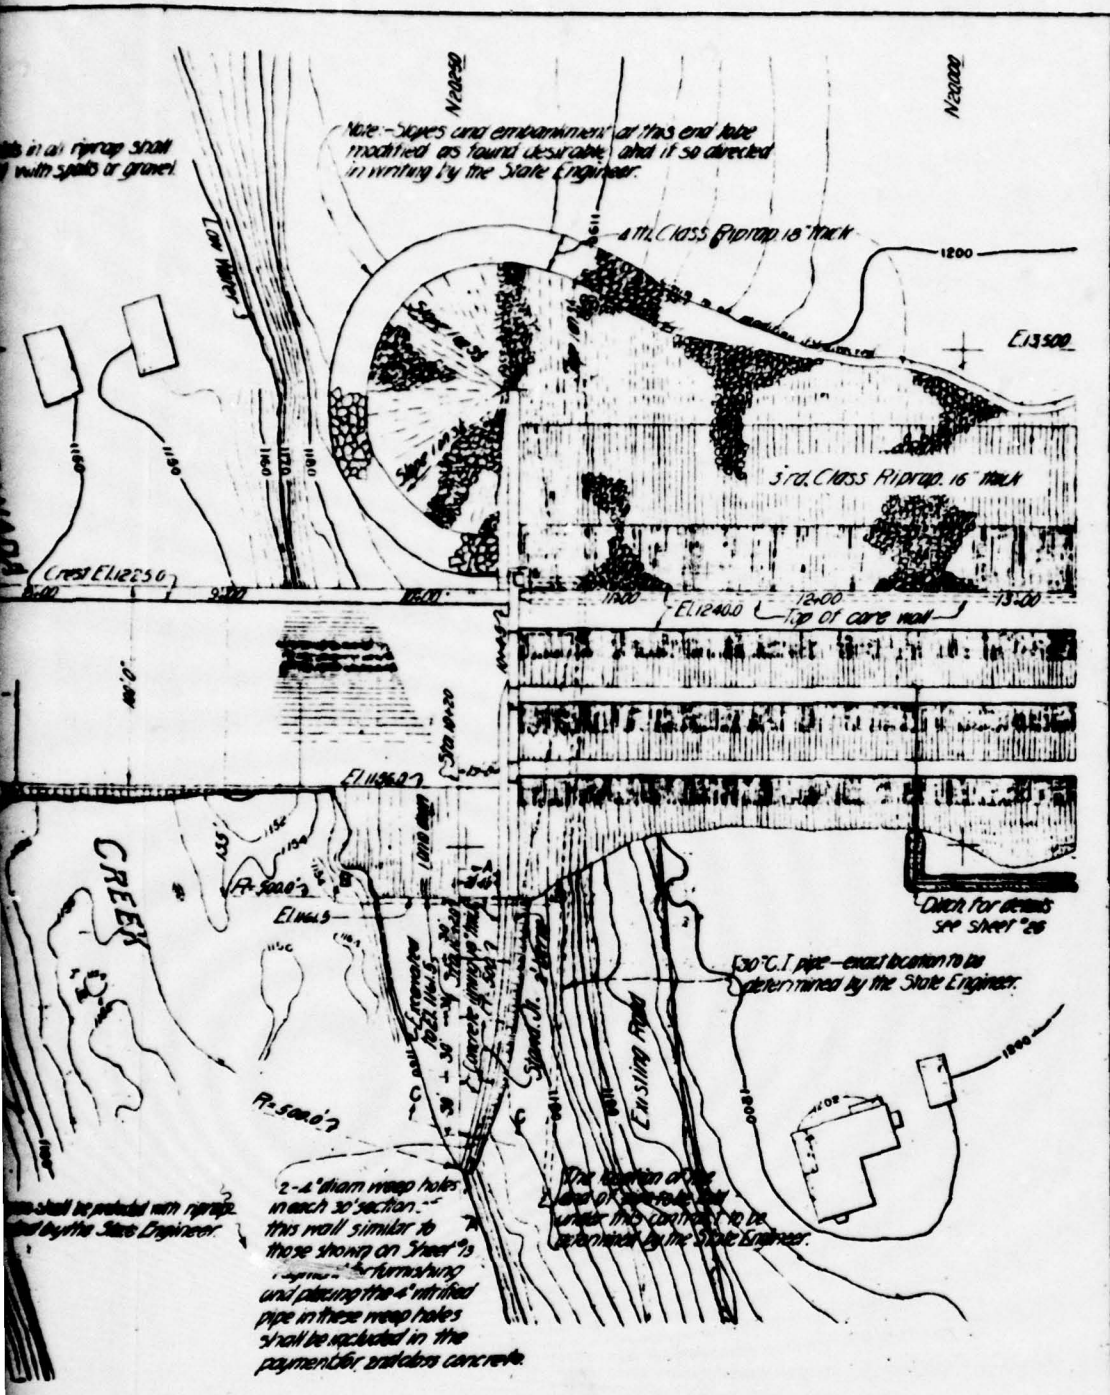
FIGURE 2
Contract No. 50.

The downstream slope of the north embankment is provided with two benches. The benches are sloped towards the center of the embankment to provide for surface drainage. A swale is constructed near the center of the embankment. The swale extends from the upper bench to a ditch downstream of the toe of the embankment. Standpipes were noted on each bench about 30 feet from the north wingwall. The water levels below the upper and lower benches were measured at 24 feet and 11.8 feet respectively. Just above the toe of the embankment is an area of stone fill over a fabric filter extending about 20 feet up the embankment. The area extends laterally about 75 feet from the north wingwall, and is provided with a 6 inch corrugated metal underdrain pipe. The pipe terminates at a drainage ditch downstream of the toe. Flow from the pipe was clear and estimated at 1 gpm. See Figure 2 for the approximate location of the standpipes and stone fill.

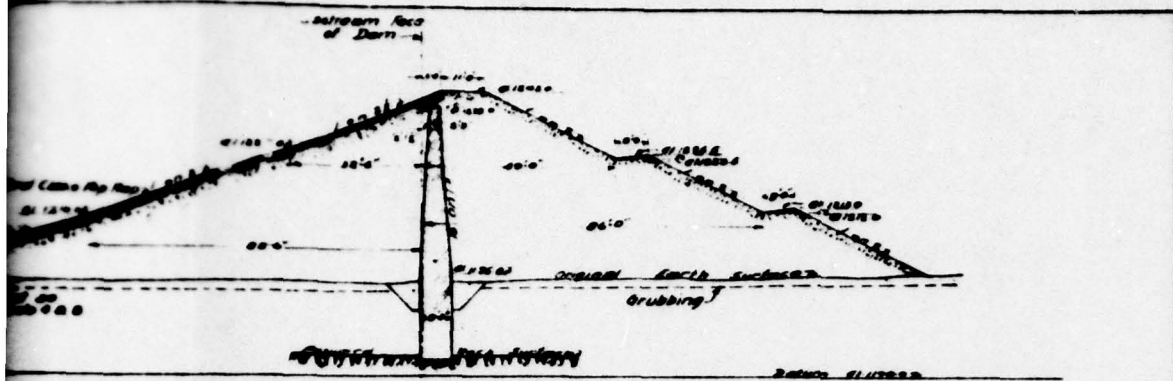
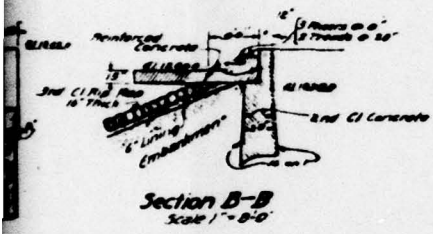
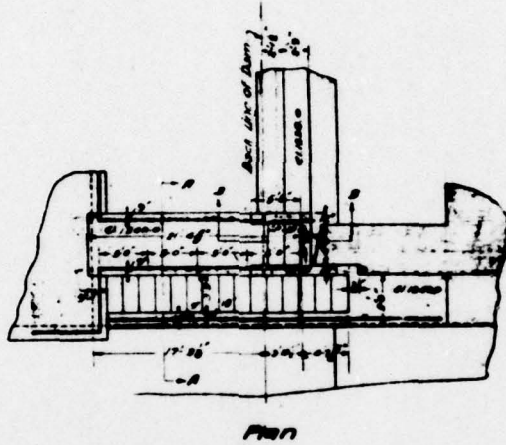
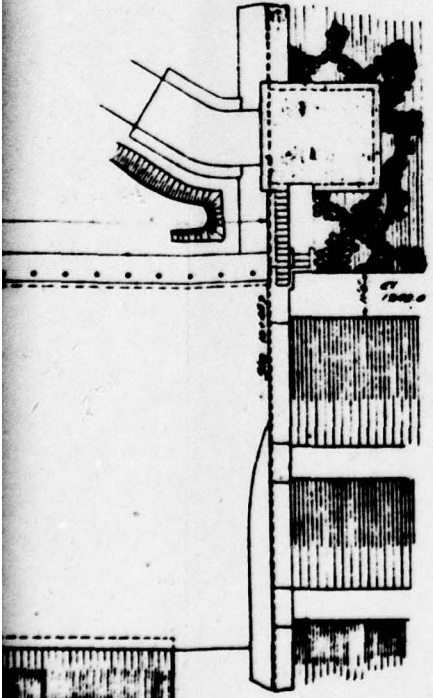
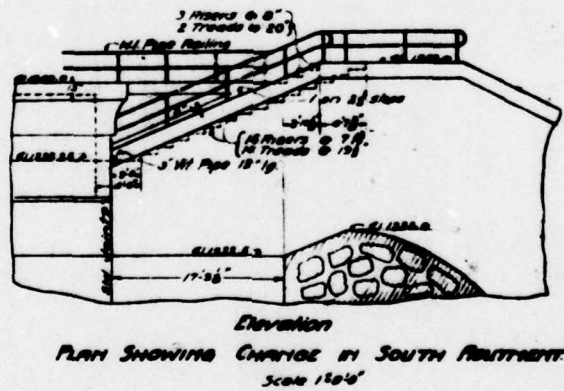
FIGURE 4
Contract No. 50.
 ALTERATION NO. 2
Erie Canal Section 5
REVISED DETAILS OF MASONRY & EARTH SECTIONS OF HINCKLEY DAM
 Scales as indicated

The earth embankment has a maximum structural height of about 48 feet, and is provided with a concrete core wall extending from 4 feet below the embankment crest into bedrock. The upstream slope of the embankment varies from 2.5:1 to 3.5:1 (horizontal to vertical), as shown on Figure 4. The downstream slope is 2:1, and is provided with two 8-foot wide benches.

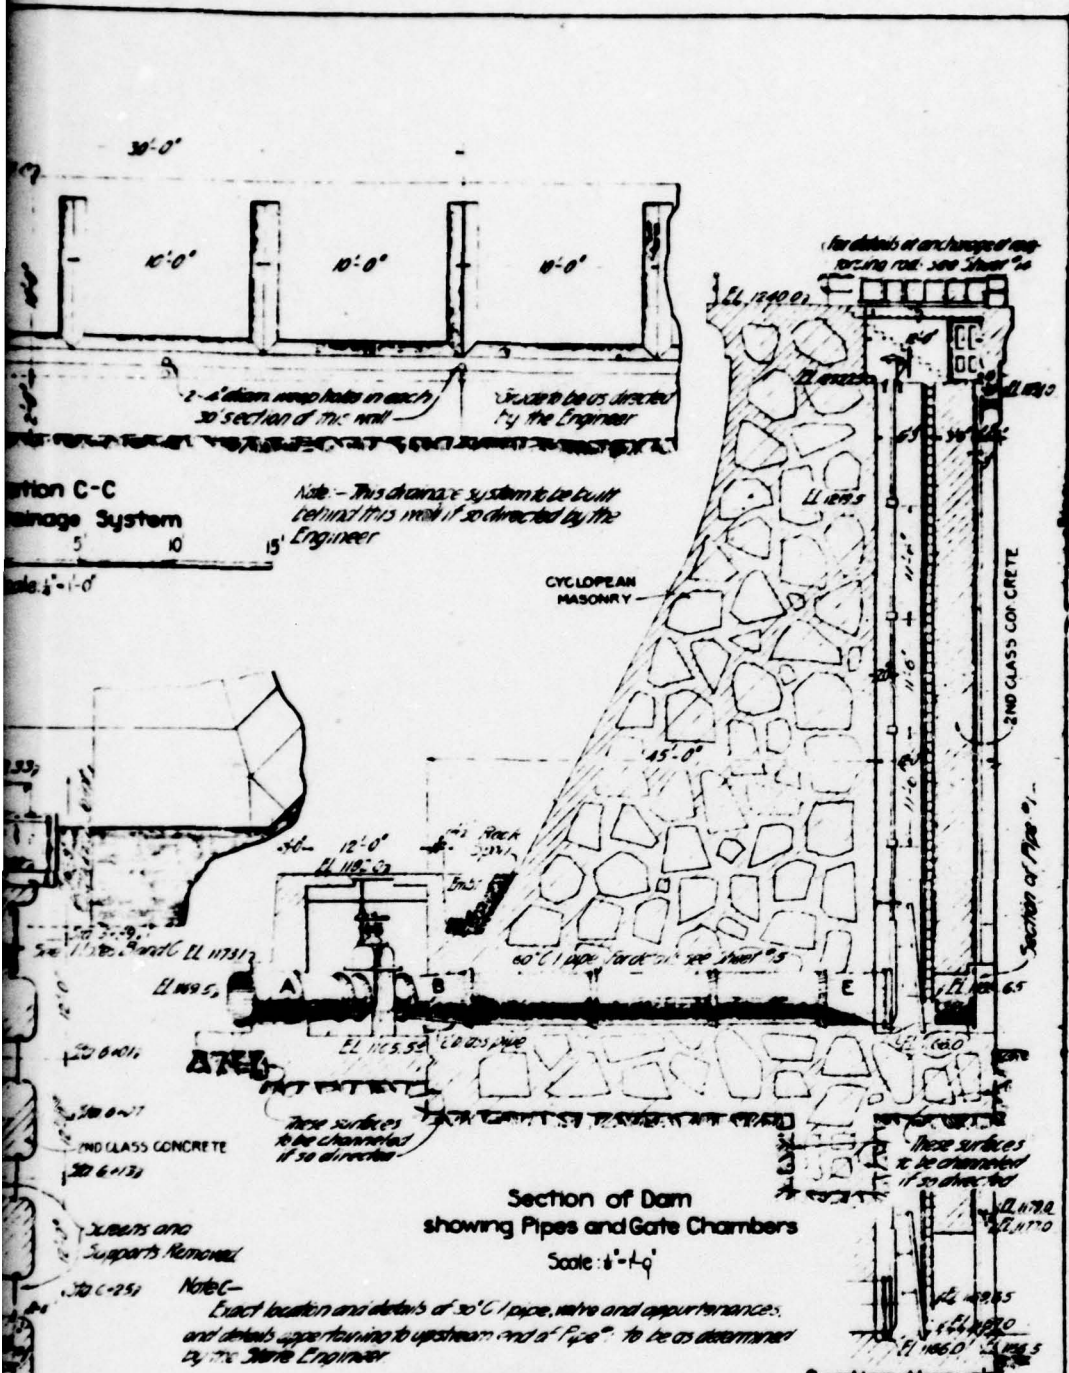
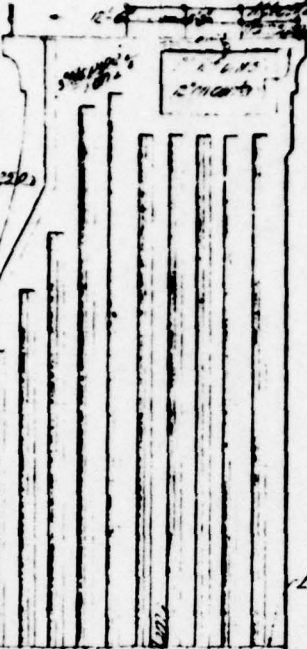
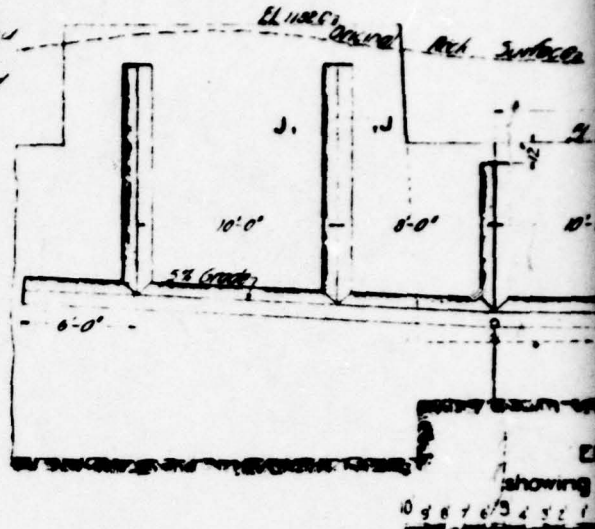
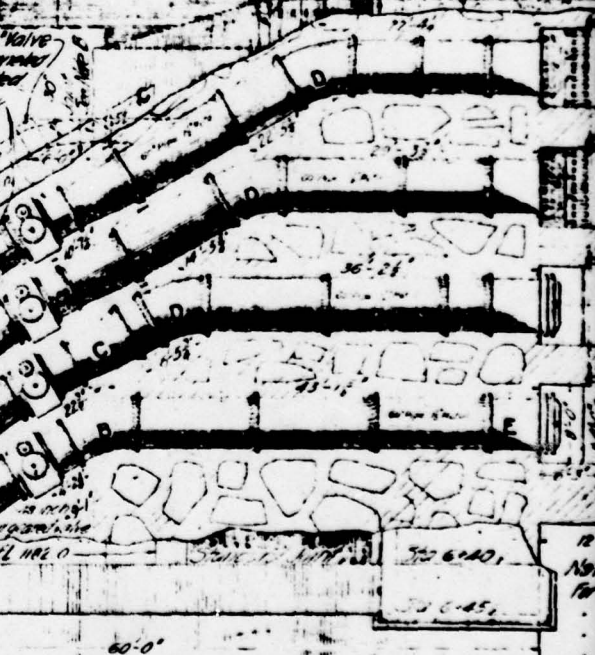
FIGURE 5
Contract No. 50.

The masonry non-overflow section is located to the north side of the spillway. The structure houses four 60 inch reservoir outlet pipes controlled by sluice gates at the upstream side of the structure. Operating assemblies for the sluice gates are located in a chamber at the top of the non-overflow section. The outlet pipes are also controlled by 48-inch spur-geared valves located in a gate chamber immediately downstream of the non-overflow section. Refer to Figure 5 for details of the outlet pipes, gates, and valves.
