Name Of Dam: UPPER NORTH RIVER NO. 76 (ELKHORN LAKE)

Location: AUGUSTA COUNTY, VIRGINIA

Inventory Number: VA. NO. 01506

PHASE I INSPECTION REPORT NATIONAL DAM SAFETY PROGRAM

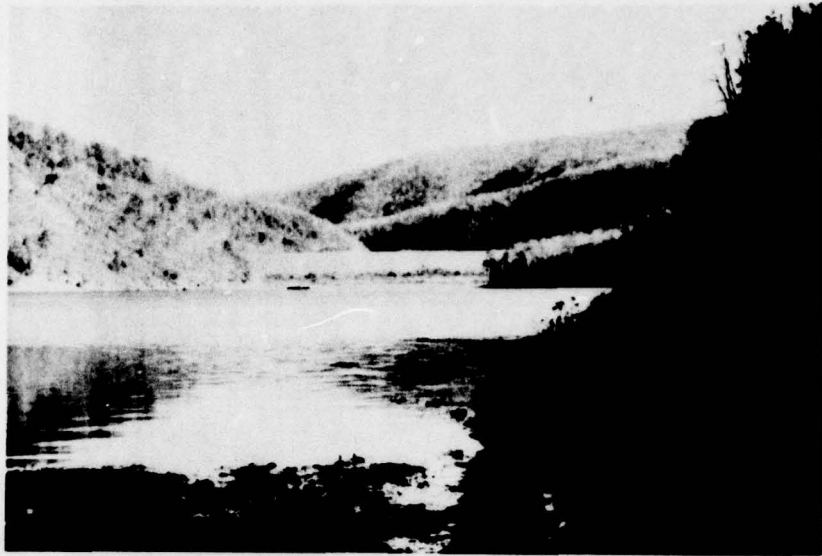
OVERALL VIEW - ELKHORN LAKE
(View from the West)
