LAKE PARSIPPANY DYKE

NO 1

NJ 00356

PHASE 1 INSPECTION REPORT
NATIONAL DAM SAFETY PROGRAM

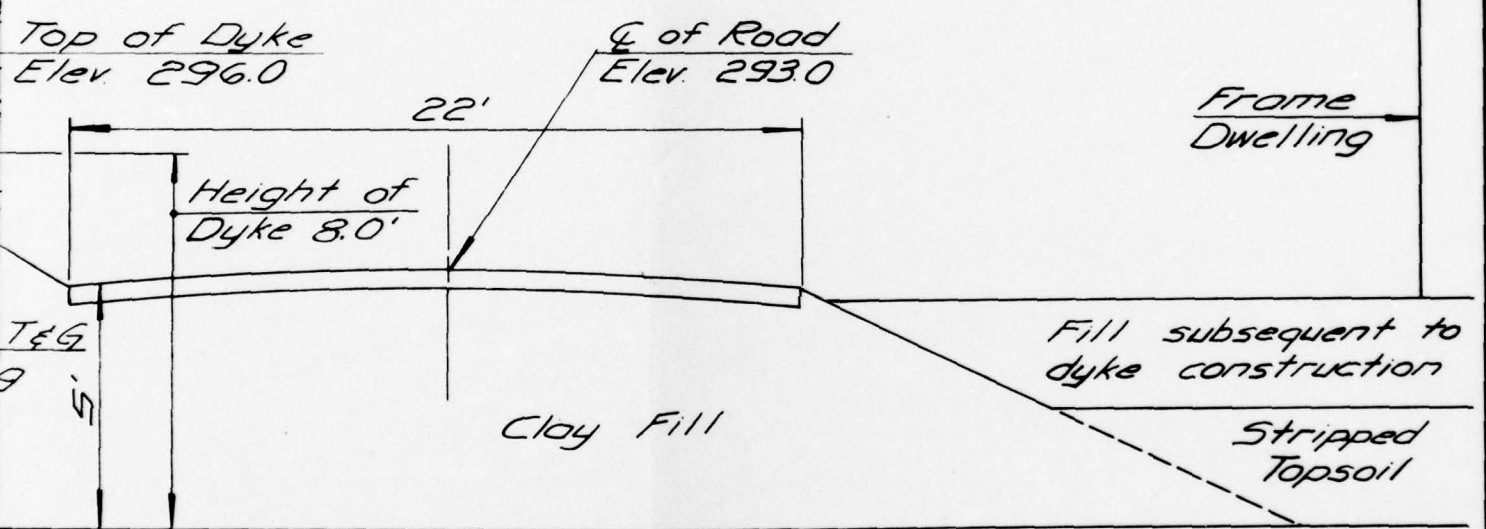
PLATE 5

Note: Information taken from
plans prepared by C.W. Wickstorm
dated Jan. 6, 1933 and field
inspection April 23, 1979.

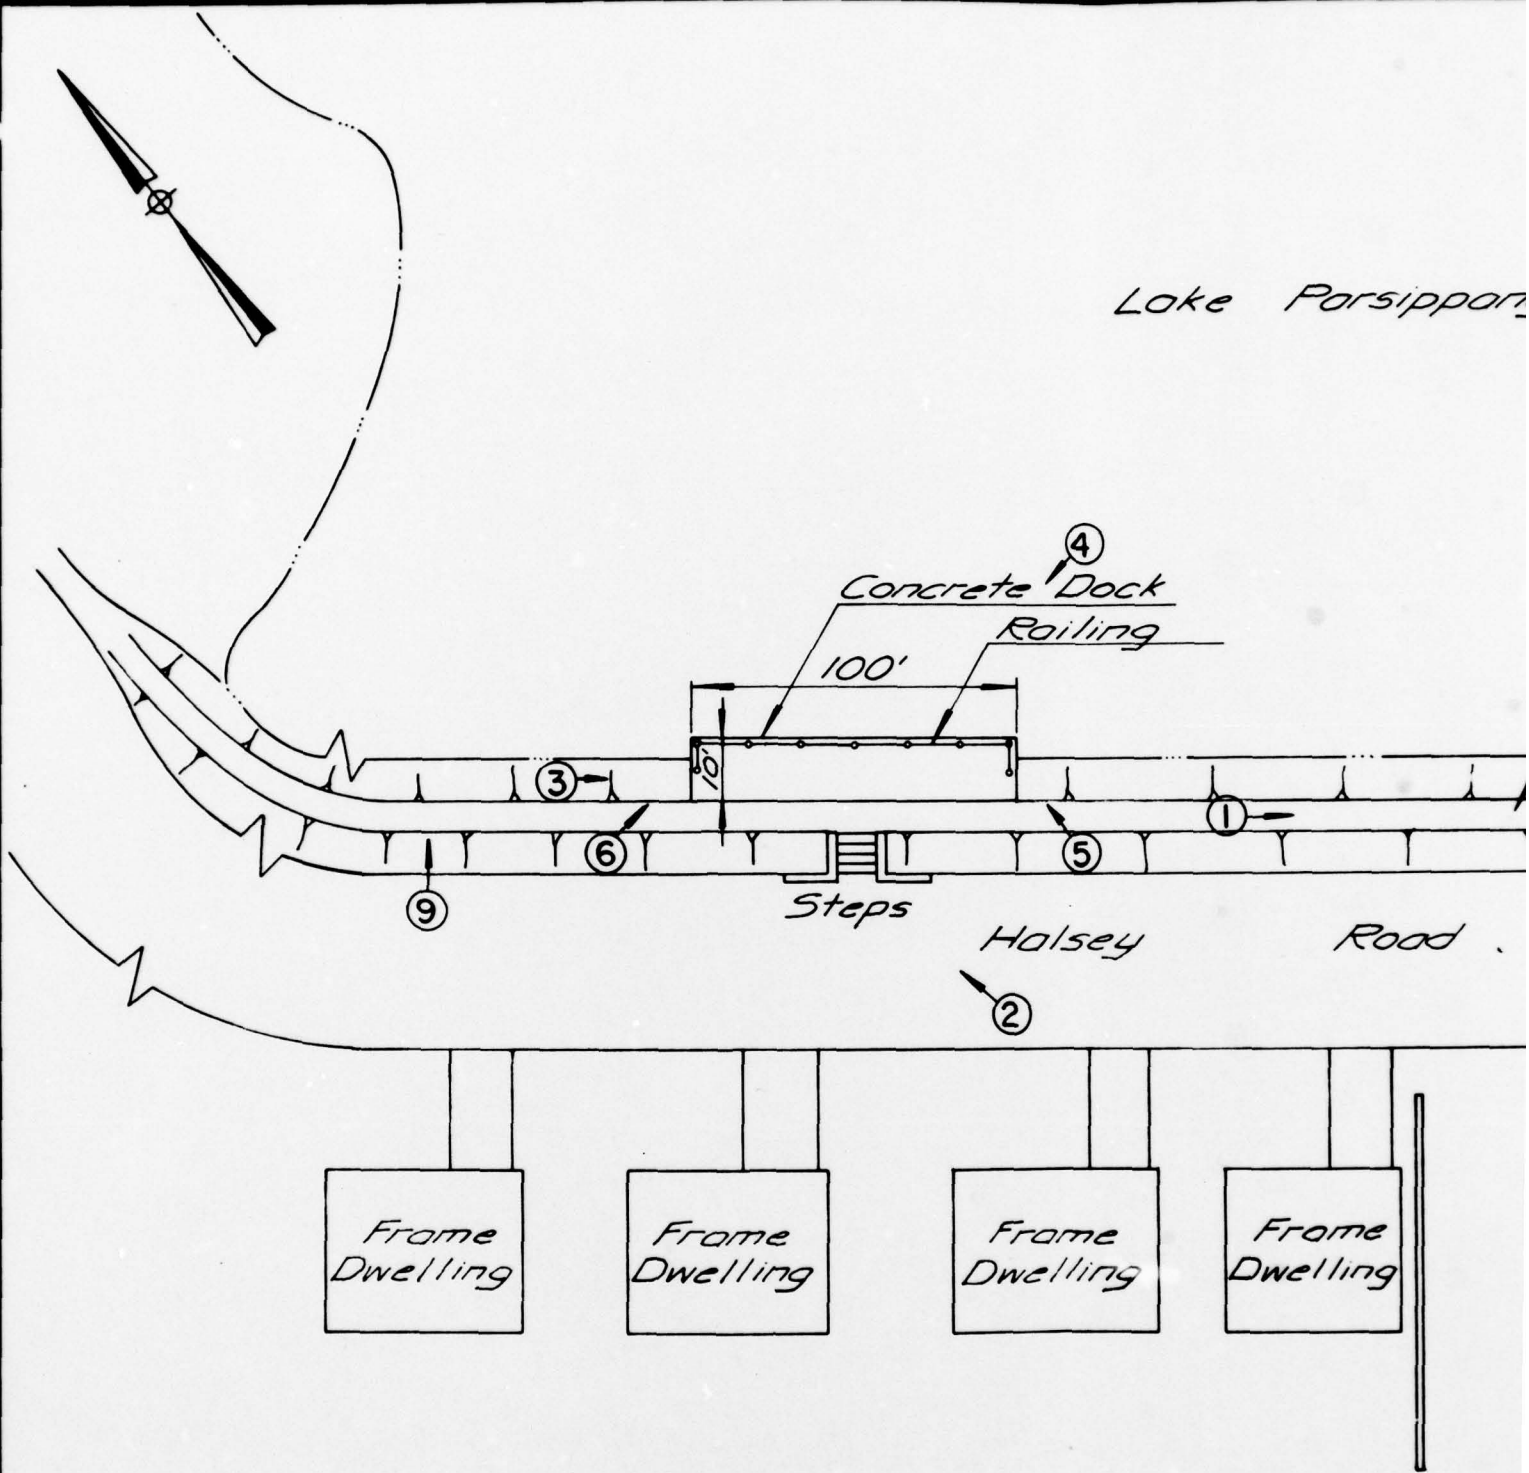
Note: Information taken from field inspection April 23, 1979.
