PASSAIC RIVER BASIN
EASTMANS BROOK, MORRIS COUNTY
NEW JERSEY

LAKE PARSIPPANY DAM
NJ 00355

PHASE 1 INSPECTION REPORT
NATIONAL DAM SAFETY PROGRAM

Lake Parsippany Dam (NJ-00355)
Passaic River Basin. Eastmans Brook,
Morris County, New Jersey. Phase 1
Inspection Report.

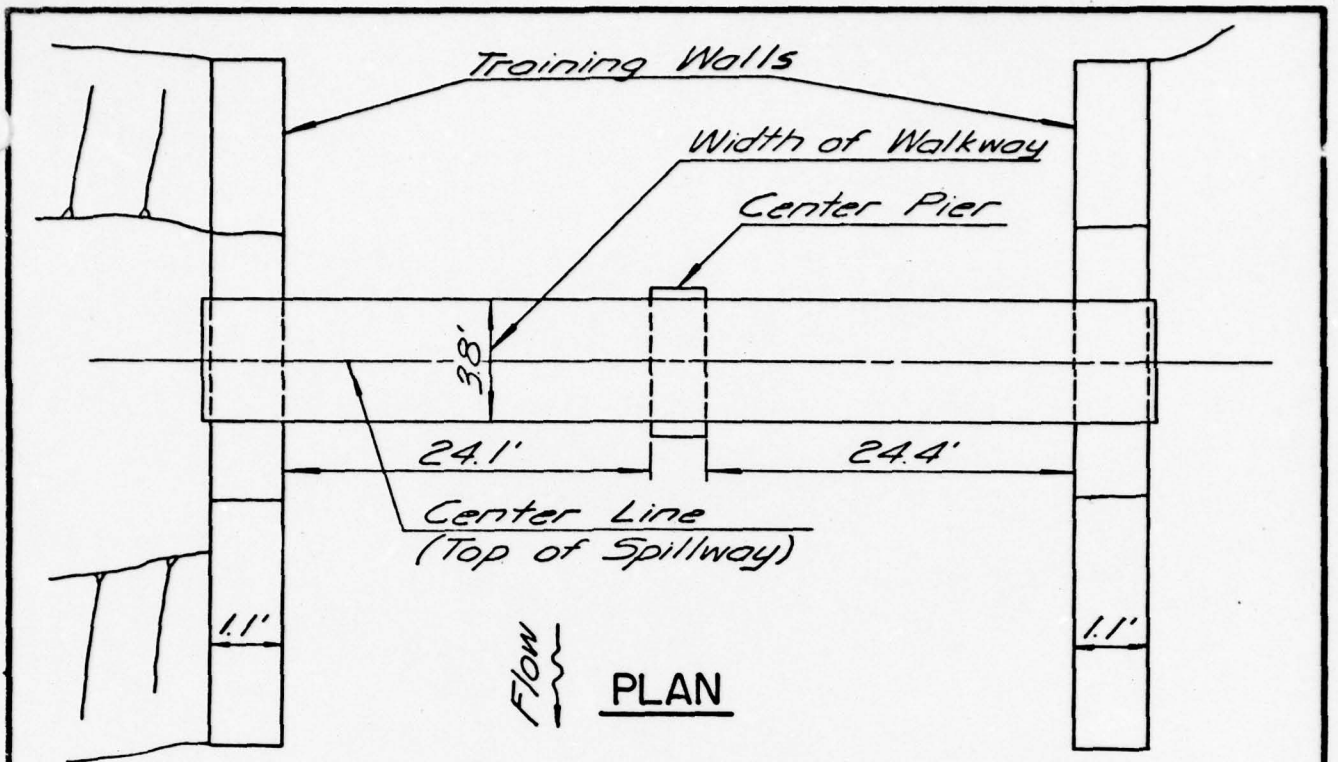
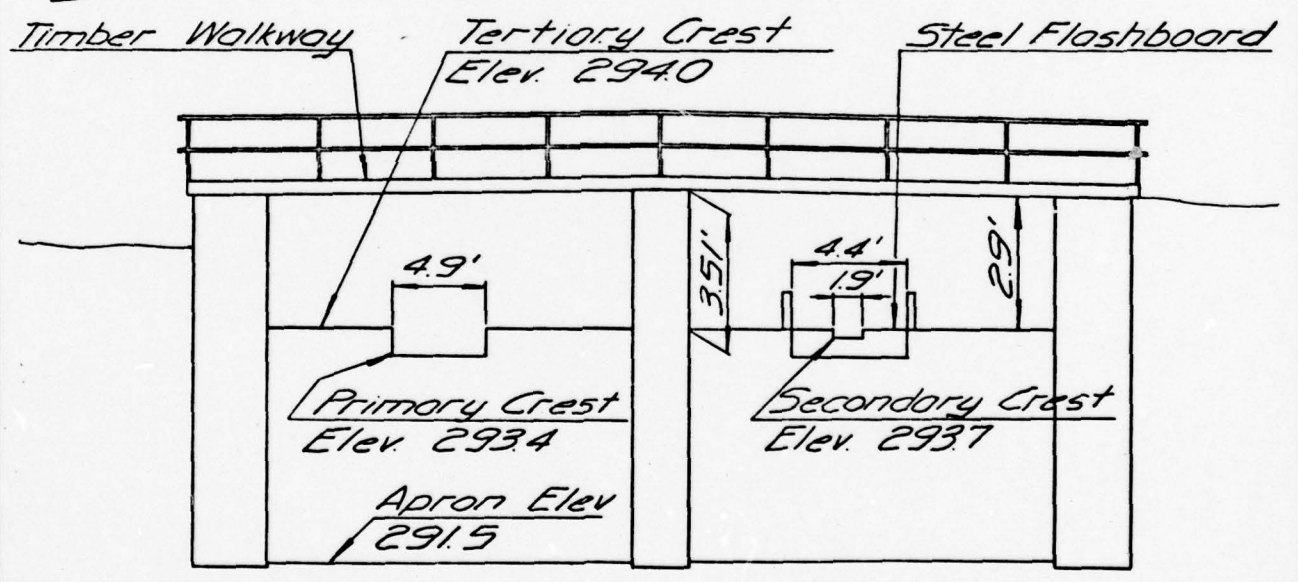
PLATE 5

The spillway, wingwalls and apron surface are in deteriorated condition. In the near future they should be thoroughly inspected and renovated by sand blasting, patching, grouting and coating with epoxy.

(4) The deteriorated concrete spillway, wingwalls and apron surface should be thoroughly inspected and repaired.

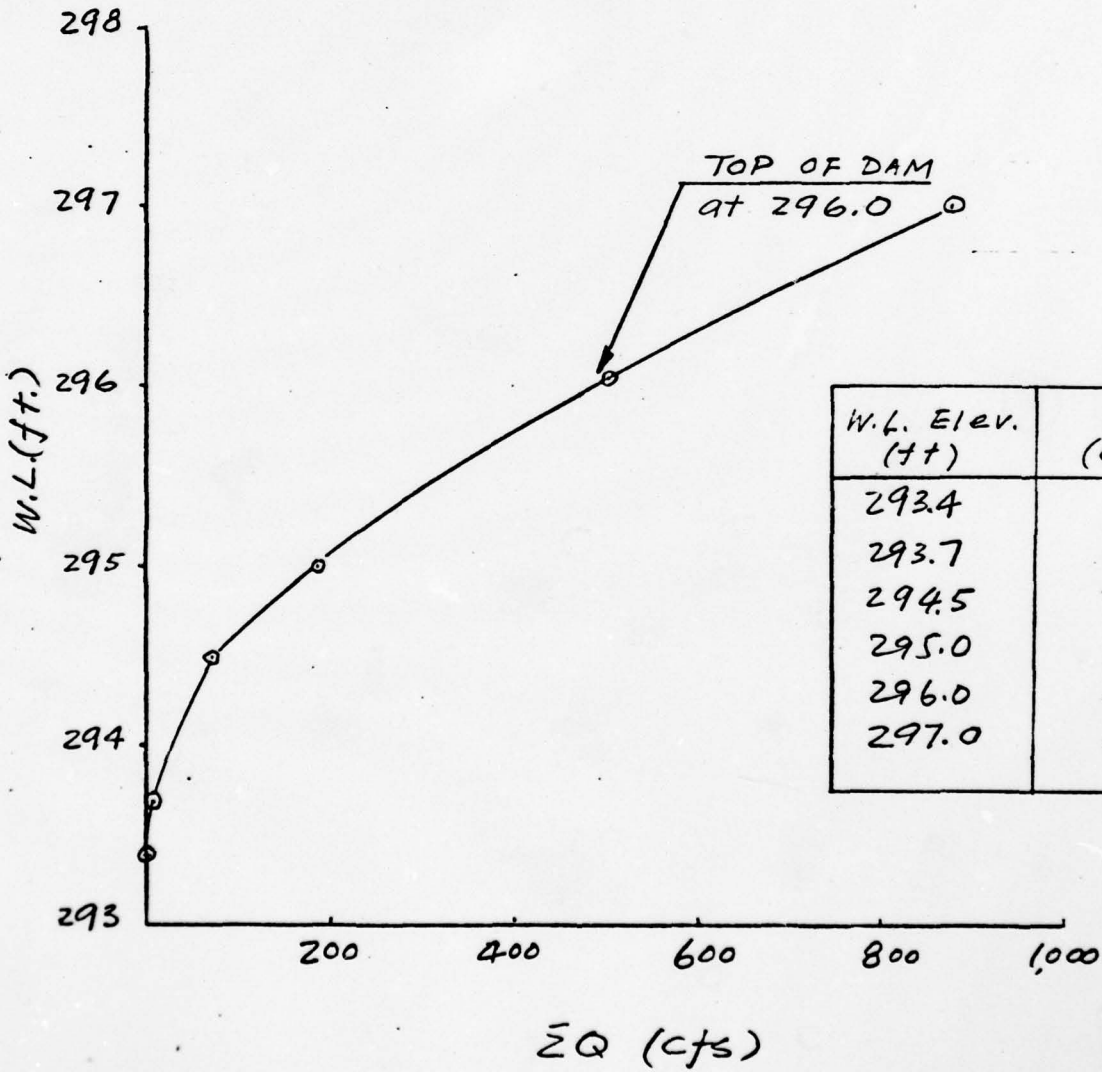
Stage-Discharge Curve

W.L. Elev. (ft)	Q (cfs)
293.4	0
293.7	3
294.5	77
295.0	193
296.0	514
297.0	870

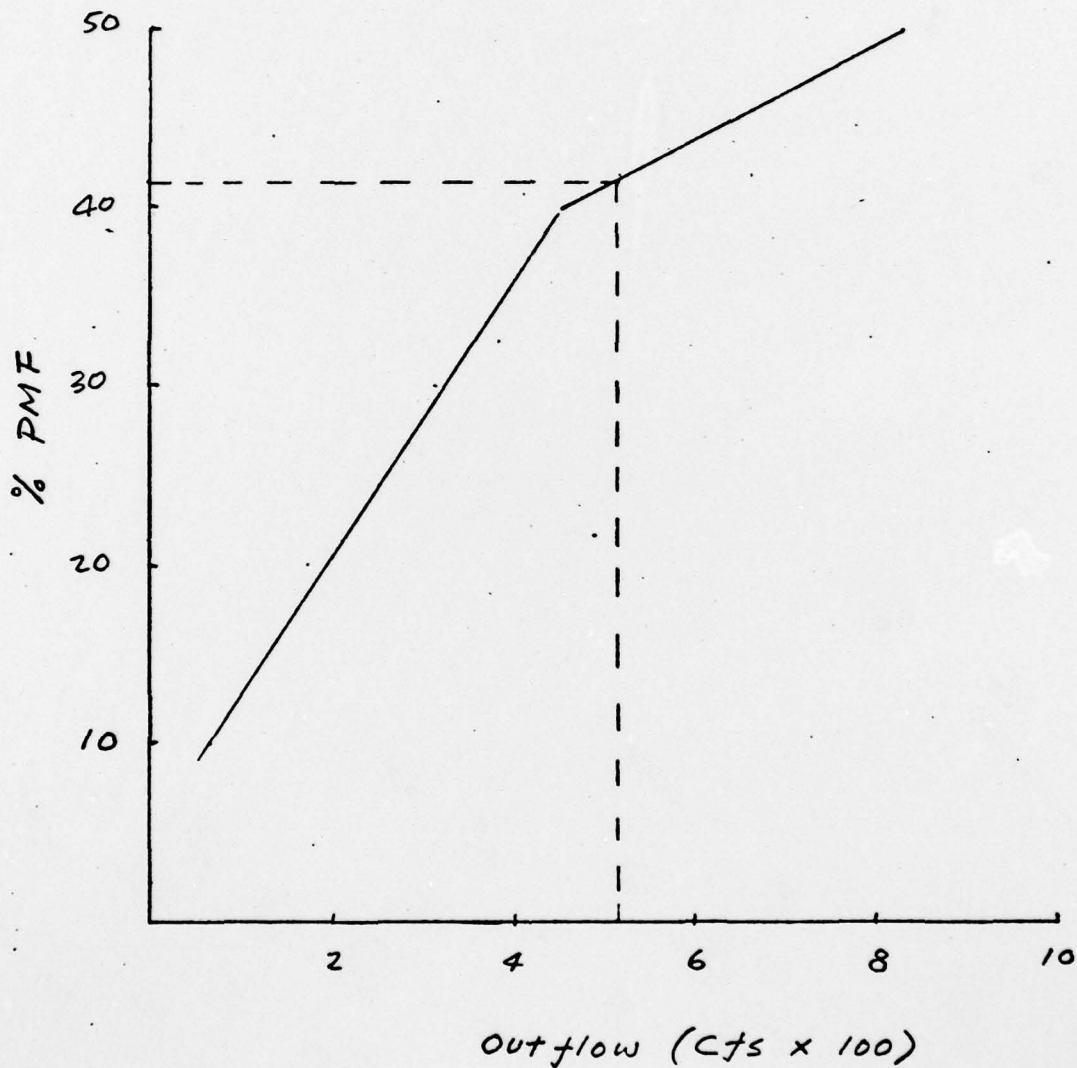
Overtopping Potential

Overtopping occurs at elev. 296 with $Q = 514 \text{ cfs}$

\therefore Dam can pass approximately 41.5 % PMF
