# COOL SPRINGS RESERVOIR DAM DE 00014

## PHASE 1 INSPECTION REPORT NATIONAL DAM SAFETY PROGRAM

Cool Springs Reservoir Dam (DE-00014),  
Delaware River Basin, Brandywine Creek,  
New Castle County, Delaware. Phase 1  
Inspection Report.

O'BRIEN & GERE ENGINEERS, INC.  
JUSTIN & COURTNEY DIVISION

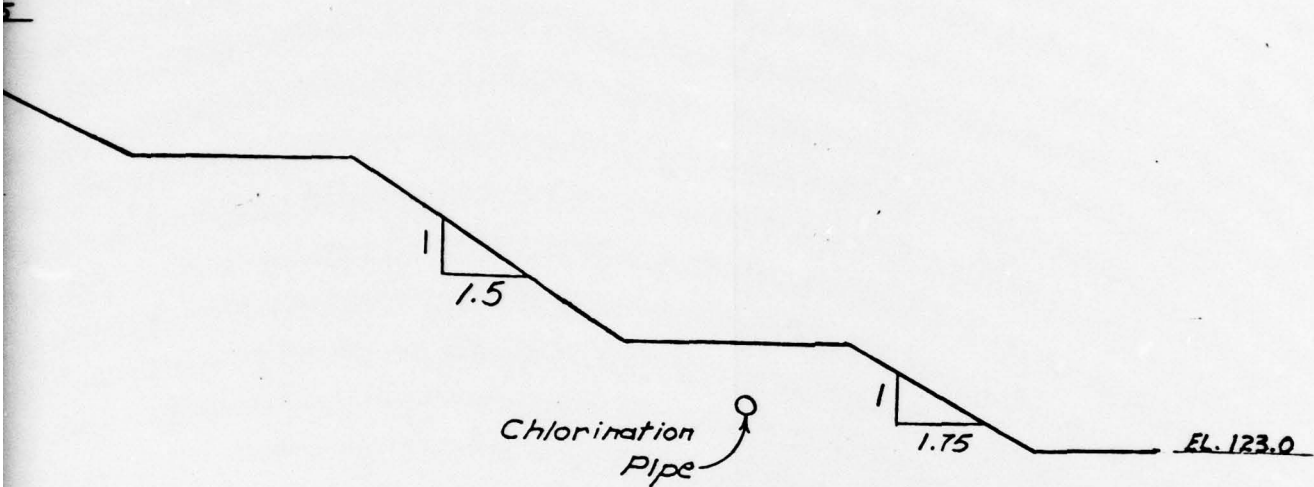
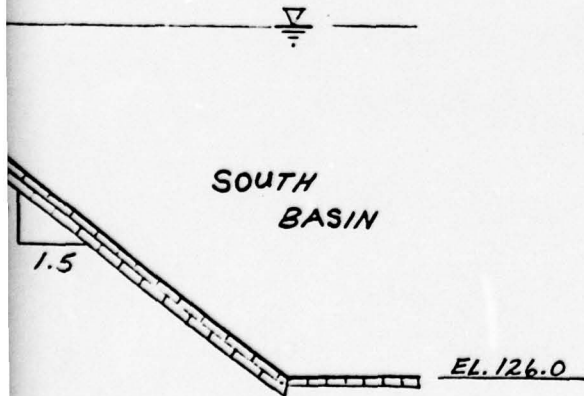
PLATE 3  
 COOL SPRING RESERVOIR  
 EMBANKMENT SECTIONS  
 WILMINGTON, DE

The dam consists of an earth embankment approximately 1,468 feet long with a maximum height of 23.5 feet. The interior slope is 1.5H:1V and the crest width is 17 feet. The 10th Street embankment slope is 1.5H:1V and is supported by a stone masonry retaining wall as shown on Plate 3, Appendix E. The embankment length along 10th Street is about 288 feet and has a maximum height of about 14 feet at the southeast corner of the reservoir. The exterior embankment slope parallel to Van Buren Street varies from 1.5H:1V to 2.H:1V and is provided with two 12 foot wide berms as shown on Plate 3. This portion of the dam has a length of about 690 feet and has a maximum height of 23.5 feet. The northern exterior slope is 1.5H:1V, has a length of 490 feet and a maximum height of about 18 feet at the northeast corner of the reservoir.

(3) The stone masonry retaining wall supporting the 10th street slope should be repointed and the missing stone blocks replaced to maintain the wall's structural integrity. According to the Owner's representative, this work is presently under way.
