DELAWARE RIVER BASIN
MUSCONETCONG RIVER,
MORRIS & SUSSEX COUNTIES
NEW JERSEY

LAKE WATERLOO DAM NJ 00276

6 PHASE 1 INSPECTION REPORT NATIONAL DAM SAFETY PROGRAM.

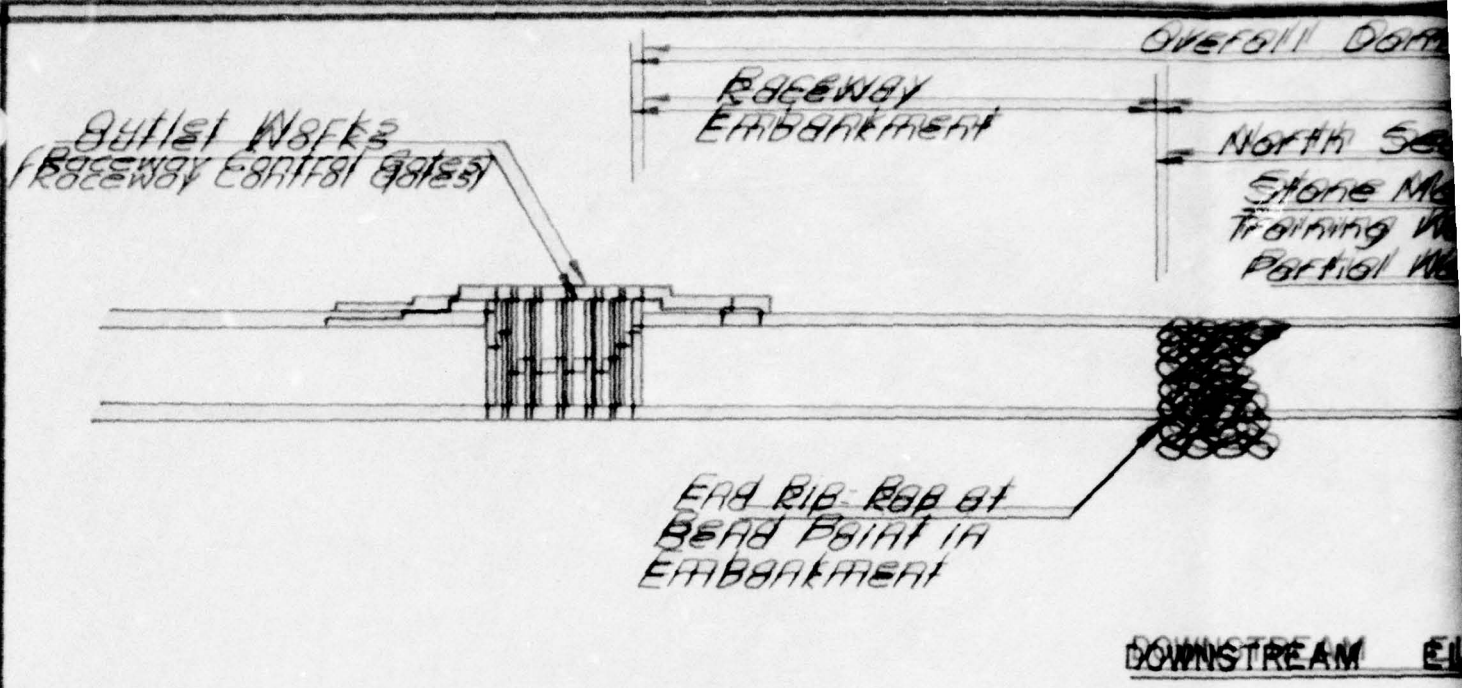
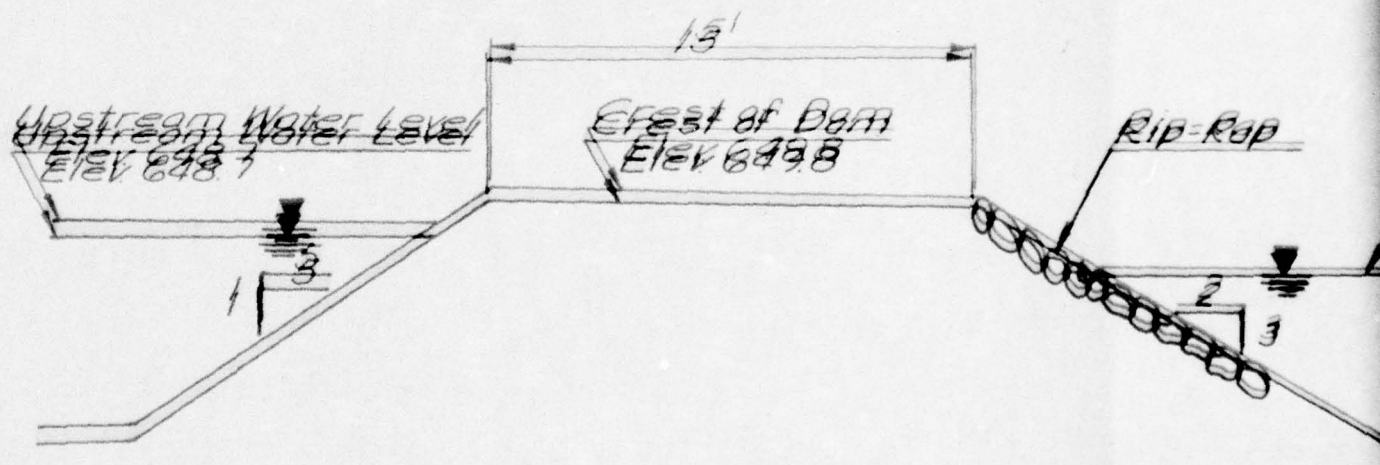
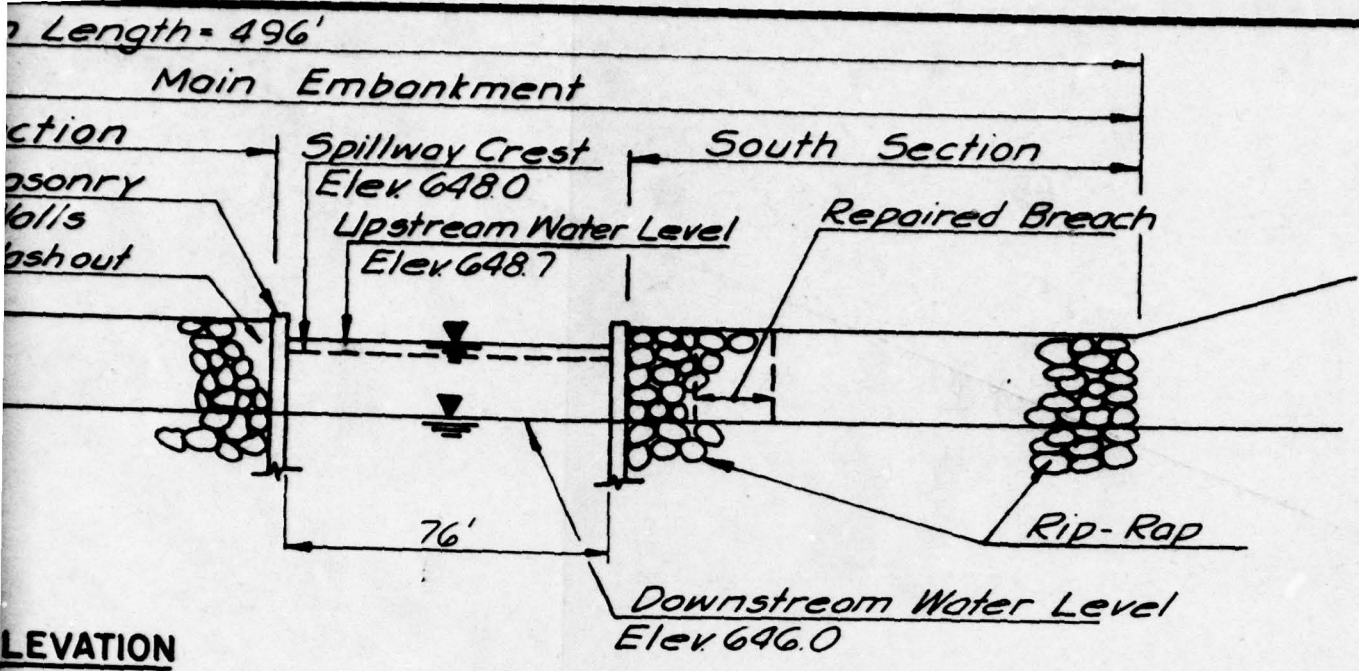
PLATE 5

DAM SECTION

ELEVATION

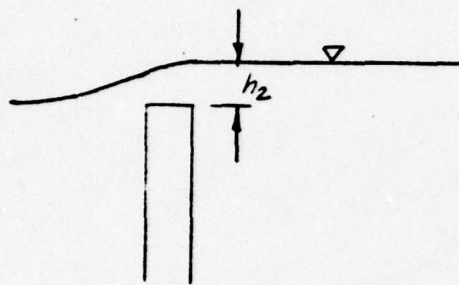
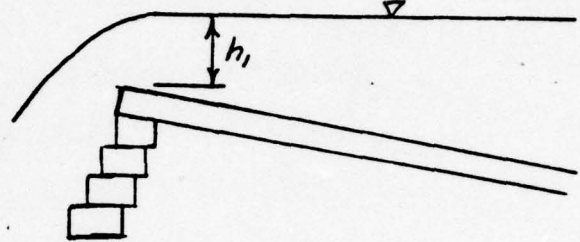
SpillwaySECTIONS

Discharge coefficients are taken from King, Handbook of Hydraulics. The spillway is assumed to be a weir with inclined upstream face. The average discharge coefficient, C_1 , is 2.93. The outlet works is assumed to be a sharp crested weir with average discharge coefficient, C_2 , of 3.2.
