HUDSON RIVER BASIN
BLACK CREEK TRIBUTARY, SUSSEX COUNTY
NEW JERSEY

NJ NO NAME DAM

NO 20

PHASE 1 INSPECTION REPORT
NATIONAL DAM SAFETY PROGRAM

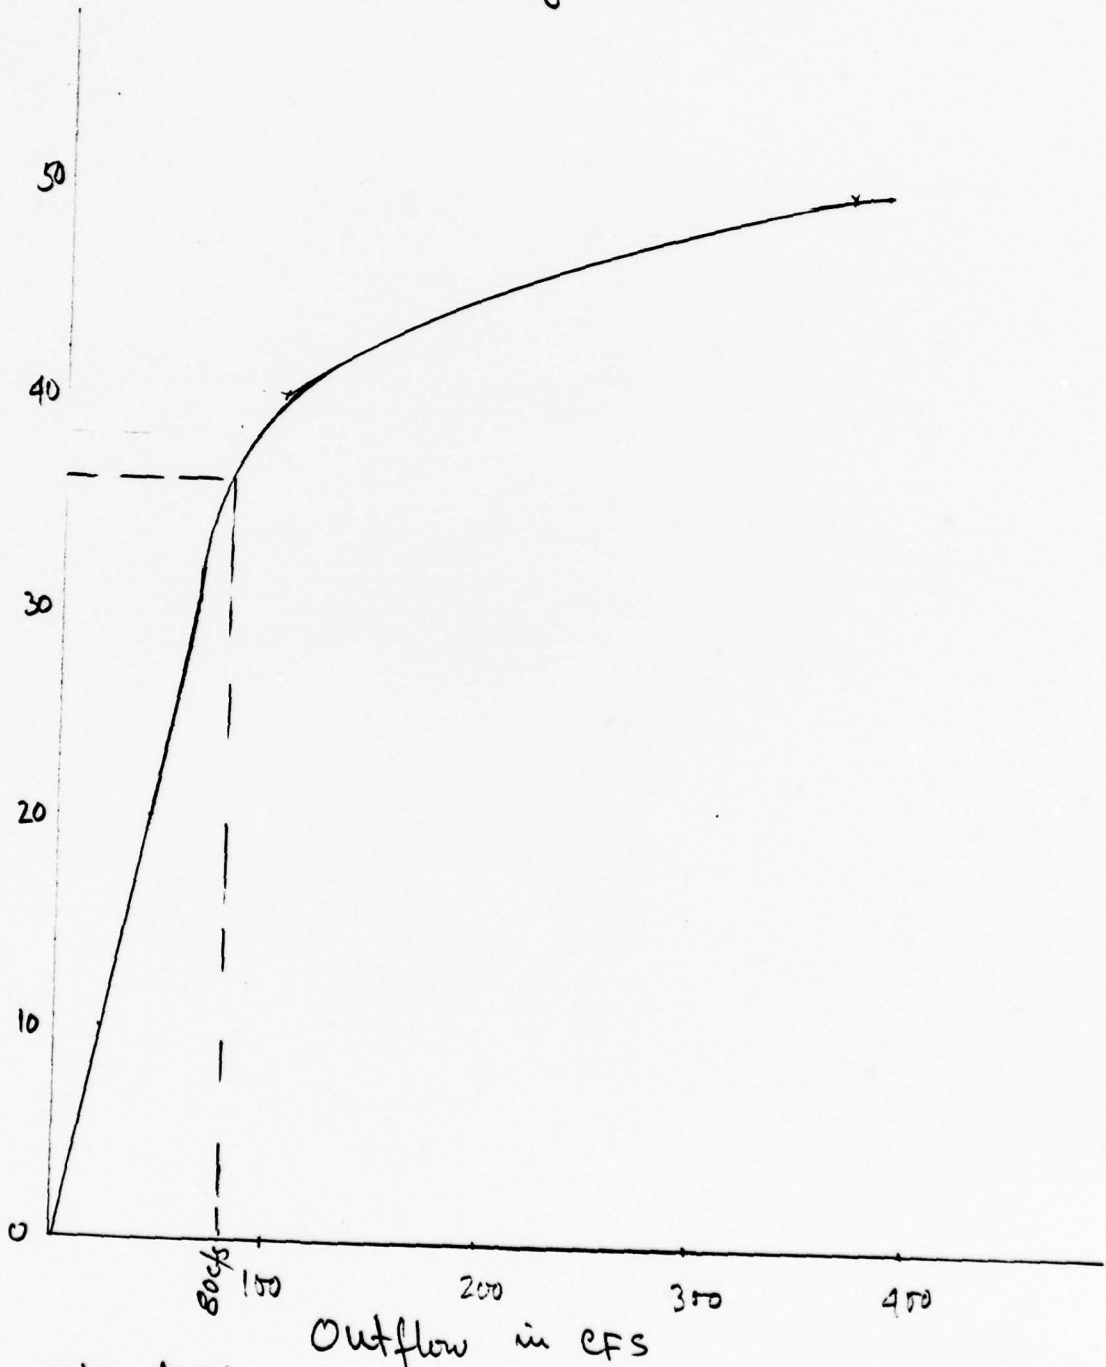
Overtopping Potential

Overtopping of Dam occurs at EL 562.95
 $Q = 80 \text{ cfs}$ (36% of PMF)

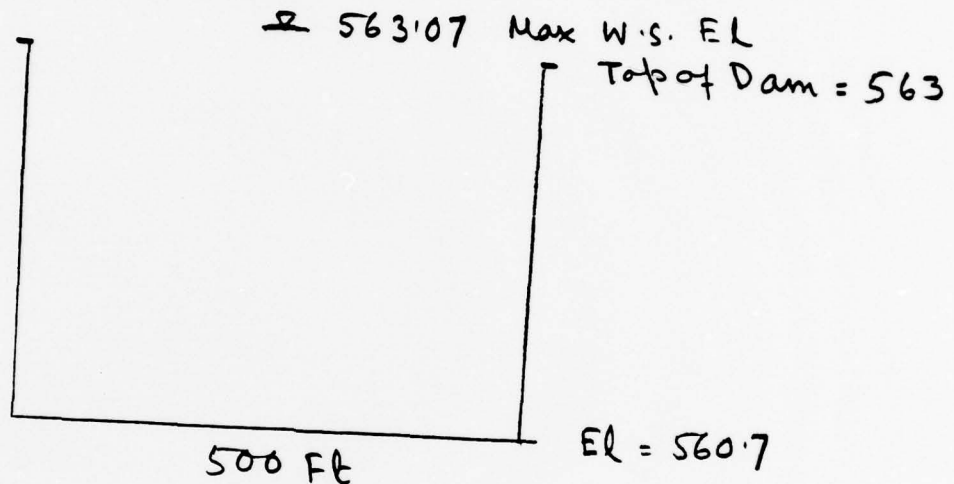
Breach Analysis

Effect of breach was analysed 2,000 ft
Downstream of the Dam.

Max. Stage without Dam break = 472.7
Max. Stage with Dam break = 474.7
