PASSAIC RIVER BASIN  
MILL BROOK, MORRIS COUNTY  
NEW JERSEY

**DALRYMPLE POND DAM**  
**NJ 00350**

**PHASE 1 INSPECTION REPORT**  
**NATIONAL DAM SAFETY PROGRAM.**

30 APRIL 1979

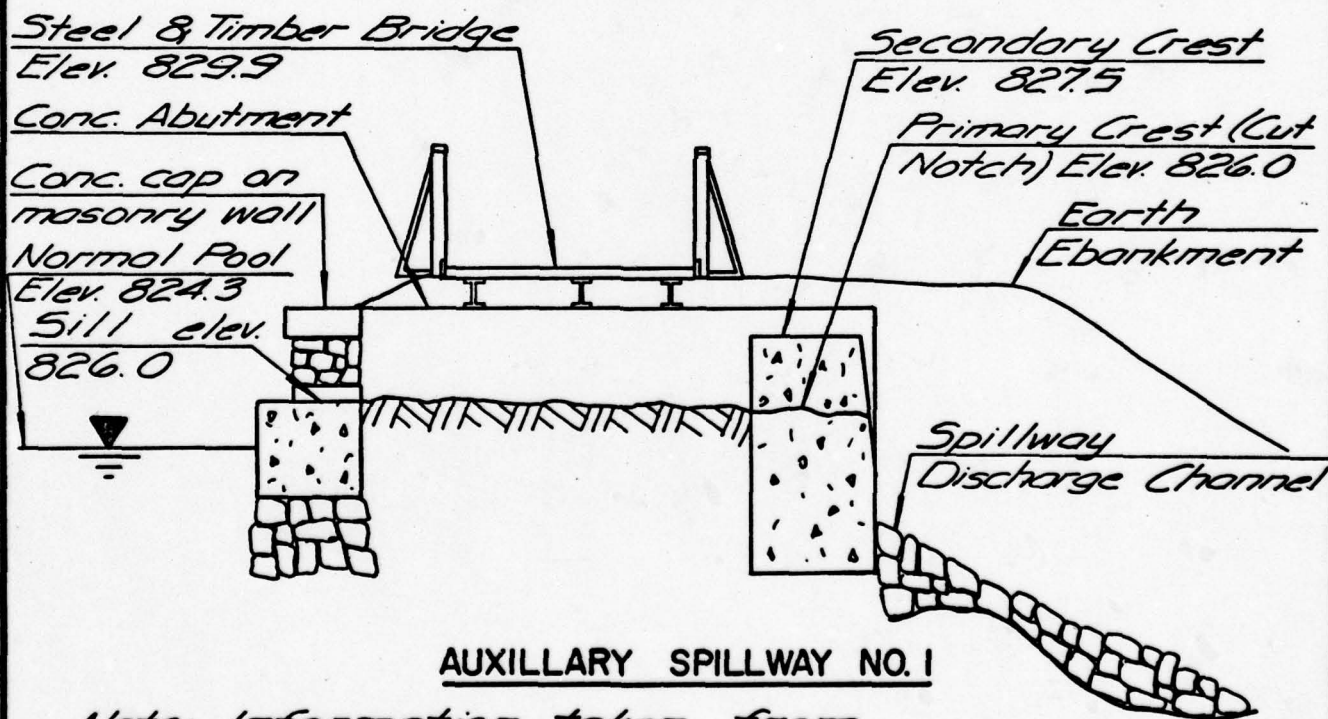
AUXILLARY SPILLWAY NO. 1

Auxiliary Spillway No. 1 is in a deteriorated condition. The concrete weir should be thoroughly renovated by patching, grouting and coating with an epoxy sealant. The junction between the dam and the discharge channel for Auxiliary Spillway No. 1 should be protected from erosion in the near future by the construction of training walls.
