NEW YORK STATE DEPT OF ENVIRONMENTAL CONSERVATION ALBANY F/G 13/2  
NATIONAL DAM SAFETY PROGRAM. LOCK 3 DAM AT MECHANICVILLE (INVEN--ETC(U)  
JUN 79 G KOCH DACW51-79-C-0001

REPORT DOCUMENTATION PAGE		READ INSTRUCTIONS BEFORE COMPLETING FORM
1. REPORT NUMBER	2. GOVT ACCESSION NO.	3. RECIPIENT'S CATALOG NUMBER
4. TITLE (and Subtitle) Phase I Inspection Report Lock 3 Dam at Mechanicville Upper Hudson River Basin Rensselaer-Saratoga Co. Inventory No. NY 215		5. TYPE OF REPORT & PERIOD COVERED Phase I Inspection Report National Dam Safety Program

PHASE 1 INSPECTION REPORT  
NATIONAL DAM SAFETY PROGRAM  
LOCK 3 DAM @ MECHANICVILLE  
I.D. No. NY - 215  
(#119 - UH)  
UPPER HUDSON RIVER BASIN  
RENSSELAER - SARATOGA COUNTY, NEW YORK

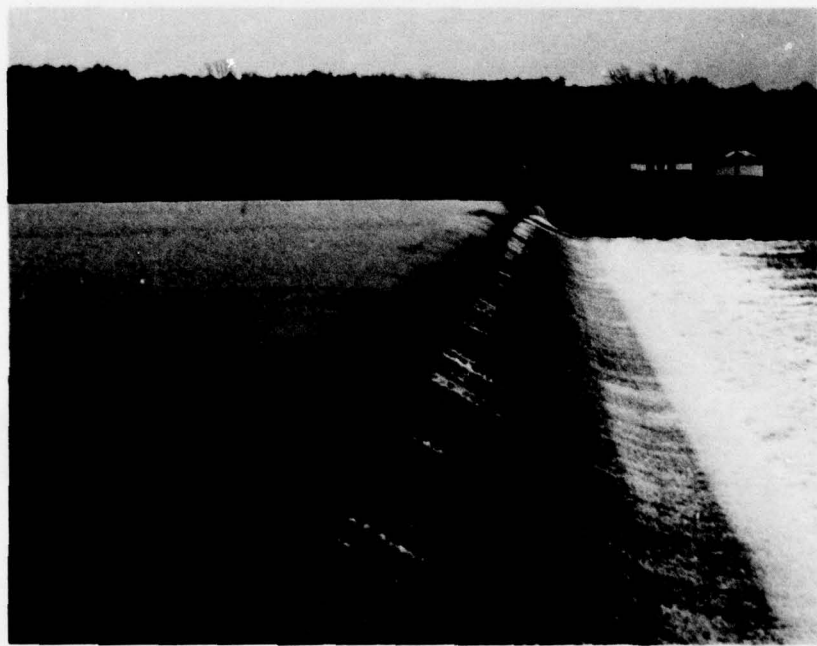
LOCK 3 DAM @ MECHANICVILLE  
(Looking East)

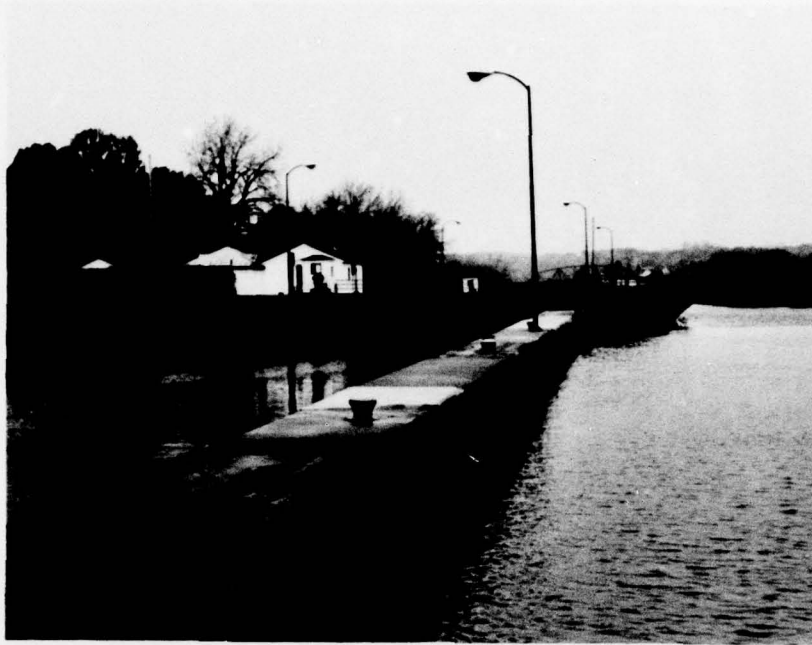
UPSTREAM APPROACH TO LOCK 3
