DELAWARE RIVER BASIN  
RACCOON CREEK, GLOUCESTER COUNTY  
NEW JERSEY

# LAKE GILMAN DAM

## NJ 00431

### PHASE 1 INSPECTION REPORT NATIONAL DAM SAFETY PROGRAM

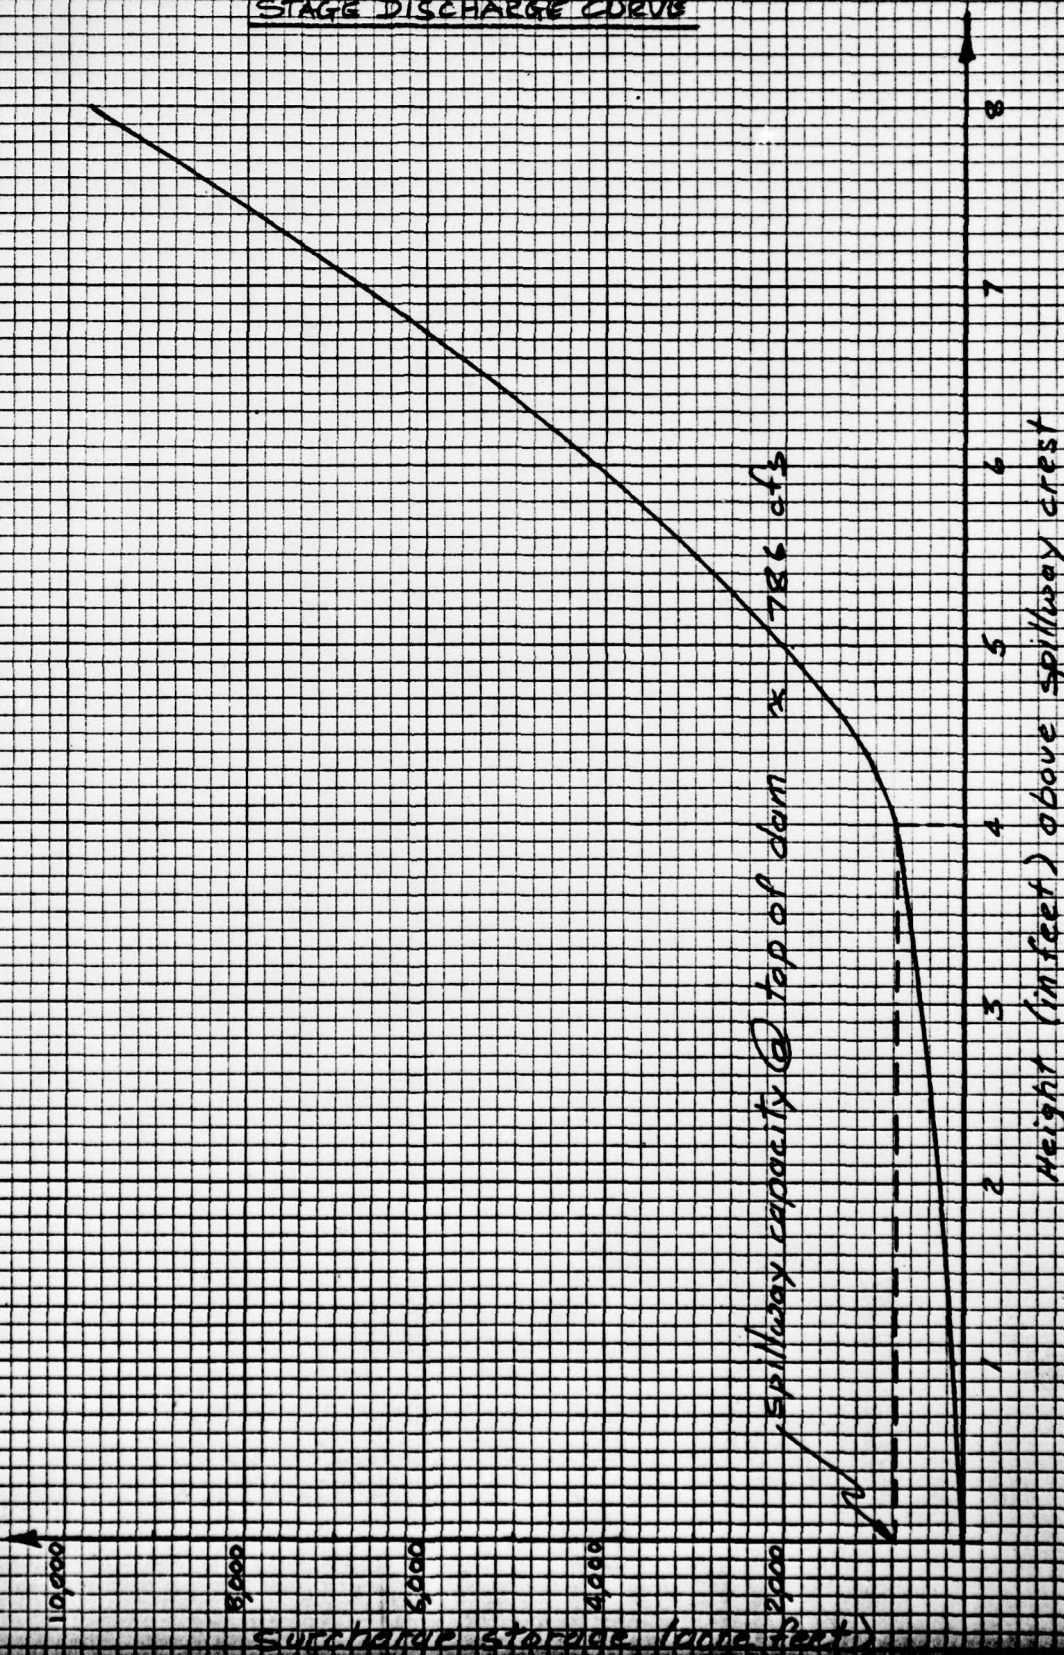
LAKE GILMAN DAM  
STAGE DISCHARGE CURVE

NOTE: The spillway is a drop inlet structure open on three sides. However the front has a gate structure which would reduce the hydraulic capacity as the water rises, thus the coefficient of discharge is reduced in the above calculation.
