# PHASE I INSPECTION REPORT

## NATIONAL DAM SAFETY PROGRAM

COLEMAN FALLS DAM  
AMHERST COUNTY, VIRGINIA  
INVENTORY NO. 05918

Name of Dam: Coleman Falls Dam  
State: Virginia  
County: Amherst County  
USGS Quad Sheet: Big Island, Virginia  
Stream: James River  
Date of Inspection: July 12, 1979

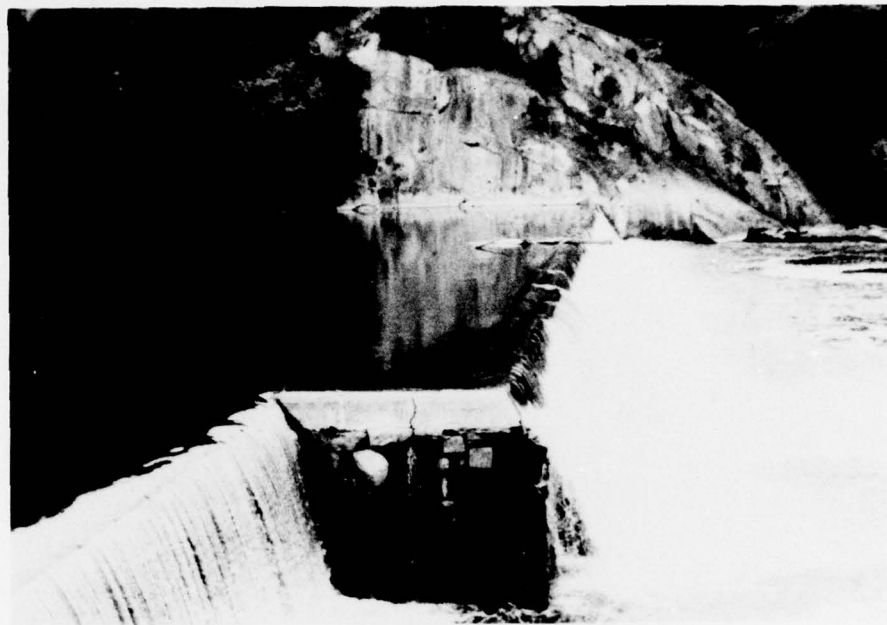
PHOTOGRAPH NO. 1  
Overview

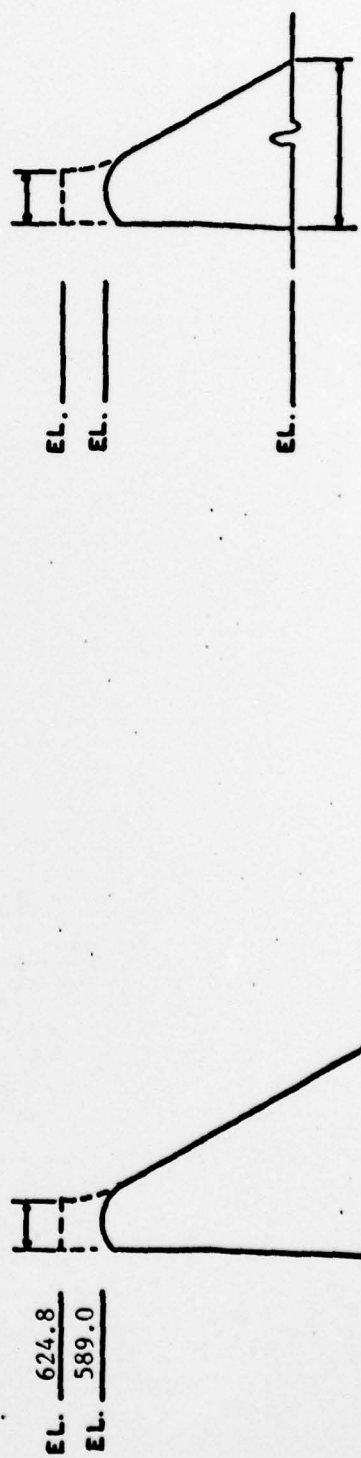
PARTIAL SECTION

LOADING CASE	ELEV. HEAD WATER	ELEV. TAIL WATER	ΣV	ΣH	ΣH / ΣV	LOCATION RESULTANT FROM TOE	% BASE IN COMPRESSION	FACTOR SAFETY SLIDING	FOUNDATION PRESSURE	
									TOE	HEEL
NORMAL POOL	589.0	572.0	33.3 <sup>k</sup>	12.2 <sup>k</sup>	0.37	7.9'			2.8 <sup>k</sup> sf	0.1 <sup>k</sup> sf
1/2 PMF	624.8	617.0	25.6 <sup>k</sup>	25.7 <sup>k</sup>	1.0	7.7'			2.2	0

THIS ANALYSIS IS BASED ON THE ASSUMED GEOMETRIC CONFIGURATION SINCE NO DRAWINGS WERE AVAILABLE TO VERIFY THE DIMENSIONS OF THE DAM.
