# PHASE I INSPECTION REPORT

## NATIONAL DAM SAFETY PROGRAM

AUGUST, 1979

SCOTTS MILL DAM  
CITY OF LYNCHBURG, VIRGINIA  
INVENTORY NO. VA 68001

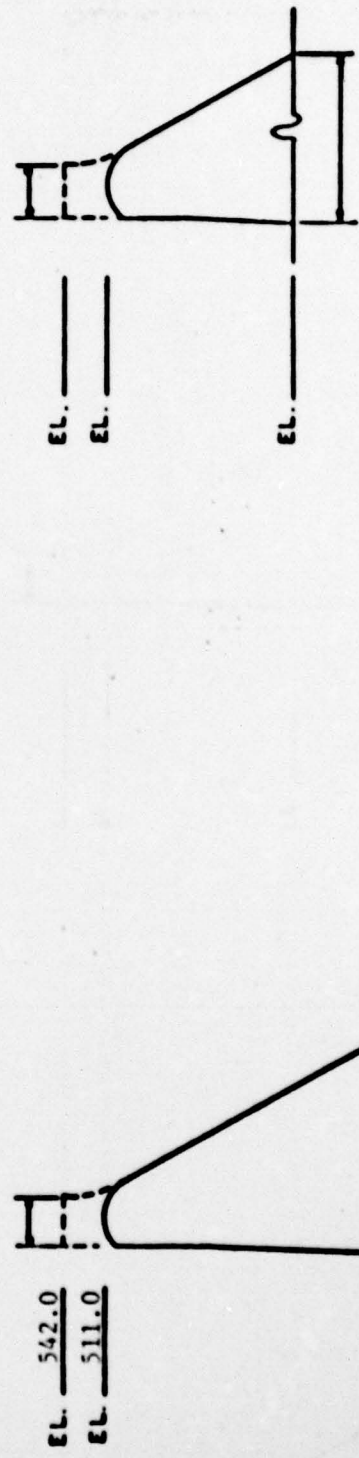
PARTIAL SECTION

LOADING CASE	ELEV. HEAD WATER	ELEV. TAIL WATER	ΣV	ΣM	ΣM ΣV	LOCATION RESULTANT IN FROM TOE	% BASE IN COMPRESSION	FACTOR SAFETY SLIDING	FOUNDATION PRESSURE	
									TOE	HEEL
NORMAL POOL	511.0	499.0	18.9 <sup>k</sup>	7.2 <sup>k</sup>	.42	6.1'			2.1 ksf	--
1/2 PMF	542.0	540.2	14.3 <sup>k</sup>	5.0 <sup>k</sup>	.35	6.3'			1.5 ksf	0.1 ksf
