Name Of Dam: GREGORY'S POND DAM  
Location: CHESTERFIELD COUNTY  
Inventory Number: VA. 04122

# PHASE I INSPECTION REPORT

## NATIONAL DAM SAFETY PROGRAM

GREGORY'S POND DAM  
CHESTERFIELD COUNTY, VIRGINIA  
INVENTORY NO. 04122

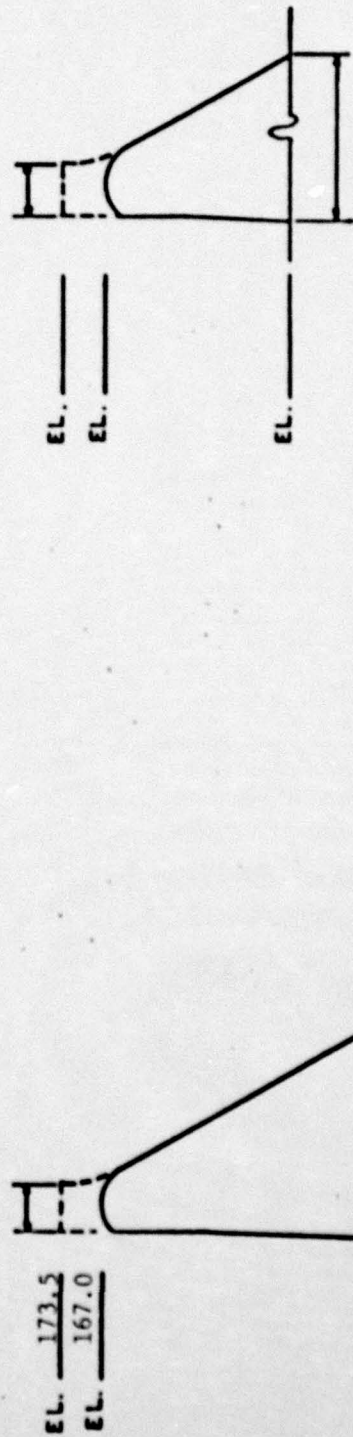
ANALYSIS DONE ON X FULL SECTION — PARTIAL SECTION  
LOCATION OF SECTION — CENTER OF SPILLWAY  
ANALYSIS PREPARED BY \_\_\_\_\_

LOADING CASE	ELEV. HEAD WATER	ELEV. TAIL WATER	$\Sigma V$	$\Sigma H$	$\frac{\Sigma H}{\Sigma V}$	LOCATION RESULTANT FROM TOE	% BASE IN COMPRESSION	FACTOR SAFETY SLIDING	FOUNDATION PRESSURE	
									TOE	HEEL
NORMAL POOL	167	155	10.08 <sup>k</sup>	4.5 <sup>k</sup>	0.45	4'			1.7	--
100-YEAR FLOOD	173.5	167	8.0 <sup>k</sup>	6.2 <sup>k</sup>	0.78	4'			1.3	--
