DELAWARE RIVER BASIN

ST. JOSEPHS LAKE DAM

SULLIVAN COUNTY, NEW YORK
INVENTORY No. NY 324

PHASE I INSPECTION REPORT
NATIONAL DAM SAFETY PROGRAM

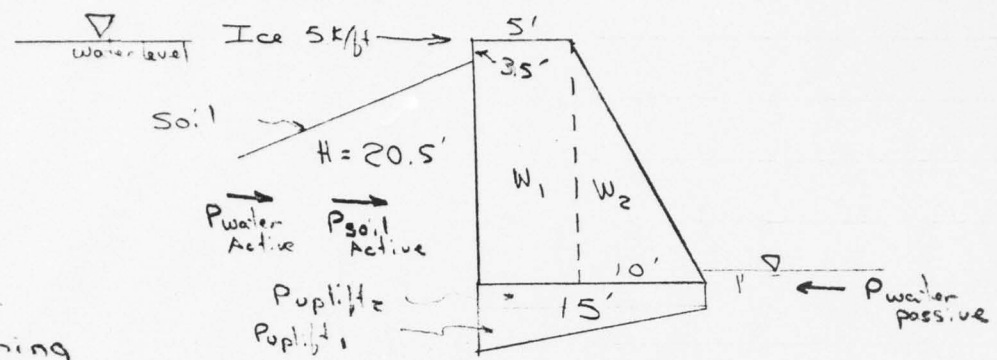
Stability Analysis
St. Josephs Dam

$$\text{F.S. Sliding} = .51$$

Since the dam has withstood these forces without failure (note low sliding factors of safety) the assumed geometry must be incorrect and this analysis invalid. Need More Info.
