DASHVILLE DAM

ULSTER COUNTY, NEW YORK

INVENTORY NO. N.Y. 76

**PHASE I INSPECTION REPORT
NATIONAL DAM SAFETY PROGRAM**

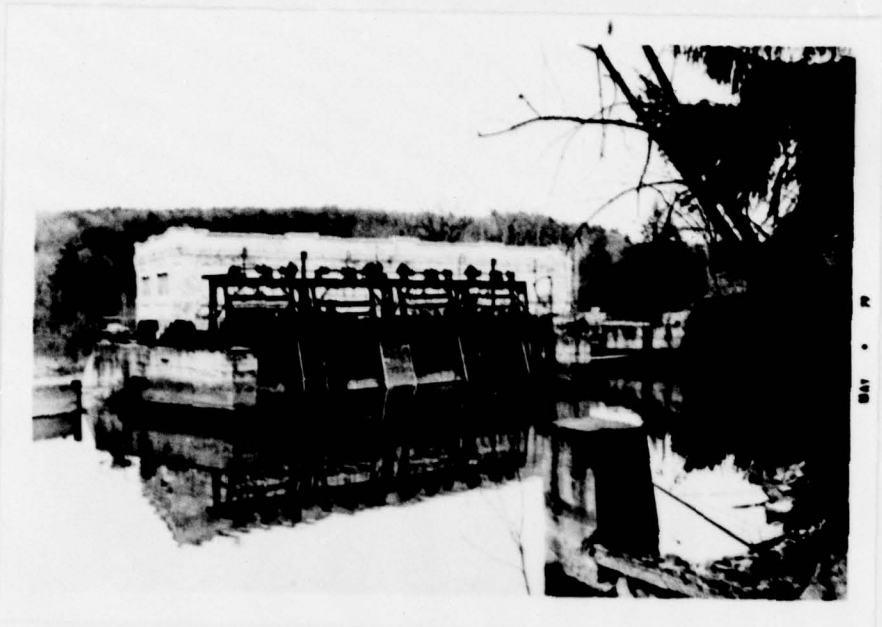
POWER STATION - UPSTREAM

Concrete surfaces on the powerhouse were spalling and deteriorated. The intake structure has been repaired several times in the past 50 years. At the time of the inspection, divers were repairing the trash racks.

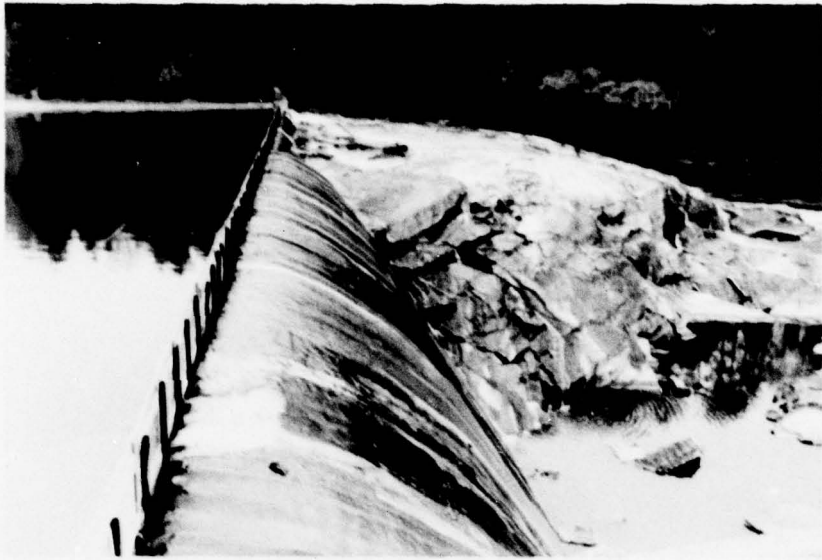
SPILLWAY - OGEE SECTION

Water flowing over the spillway in the area where the flashboards were opened had scoured some of the backfill from beneath the northwest abutment forming a small void. The abutment is founded on rock, so this hole does not appear to be serious.

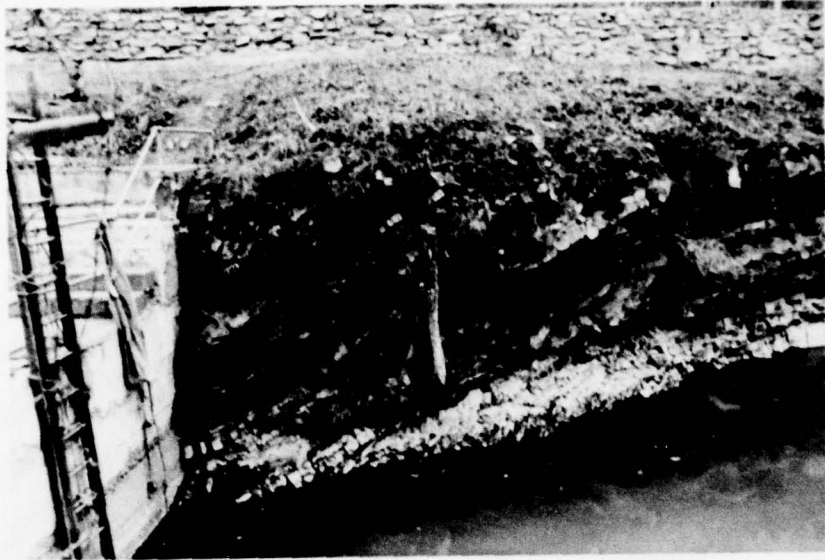
SUBSURFACE STRATA @ POWER STATION

The bedrock at the southeastern abutment was decomposed and fractured. However, the concrete abutment appeared to extend far enough into the rock to provide an adequate cutoff.
